## **Brief Report on Compliance Verification of Common Bio medical Waste Treatment and Disposal Facility operated by M/s. Puducherry Solid waste Management Company Private Limited, Puducherry**

Sub: Brief Report on Compliance Verification of Common Bio medical Waste Treatment and Disposal Facility operated by M/s. Puducherry Solid waste Management Company Private Limited, Puducherry

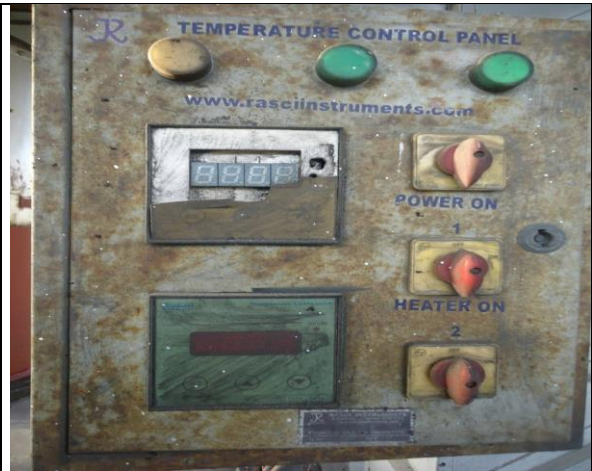
c)	Manual feeding of biomedical waste is in practice in place of conveyer or mechanized feeding device for charging the bio-medical waste in to the incinerator and incinerator is not attaché with PLC system	Still manual feeding is in practice and no PLC provided. <b>Fig.No.1</b> indicates display indicator not working  <b>Not complied</b>

d)	Primary and secondary chambers of the incinerator are not fitted with thermo couples to measure and monitor the temperatures maintained and neither records on operation of incinerator maintained as required under BMW Rules	Thermo couples are provided but digital display not working. It was showing secondary chamber temperature 842 °C. Temperature not maintained as per guidelines. No PLC provided.  <b>Not complied</b>

Fig No.1 Temperature Display not working

3. To provide programmable logic control, Temperature control and recording systems to the primary and secondary chambers.
4. To maintain sufficient quantity of secondary fuel for the burners and to keep the burners in operating condition.

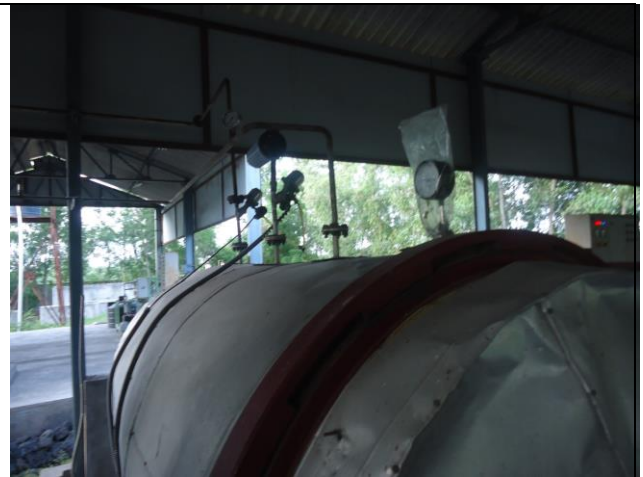
j)	Autoclave installed with the facility is not provided with pressure and temperature measuring devices and neither PLC with recording facilities attached with for recording critical operational parameters are required under the BMW Rules.	Temperature and pressure gauge provided but not connected with PLC and no storage/record on operation ( <b>Fig.No.3</b> ) <b>Not complied</b>

Fig No.3 Pressure guage provided with autoclave

7. To provide online analyzer as to continuously measure the parameters like CO, CO<sub>2</sub>, O<sub>2</sub> and to maintain the record.
8. To provide adequate controls with Autoclave as to store the operating parameters and events and to take up pore and validation test regularly.

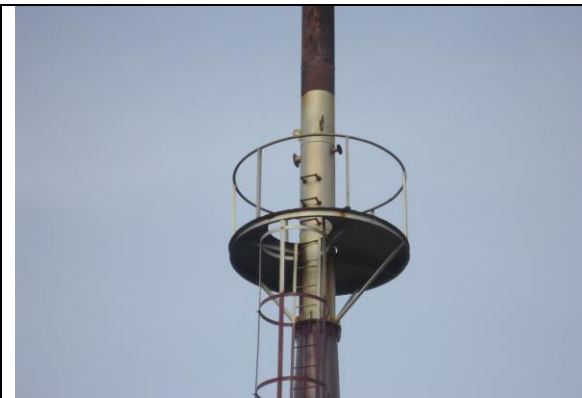
to packed bed column of the APCD	<b>Complied</b>
h)	Monitoring provision provided to the stack attached with the incinerator is not as per the CPCB guidelines ie emissions regulations Part-3	Not as per emissions regulations Part-3. However, source emission monitoring carried out. The Particulate Matter Concentration (with CO <sub>2</sub> Correction) is exceeding and 25 times higher than the limit prescribed.  Condition of plat form reflected in <b>Fig No.2</b> <b>Not complied</b>

Fig. No.2 Platform Condition

5. To provide devices for measuring negative draft in primary chamber and pressure drop across packed bed column of the APCD.
6. To provide proper platform with adequate supports as per emission regulation part – III.

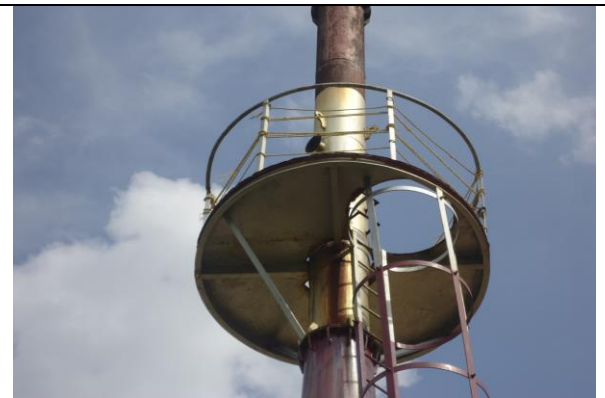
By tying rope around the platform, source emission monitoring carried out

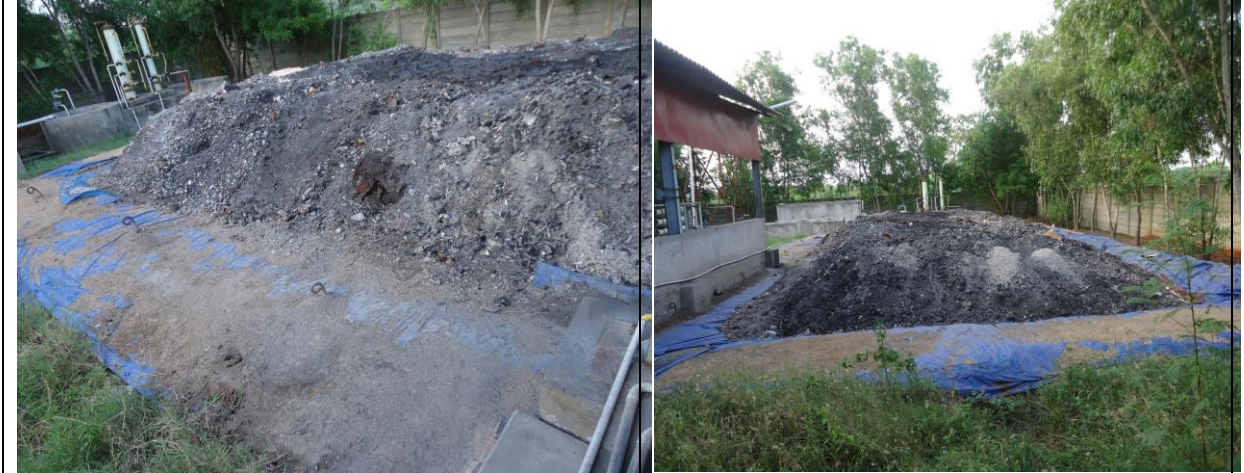
n)	The incineration ash & sludge generated from the facility is stored in the in house land fill site without any pretreatment/stabilization and the liner provided to the in house land fill is not as per the CPCB guidelines	Huge quantity of ash and sludge is stored in open space and further dumping/storage is not possible since already pit is formed heap of waste. ( <b>fig.No.4</b> is self indicative) <b>Not Complied</b>

3	The autoclave and shredder were found to be out of service. The autoclaved plastic syringes and I.V.bottles were stored in bags without shredding. Few bags with plastic bottles and syringes were put on the tree bases.	<p>Autoclave and shredder was in operation during inspection</p> <p style="text-align: right;"><b>Complied</b></p>
4	The BMW transporting vehicle was not labeled properly. Only on the top of the vehicle the name of the company was written with light visibility, which is violation as per the Bio-Medical waste (Management & Handling) Rules, 1998. The lable shall be provided in all the sides.	<p>Few vehicles labeled and others not labeled</p> <p style="text-align: right;"><b>Not Complied</b></p>
5	The secured land fill area is almost filled.	<p><b>Fig No.4</b> is self explanatory</p> <p style="text-align: right;"><b>Not Complied</b></p>

Fig.No.4 Heap formation of Ash and sludge stored

11. To dispose the ash and sludge stored in open space and to stop further dumping/storage with immediate effect.
12. To identify the alternate location for further storage and to ensure to provide proper linings to the storage area as per the guidelines of CPCB.
13. To provide proper labeling to the vehicles used for transporting biomedical waste.
14. To maintain proper record for the waste received, stored, incinerated, auto claved, shredded and quantity of ash & sludge generated, stored and disposed.
