Brief Report on Compliance Verification of Common Bio medical Waste Treatment and Disposal Facility operated by M/s. Puducherry Solid waste Management Company Private Limited, Puducherry

Sub: Brief Report on Compliance Verification of Common Bio medical Waste Treatment and Disposal Facility operated by M/s. Puducherry Solid waste Management Company Private Limited, Puducherry

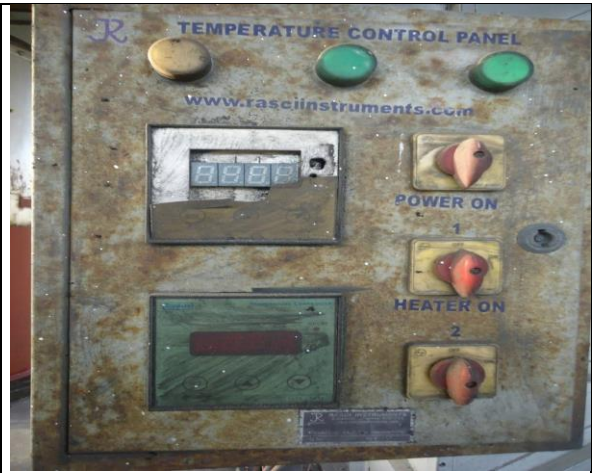
c)	Manual feeding of biomedical waste is in practice in place of conveyer or mechanized feeding device for charging the bio-medical waste in to the incinerator and incinerator is not attaché with PLC system	Still manual feeding is in practice and no PLC provided. Fig.No.1 indicates display indicator not working Not complied

d)	Primary and secondary chambers of the incinerator are not fitted with thermo couples to measure and monitor the temperatures maintained and neither records on operation of incinerator maintained as required under BMW Rules	Thermo couples are provided but digital display not working. It was showing secondary chamber temperature 842 °C. Temperature not maintained as per guidelines. No PLC provided. Not complied

Fig No.1 Temperature Display not working

3. To provide programmable logic control, Temperature control and recording systems to the primary and secondary chambers.
4. To maintain sufficient quantity of secondary fuel for the burners and to keep the burners in operating condition.

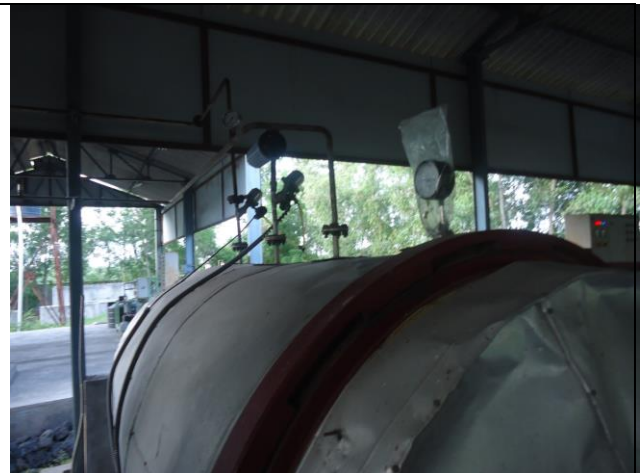
j)	Autoclave installed with the facility is not provided with pressure and temperature measuring devices and neither PLC with recording facilities attached with for recording critical operational parameters are required under the BMW Rules.	Temperature and pressure gauge provided but not connected with PLC and no storage/record on operation (Fig.No.3) Not complied

Fig No.3 Pressure guage provided with autoclave

7. To provide online analyzer as to continuously measure the parameters like CO, CO₂, O₂ and to maintain the record.
8. To provide adequate controls with Autoclave as to store the operating parameters and events and to take up pore and validation test regularly.

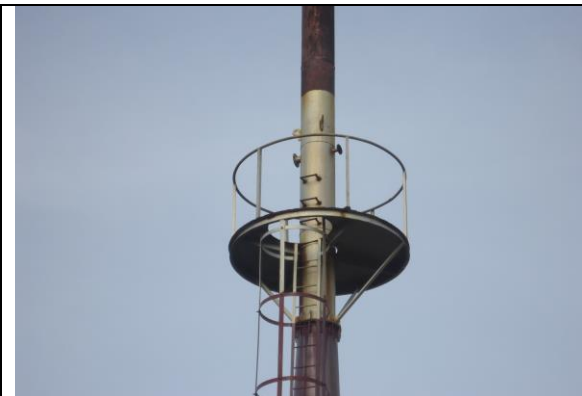
to packed bed column of the APCD	Complied
h)	Monitoring provision provided to the stack attached with the incinerator is not as per the CPCB guidelines ie emissions regulations Part-3	Not as per emissions regulations Part-3. However, source emission monitoring carried out. The Particulate Matter Concentration (with CO ₂ Correction) is exceeding and 25 times higher than the limit prescribed. Condition of plat form reflected in Fig No.2 Not complied

Fig. No.2 Platform Condition

5. To provide devices for measuring negative draft in primary chamber and pressure drop across packed bed column of the APCD.
6. To provide proper platform with adequate supports as per emission regulation part – III.

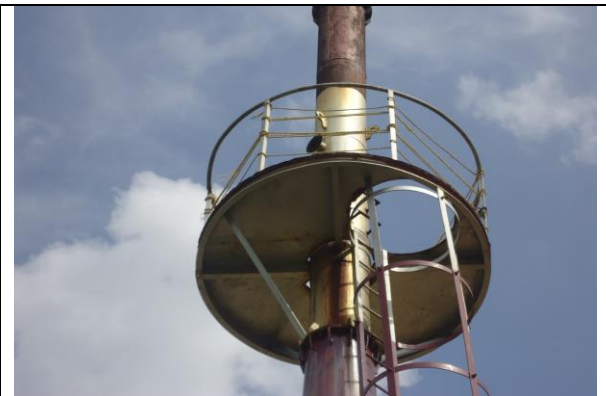
By tying rope around the platform, source emission monitoring carried out
