Brief Report on Compliance Verification of Common Bio medical Waste Treatment and Disposal Facility operated by M/s. Puducherry Solid waste Management Company Private Limited, Puducherry

Sub: Brief Report on Compliance Verification of Common Bio medical Waste Treatment and Disposal Facility operated by M/s. Puducherry Solid waste Management Company Private Limited, Puducherry

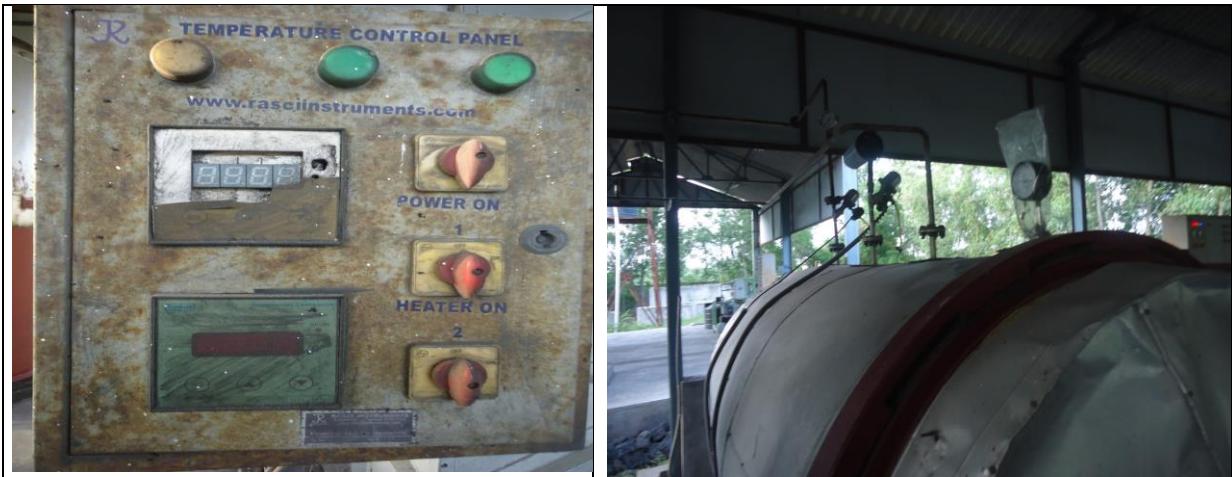
c)	Manual feeding of biomedical waste is in practice in place of conveyer or mechanized feeding device for charging the bio-medical waste in to the incinerator and incinerator is not attaché with PLC system	Still manual feeding is in practice and no PLC provided. Fig.No.1 indicates display indicator not working Not complied

d)	Primary and secondary chambers of the incinerator are not fitted with thermo couples to measure and monitor the temperatures maintained and neither records on operation of incinerator maintained as required under BMW Rules	Thermo couples are provided but digital display not working. It was showing secondary chamber temperature 842 °C. Temperature not maintained as per guidelines. No PLC provided. Not complied

j)	Autoclave installed with the facility is not provided with pressure and temperature measuring devices and neither PLC with recording facilities attached with for recording critical operational parameters are required under the BMW Rules.	<p>Temperature and pressure gauge provided but not connected with PLC and no storage/record on operation (Fig.No.3)</p> <p style="text-align: right;">Not complied</p>

Fig No.1 Temperature Display not working

Fig No.3 Pressure guage provided with autoclave

3. To provide programmable logic control, Temperature control and recording systems to the primary and secondary chambers.
4. To maintain sufficient quantity of secondary fuel for the burners and to keep the burners in operating condition.

7. To provide online analyzer as to continuously measure the parameters like CO, CO₂, O₂ and to maintain the record.
8. To provide adequate controls with Autoclave as to store the operating parameters and events and to take up pore and validation test regularly.

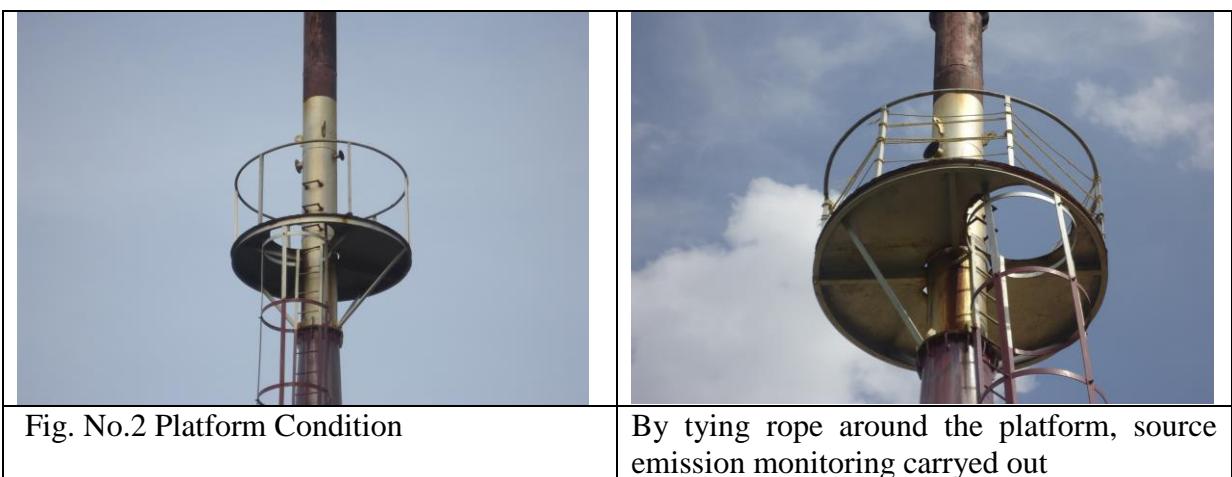
Fig. No.2 Platform Condition

to packed bed column of the APCD	Complied
h)	Monitoring provision provided to the stack attached with the incinerator is not as per the CPCB guidelines ie emissions regulations Part-3	<p>Not as per emissions regulations Part-3. However, source emission monitoring carried out.</p> <p>The Particulate Matter Concentration (with CO₂ Correction) is exceeding and 25 times higher than the limit prescribed.</p> <p>Condition of plat form reflected in Fig No.2</p> <p style="text-align: right;">Not complied</p>

By tying rope around the platform, source emission monitoring carried out

5. To provide devices for measuring negative draft in primary chamber and pressure drop across packed bed column of the APCD.
6. To provide proper platform with adequate supports as per emission regulation part – III.

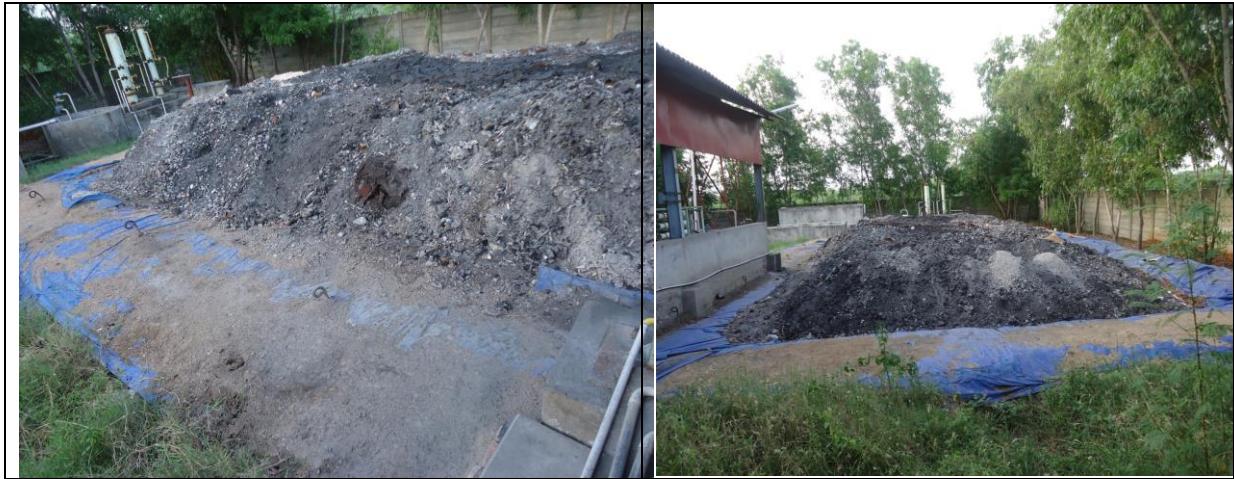
n)	The incineration ash & sludge generated from the facility is stored in the in house land fill site without any pretreatment/stabilization and the liner provided to the in house land fill is not as per the CPCB guidelines	<p>Huge quantity of ash and sludge is stored in open space and further dumping/storage is not possible since already pit is formed heap of waste. (fig.No.4 is self indicative)</p> <p style="text-align: right;">Not Complied</p>

3	The autoclave and shredder were found to be out of service. The autoclaved plastic syringes and I.V.bottles were stored in bags without shredding. Few bags with plastic bottles and syringes were put on the tree bases.	<p>Autoclave and shredder was in operation during inspection</p> <p style="text-align: right;">Complied</p>
4	The BMW transporting vehicle was not labeled properly. Only on the top of the vehicle the name of the company was written with light visibility, which is violation as per the Bio-Medical waste (Management & Handling) Rules, 1998. The lable shall be provided in all the sides.	<p>Few vehicles labeled and others not labeled</p> <p style="text-align: right;">Not Complied</p>
5	The secured land fill area is almost filled.	<p>Fig No.4 is self explanatory</p> <p style="text-align: right;">Not Complied</p>

Fig.No.4 Heap formation of Ash and sludge stored

11. To dispose the ash and sludge stored in open space and to stop further dumping/storage with immediate effect.
12. To identify the alternate location for further storage and to ensure to provide proper linings to the storage area as per the guidelines of CPCB.
13. To provide proper labeling to the vehicles used for transporting biomedical waste.
14. To maintain proper record for the waste received, stored, incinerated, auto claved, shredded and quantity of ash & sludge generated, stored and disposed.
