**INSPECTION REPORT ON
M/S EVB TECHNOLOGIES PVT. LTD.,
CBWTF, KANAVARAM,
PALLAKADIUM VILLAGE,
RAJANAGARAM MANDAL,
EAST GODAVARI DISTRICT,
ANDHRA PRADESH**

**ZONAL
OFFICE (SOUTH),
BENGALURU**

PHOTOGRAPHS TAKEN DURING INSPECTION

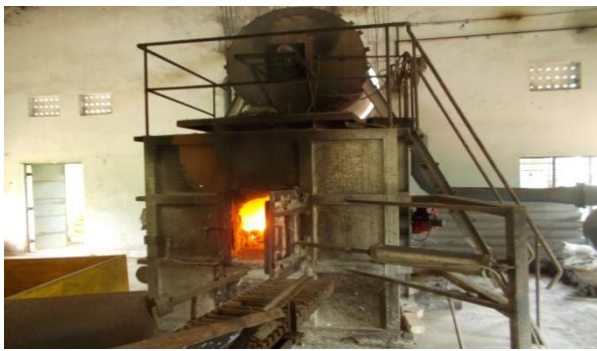
18.2	List the shortcomings and any other observations on incineration system with reference to guidelines	1. Provision has not been made in the primary chamber to measure the water column pressure. 2. Scrubbing medium was not used with Venturi & Wet Scrubbers due to damage occurred in these APCDs.

Fig 3: View of incinerator

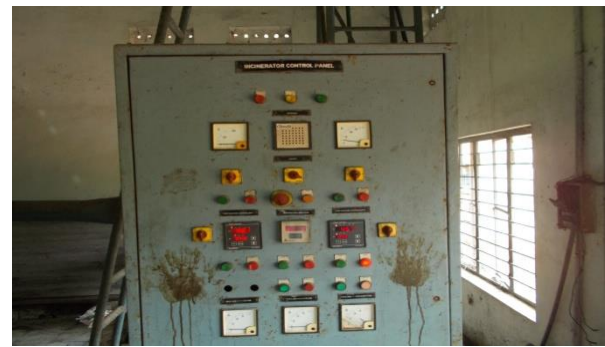
Fig 4: View of Programmable Logic Control
