**INSPECTION REPORT ON
M/S EVB TECHNOLOGIES PVT. LTD.,
CBWTF, KANAVARAM,
PALLAKADIUM VILLAGE,
RAJANAGARAM MANDAL,
EAST GODAVARI DISTRICT,
ANDHRA PRADESH**

**ZONAL
OFFICE (SOUTH),
BENGALURU**

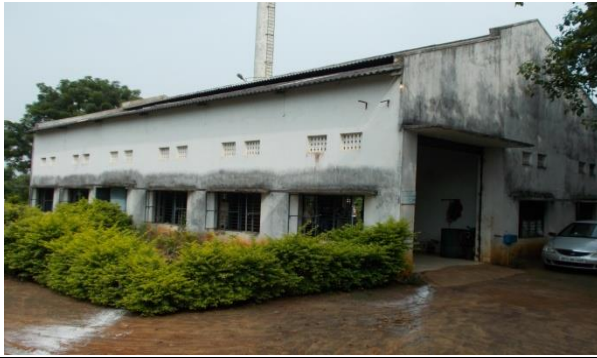
Fig 1: View of the facility

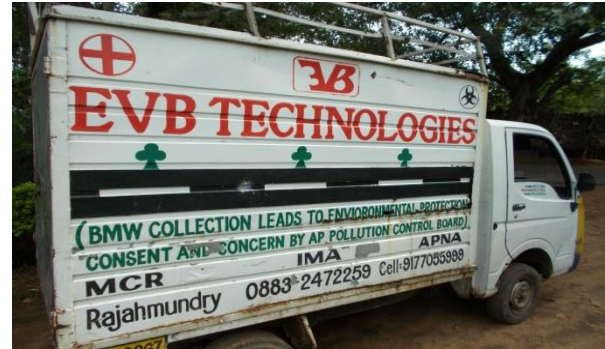
Fig 2: View of BM waste transporting vehicle

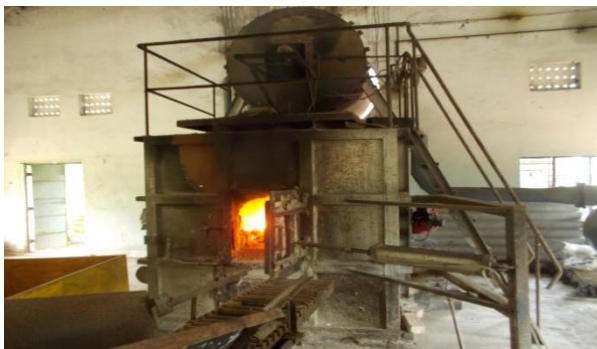
| 18.2 | List the shortcomings and any other observations on incineration system with reference to guidelines | 1. Provision has not been made in the primary chamber to measure the water column pressure. 2. Scrubbing medium was not used with Venturi & Wet Scrubbers due to damage occurred in these APCDs. |

Fig 3: View of incinerator

| 26.0 | <p>RECOMMENDATIONS:</p> <p>The facility should be directed:-</p> <ul style="list-style-type: none"> — To take control measures to maintain the pH of discharged effluent from ETP within the limit as prescribed in the consent order immediately. — To install the devices to measure negative draft in primary chamber, air flow rate in the incinerator chamber and pressure drop across venturi scrubber attached with the incinerator. — To have flue gas analyzer to measure CO, CO₂ and O₂ levels in stack gases daily. — To make provision with the autoclave for mechanical feeding. — To upgrade the existing facility of the autoclave in order to record pressure details and load identification number along with date, time and temperature. — To subject the waste in the autoclave to i) a temperature of not less than 121 °C and pressure of 15 psi per an autoclave residence time of not less than 45 minutes or ii) a temperature of not less than 135 °C and pressure of 31 psi per an autoclave residence time of not less than 30 minutes in the case of vacuum autoclave possessed by the unit. — To carry out the stack emission monitoring of the incinerator stack for PM, HCl, NO_x, CO, CO₂, O₂ & CE, also, the volatile organic matter in the incinerator ash, validation test of autoclave and applicable parameters for liquid effluent, if discharged, through approved laboratory and submit the quarterly report to SPCB. — To provide acoustic barrier with the D.G. Set and installation of stack as per norms of Emission Regulation Part – IV. — To make provision in the primary chamber to measure the water column pressure as minimum negative draft of 1.27 to 2.54 mm of water column to be maintained to avoid leakage of gaseous emissions from the chamber and also for safety reasons. — To replace the scrubber and cyclone dust collector at the earliest and not to allow to |

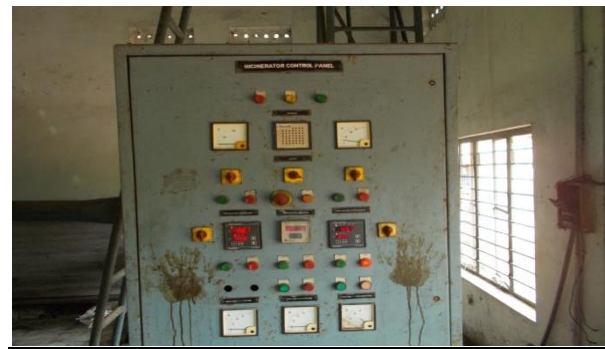
Fig 4: View of Programmable Logic Control

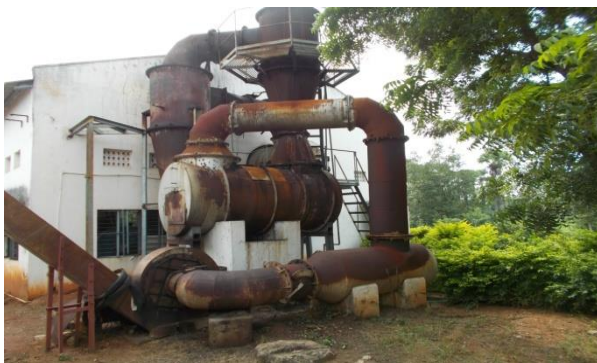
| | <p>pressure.</p> <ul style="list-style-type: none"> • Scrubbing medium was not used with Venturi & Wet Scrubbers due to damage occurred in scrubber tank. To replace the scrubber and cyclone dust collector, the facility has already placed the work order and a copy of which was shown during inspection. • No provision for mechanical feeding exists with the autoclave. Autoclave record shows that it records only date, time and temperature. There is no facility to record load identification number and pressure details. Pressure Gauge found not working |

Fig 5:View of APCDs attached with incinerator

| | <p>operate the system without scrubbing medium.</p> <p>— To display an identification board of durable material covering the name of the facility, the name, address and telephone number of the operator and the prescribed authority, the hours of operation and the telephone numbers of personnel to be contacted in the event of an emergency along with hazardous waste generation & its disposal details, standards prescribed in the combined consent order etc. at the entrance of the facility.</p> | |

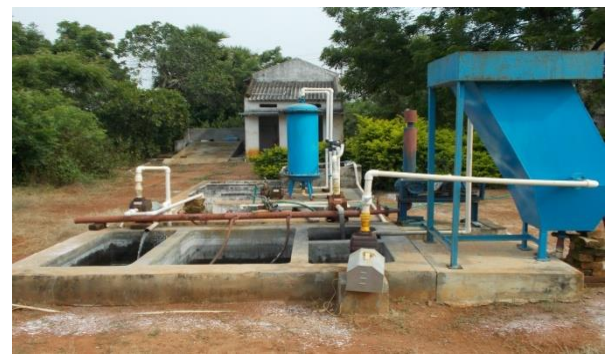
| 18.10 | Effluent treatment plant details | Collection Tank having Zig Zag System → Eq. tank → Primary Settling Tank → Aeration Tank → Sec. Clarifier → Sand filter → Carbon filter → Treated water collection tank → This treated water is used for gardening. As scrubbing liquid was not used in ventury and scrubber due to damage occurred in these equipments, there was no liquid effluent from this section to ETP. Now, only the effluent generated during washing is treated in ETP as informed by the industry. There was no influent to ETP during inspection. |

The above results show that the pH of the discharged effluent is highly acidic and not as per the prescribed limit. The test report is enclosed here with as **Annexure – 3**.

Fig 6: View of ETP

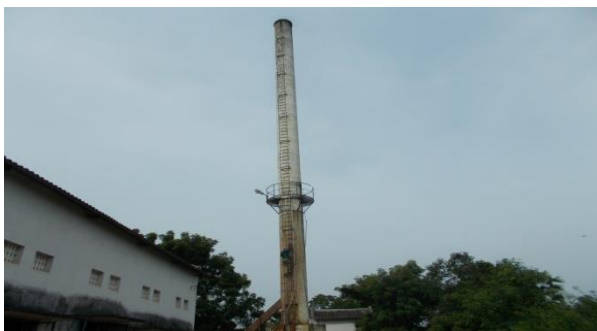
The above stack emission monitoring results reveal that the Combustion Efficiency is 97.35% which is less than the limit prescribed of minimum 99% under Schedule V of the BMW Rules. The test report is enclosed here with as **Annexure – 2**.

Fig 7: View of stack connected to incinerator

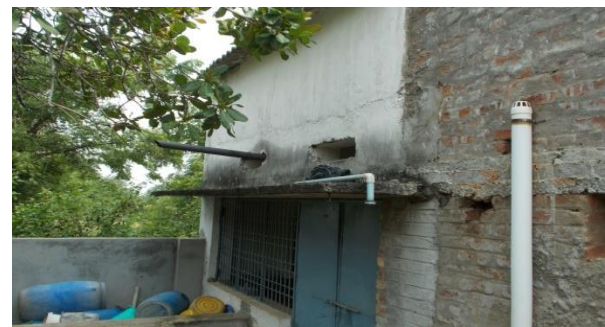
- The facility is having 55 KVA D.G. Set. Acoustic barrier not provided and stack provided is not as per norms of Emission Regulation Part - IV.
- Provision has not been made in the primary chamber to measure the water column

Fig 8: View of D.G.Set room where stack of D.G.Set projected side ways
