**CENTRAL POLLUTION CONTROL BOARD
ZONAL OFFICE (SOUTH), BENGALURU**

**REPORT ON MUNICIPAL SOLID WASTE MANAGEMENT &
PROCESSING FACILITY AT KOCHI, KERALA**

Photographs of MSWDF at Brahmapuram, Kochin

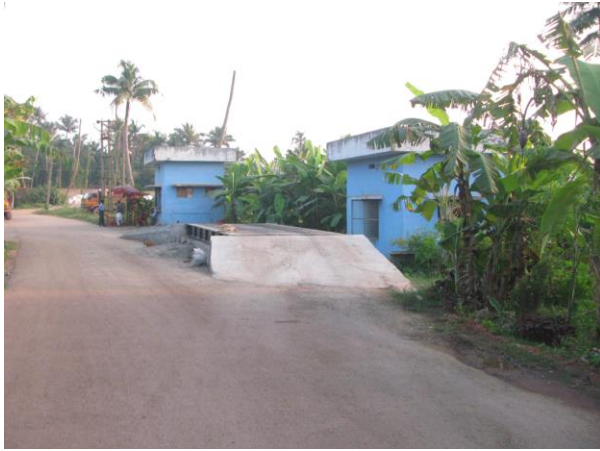
On the day of inspection **11.12.2013**, it was observed that the quantity of municipal received by the facility was 96.780 MT in a 27 trips of vehicle from 12.30 Hrs. to 16.15Hrs. The unit has Weigh Bridge to record the quantity of solid wastes received and vehicle details, time of arrival are maintained in a record.

Fig.1 : Weigh Bridge at the entrance

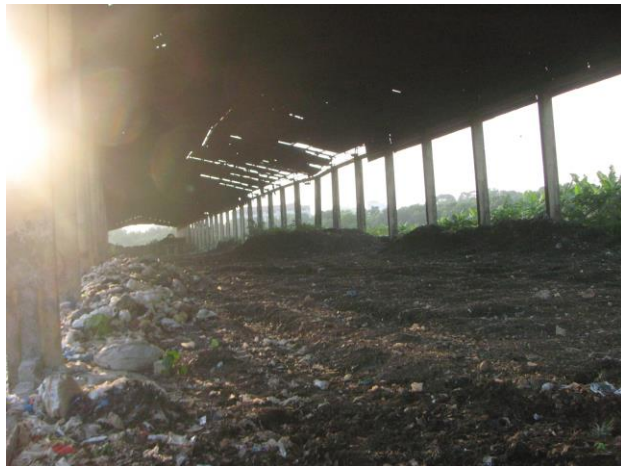
- The waste storage area is provided with shed, but due to poor design & construction, the sheds have collapsed at many places and not repaired and maintained. This facility is developed with a fund of Jawaharlal Nehru National Urban Renewal Mission.

Fig.3 : Shed used for MSW storage

- To repair the existing sheds provided for composting and replacing the damaged roofs. Also clear the plantation inside the shed area and drain area.
- To reconstruct the existing drains with proper system for collection of leachate and treatment of the same.

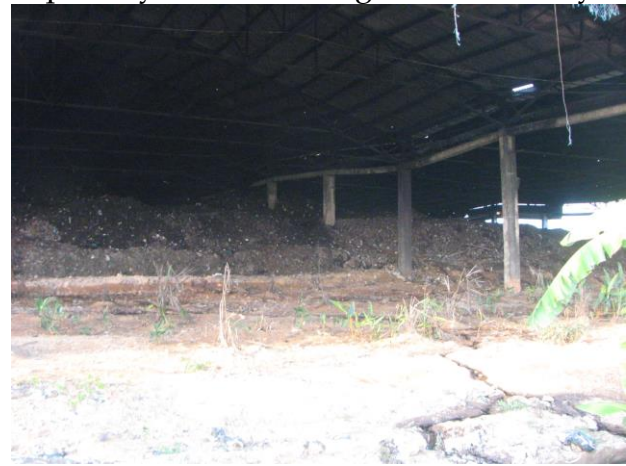
Fig.4 : Collapsed shed

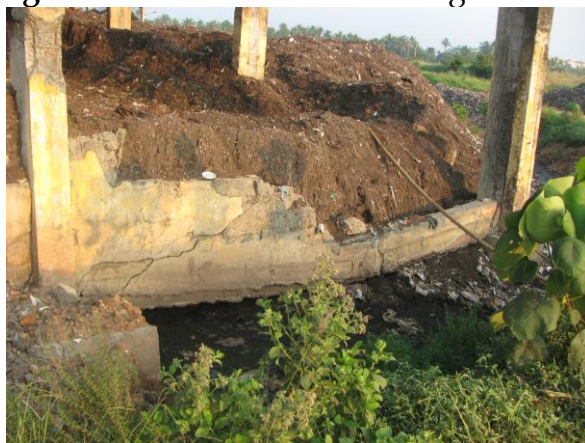
Fig.5 : collapsed structures

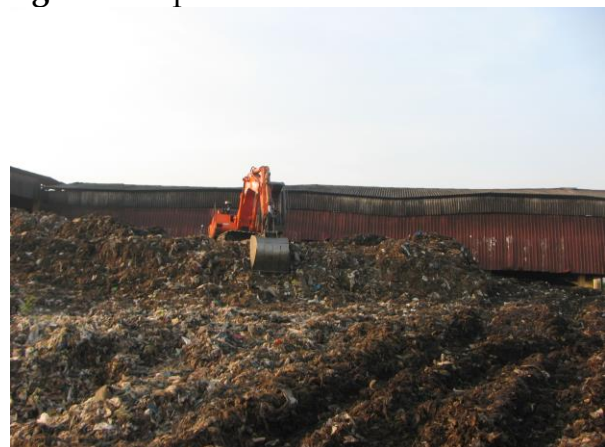
Fig.6 : Excess MSW stored in open place

- To stop dumping / storing of municipal solid waste in open place and utilise the shed area optimise for composting.
- To pave all the internal roads and develop storm water drain on the both side of the road.

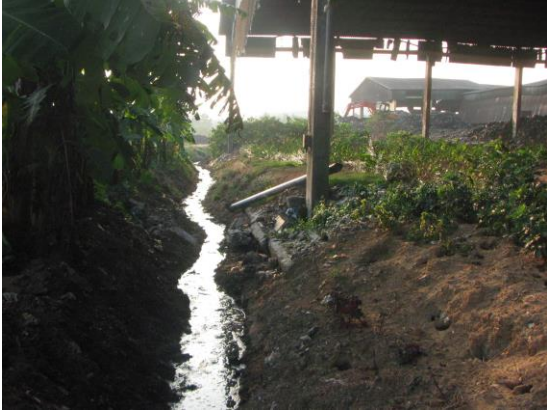
The leachate collection system, drainage system provided for totally collapsed. There is no proper maintenance & operation of the system. Housekeeping of area is very poor.

- The garland drains provided compost yard is damaged fully, leachate are poorly managed. There is no leachate treatment system, the entire leachate is utilised for plantation.

Fig.7 : No proper drain for leachate carrying, Kaccha drain

- To reconstruct and maintain the leachate treatment system.
- To improve the house keeping in process area and composting area.
- To meet the prescribed compost quality standards w.r.t Copper, to ensure safe application of compost.

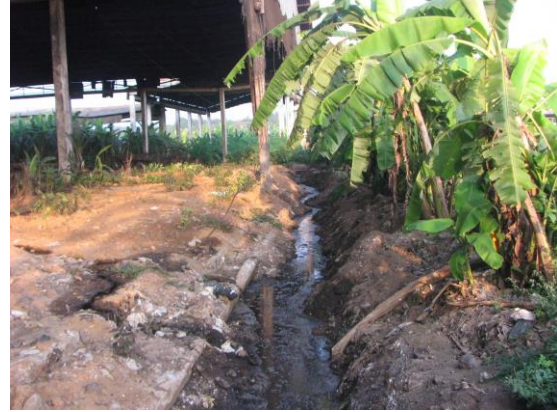
- The facility is provided with approach and internal roads for free movement up to compost area. The internal roads are to be paved and the existing storm water drains are totally collapsed not in a position to repair. The entire system to be reconstructed.

Fig. 8: Damaged drains, plantation done inside the shed area too.

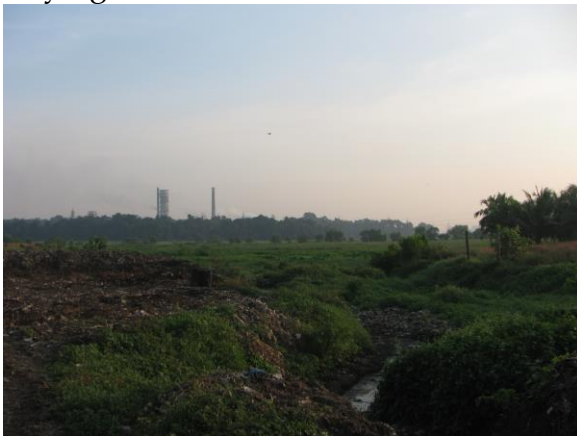
Fig.9 : Entire Leachate is used for land application

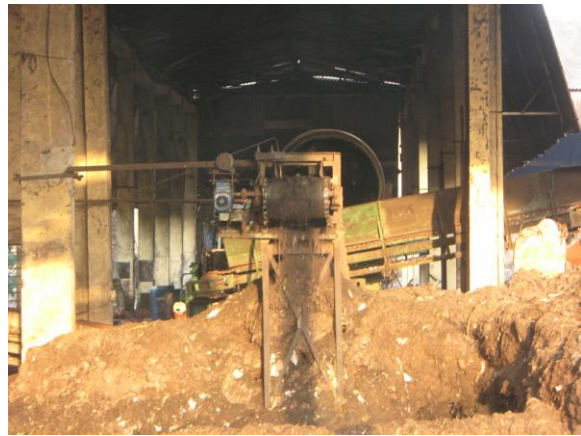
Fig.10 : Compost processing area

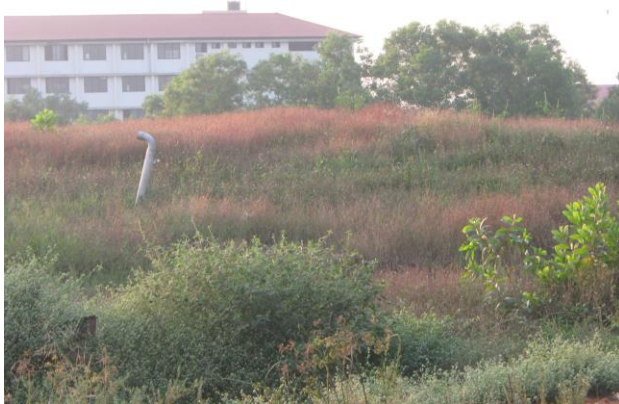
Fig.11 : Old landfill with gas venting system

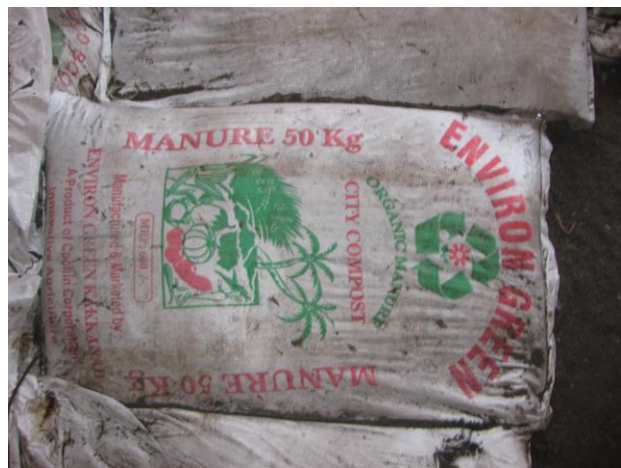
- The parameter with respect to copper is exceeding the standard in finished compost.
- The finished compost is marketed in the name of Enviro Green City Compost in 50 kg bags. This is sold at the rate of Rs. 5 per kg.
- The relevant Photographs are attached as **Annexure 1**.

Fig.12 : Finished Compost for sale
