**Central Pollution Control Board**  
**South Zone Office, Bengaluru-560079**

COMMENTS AND FOLLOW - UP

The following observations have been made during visit at **Tamilnadu**. State Pollution Control Board **Salem Advanced Environmental** Laboratory from **CPCB, South Zonal Office Bangalore**.

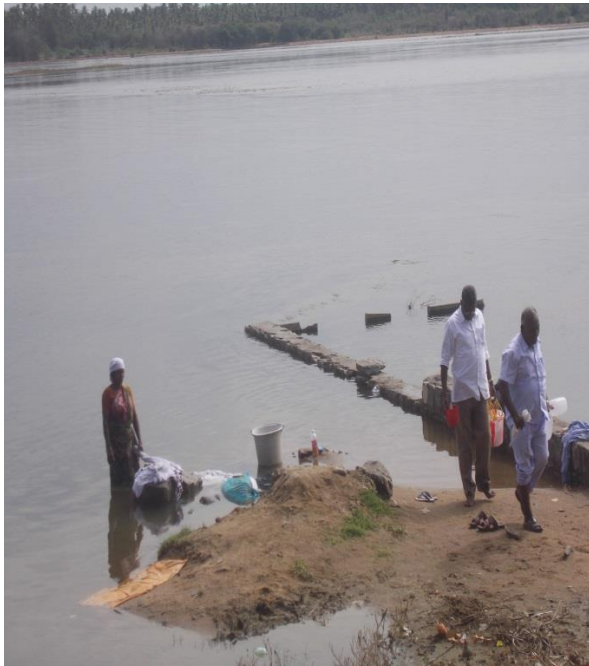
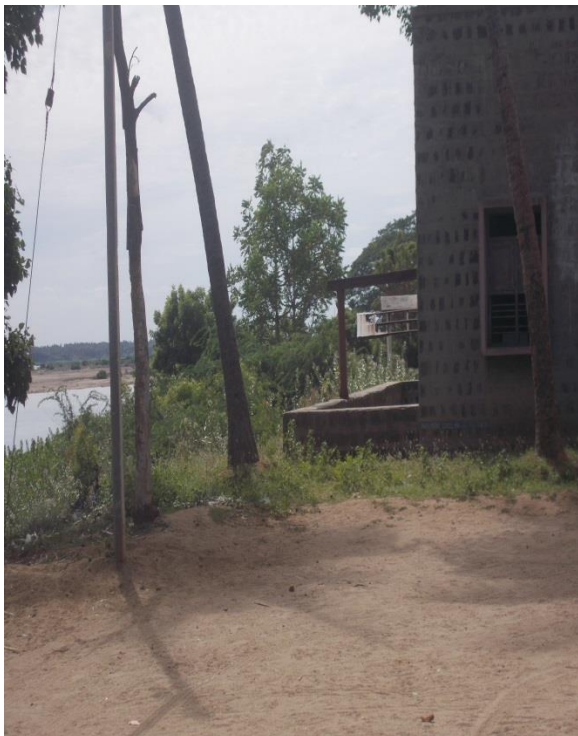
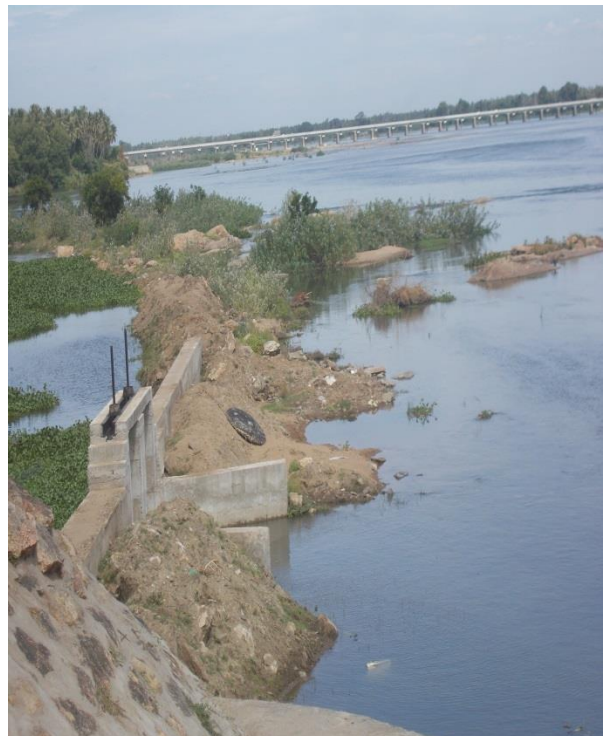
**Fig. no.1 : NWMP Location located in Pugalur ( SC-3015) – near to this station activities such as washing of cloths, irrigation diversion head and drinking water intake well were found.**

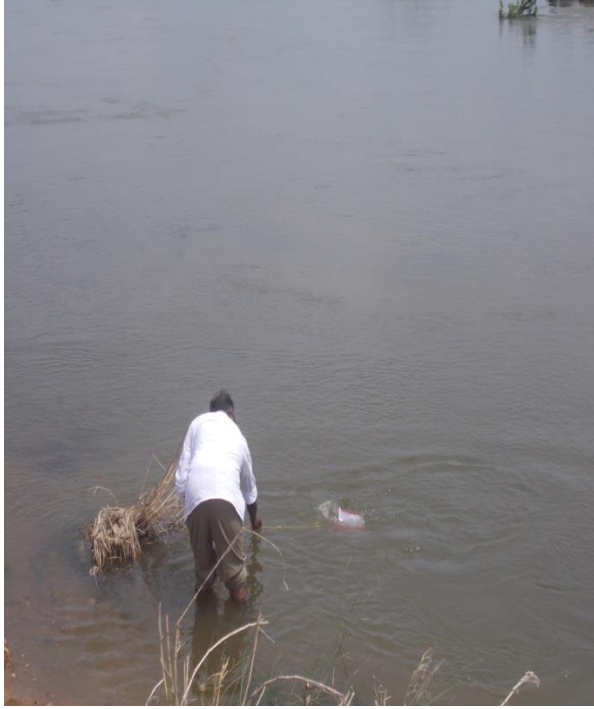
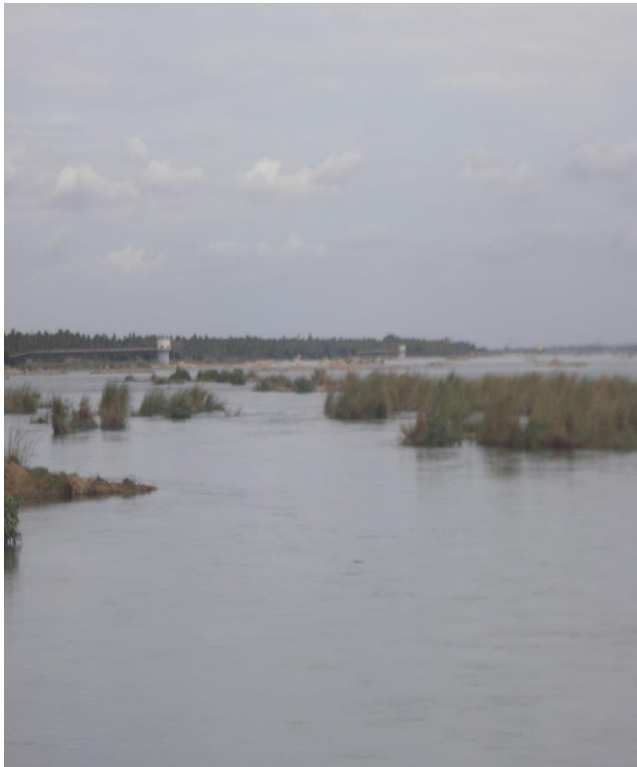
**Fig. no.2 : NWMP Location located in Thirumukudal ( SC-14515) – activities such as drinking water intake well were found upstream of this station and near to this confluence of Amaravathi river which is carrying karur treated/untreated sewage was found.**
