**BEFORE THE HON'BLE NATIONAL GREEN TRIBUNAL,
Principal Bench, New Delhi**

O.A. No. 304/2019

S. No.	Particulars	Page No.
1.	Report of the Joint Committee in compliance of orders dated 09-12-2021 & 18-01-2023 in O.A. No. 304/2019, M. Haridasan Vs. State of Kerala & ors.

**BEFORE THE NATIONAL GREEN
TRIBUNAL, PRINCIPAL BENCH,
NEW DELHI**

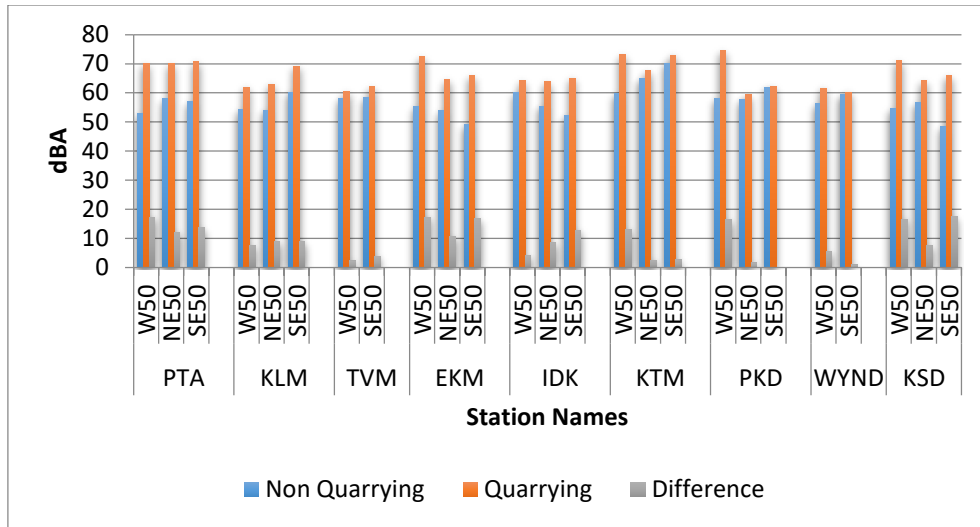
Figure 3: Difference in noise dB Leq (A) values at 50, 100 & 200 m station.

- Thus it is observed that contribution to the ambient noise due to overall quarry operation is significant in six quarries up to a distance of 100m and up to 200m in three quarries.

- Effect of noise pollution is significant up to 200 m in quarries monitored in Pathanamthitta, Ernakulam and Palakkad.
- Ambient noise standards of 55 dB(A) for residential areas are applicable from the boundary of quarry/ lease area and any increase in ambient noise by 10 dB(A) shall be deemed as violation/ exceedance in noise. As per the assessment noise significantly increased by more than 10 dB(A) up to 200m.

- Noise differences recorded at small quarries (Kollam and Wayanad) were below the 10 dB(A) and hence insignificant.
- It was observed that at noise monitoring stations at 200 m extraneous noise from other sources were reported by the monitoring team at various locations. Noise from the roads/ traffic/ public places contributed to the overall ambient noise in few locations. Hence, the influence of noise may be limited to 150m and not till 200m. For practical purposes with NONEL technology, it would be safe to earmark an area of 150m from the blasting zone as a noise influence area.

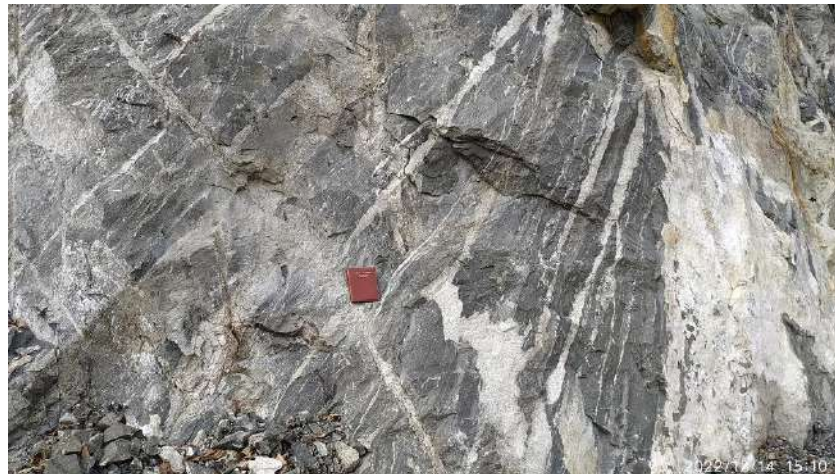
Plate 5.1.2. View of nature of rock deposit in Granite Building Stone Quarry

Studies on the land profile, nature of rock deposit and rebound hardness on the fresh rock surfaces were also conducted. It was observed that some of the residential houses are located at higher level than the quarry operations. The rock deposits are found to be massive in nature with limited joints (**Plates 5.1.2 & 5.1.3**). Rebound hardness values tested on the fresh rock surface varied from 52 to 70 and the average value is 61.10.

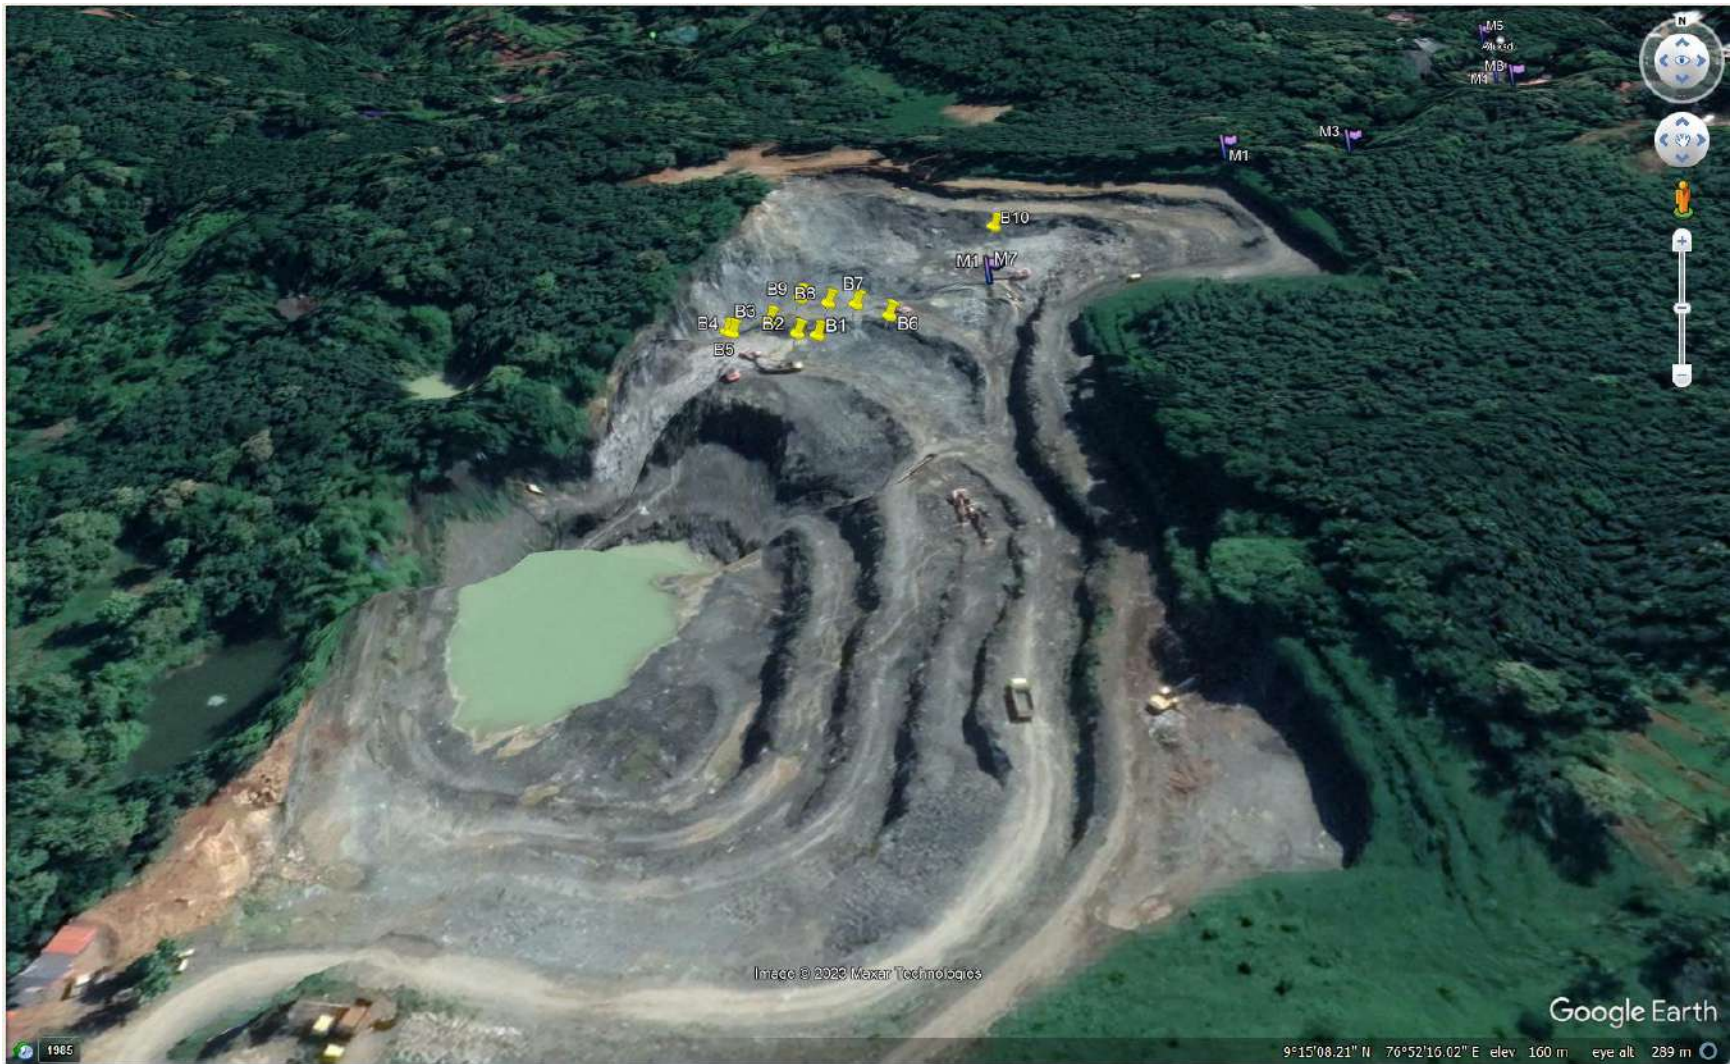
Figure 5.1.1. Google map showing location of experimental blasts (B#1 to 10) at Granite Building Stone Quarry of M/s Adukadu Granites Private Limited, Pathanamthitta District

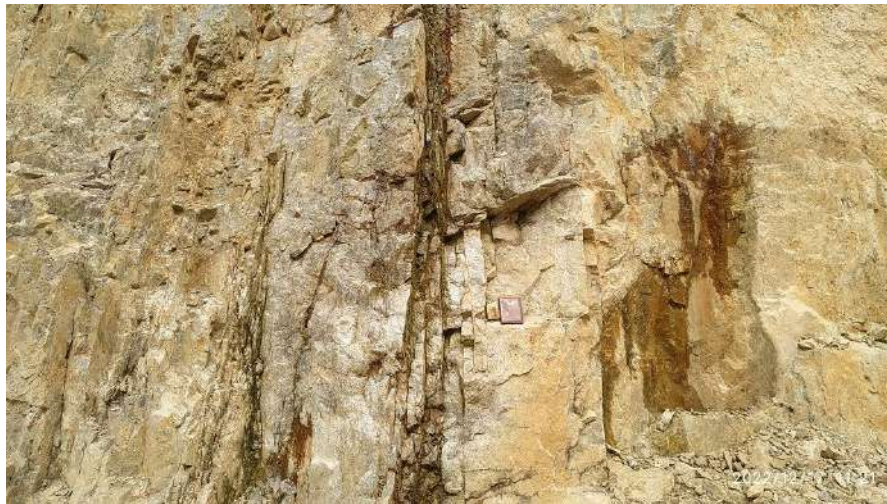
Plate 5.2.2. View of closely spacing joints dipping towards East

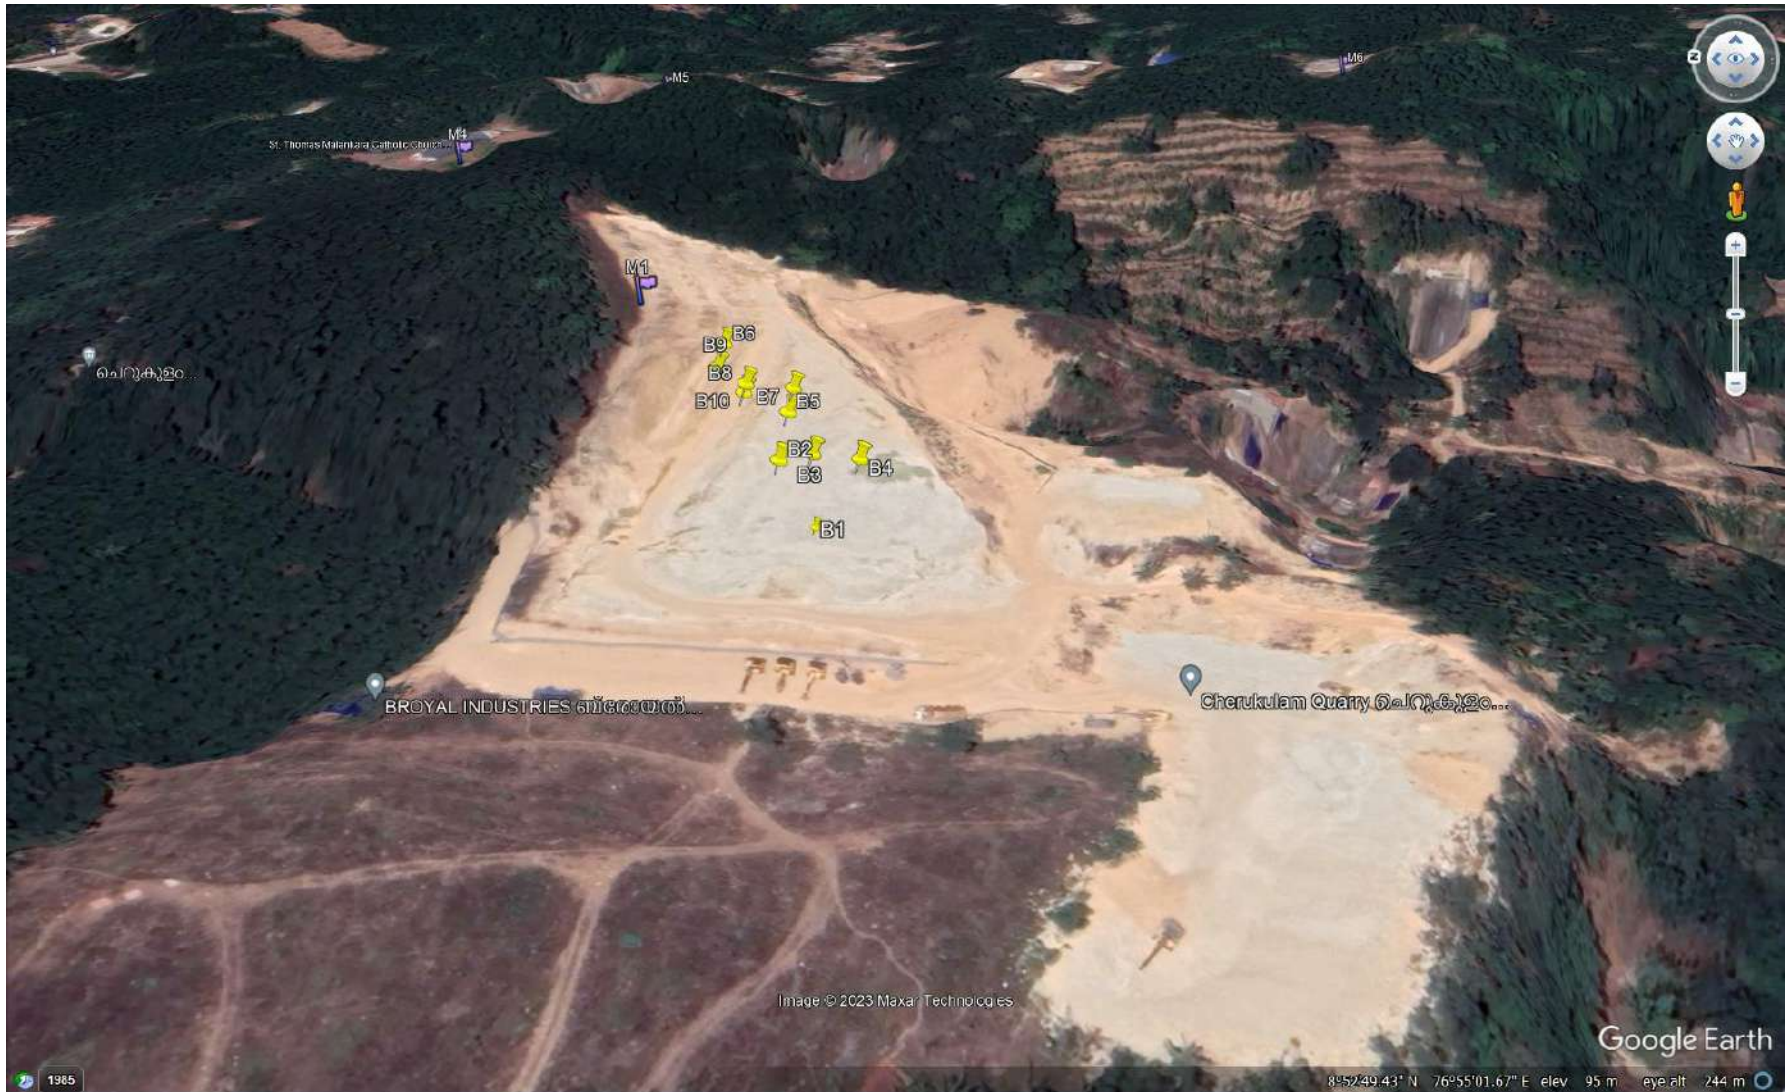
Figure 5.2.1. Google map showing locations of the experimental blasts at granite building stone quarry of Muhammad Roshen, Kollam District

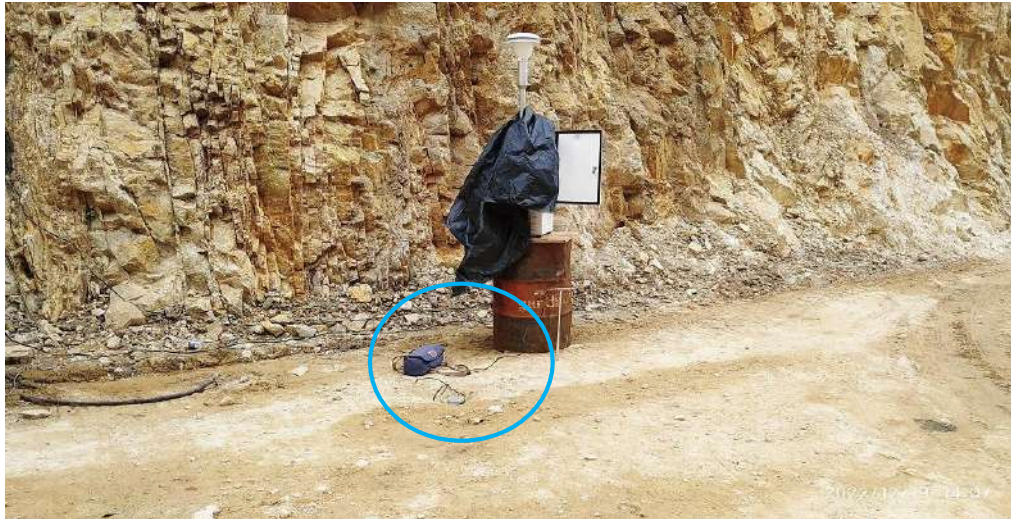
Plate 5.2.7. View of vibration monitoring point on the haul road

The geophone of the seismographs was firmly fixed on ground surfaces using Plaster of Paris. Microphone for recording air overpressure were also fixed near the geophones. The distances of vibration monitoring points from the different experimental blasts varied from 50 to 500 m.

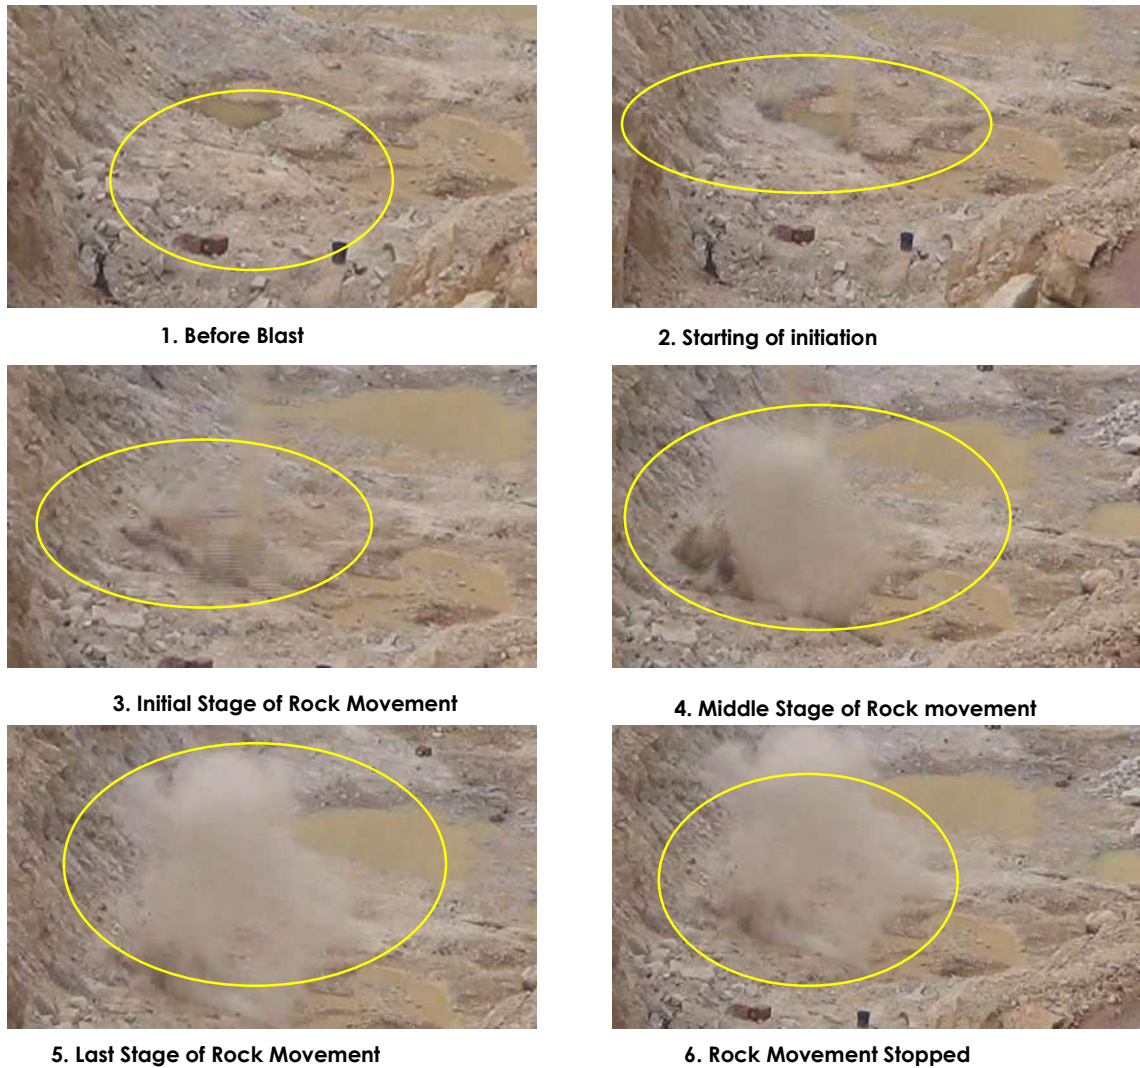
Figure 5.2.16. View of the sequences of rock movement in the Experimental Blast at granite building stone quarry of Muhammad Roshen, Kollam District

In some of the experimental blasts, burden and spacing were reduced to obtain better rock fragmentation with the same explosive charge. Muffling was also done using belt conveyors and sandbags. Flyrocks were completely controlled in all the blasts. The blasting event recorded in one of the experimental blasts, i.e. Blast No. 4 is shown in **Figure 5.2.16**.

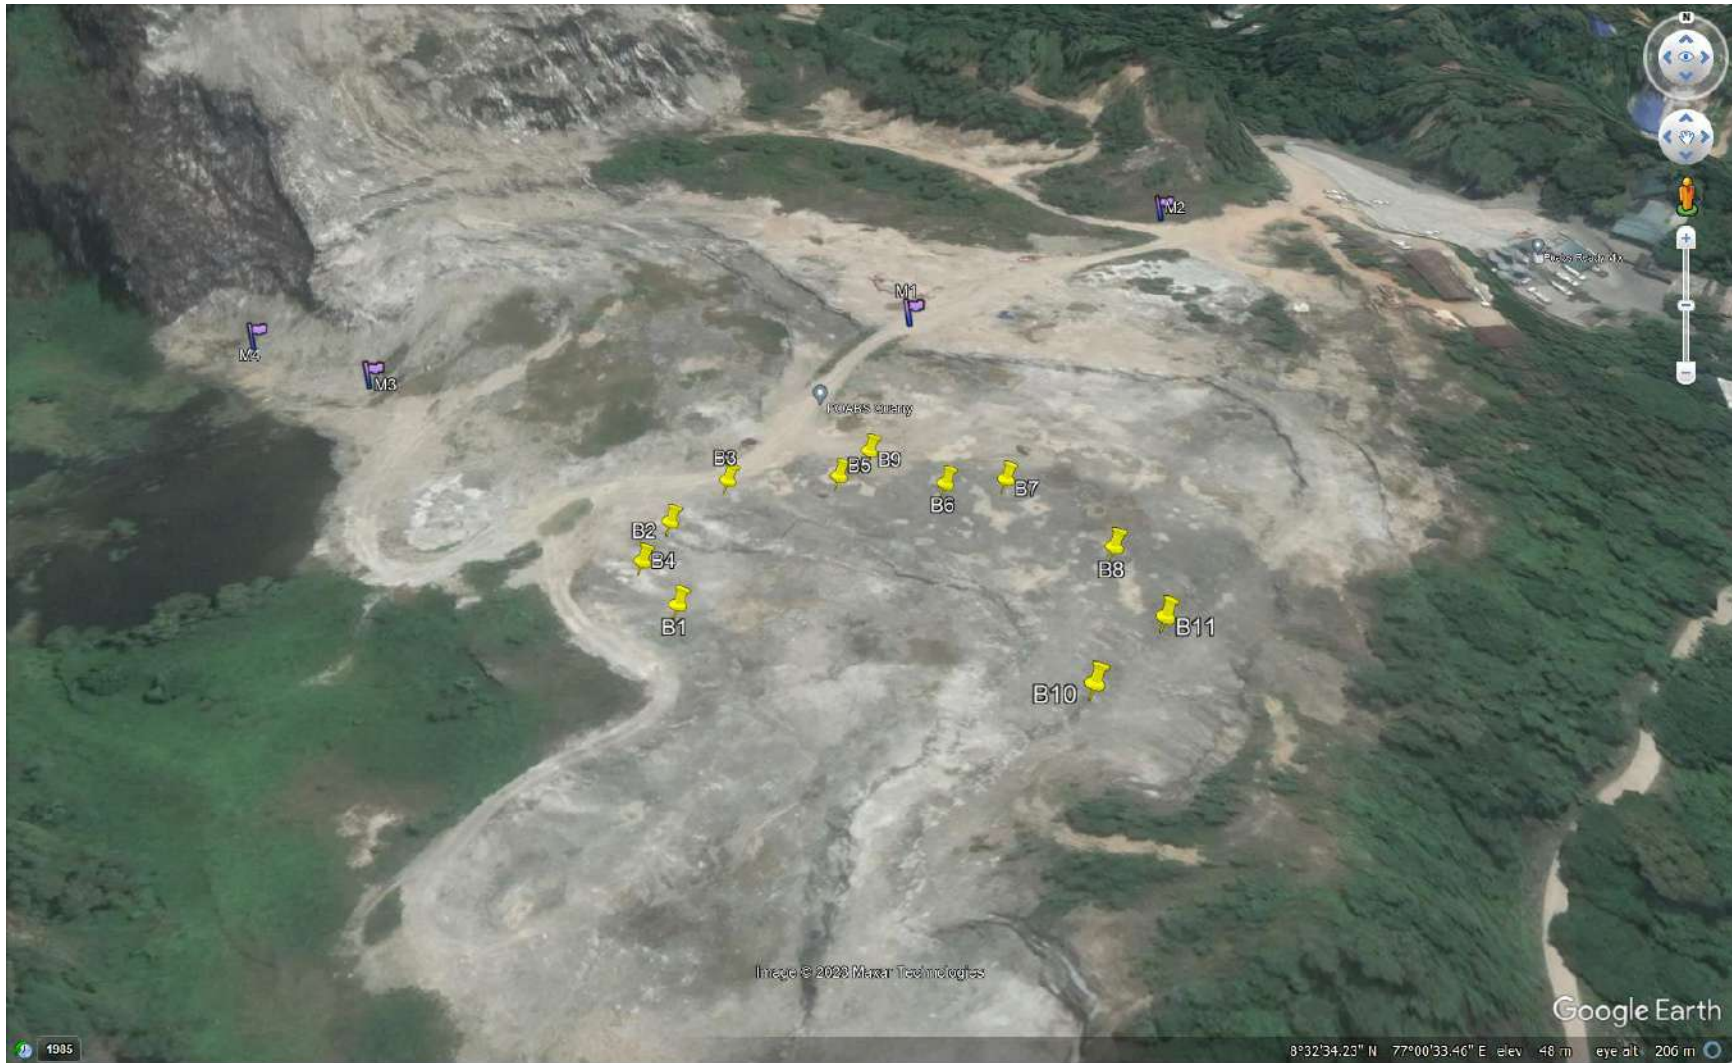
Figure 5.3.2. Google map showing location of experimental blasts at granite building stone quarry of M/s POABS Granites Pvt. Ltd., Trivandrum

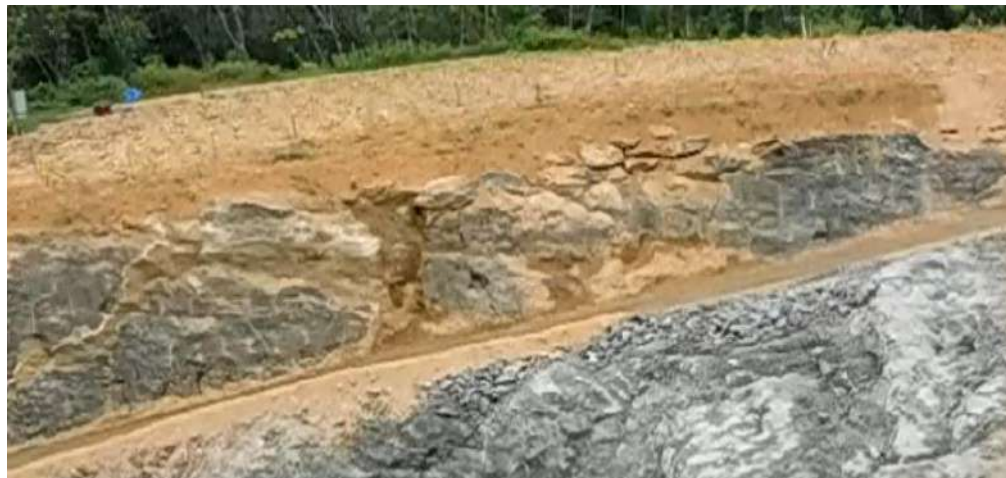
Plate 5.4.3. Variation in top strata matrix at Parackal Stone Quarry

The highest elevation of the mine area is 90 m MSL, in the SW central part and lowest is 45 m MSL, in the north direction. Topographically, the area is undulating. Main rock type in the mine area is granite building stone. At places where there are exposed, the granite building stone is medium to coarse grained with dark grey quartz. The soil and over burden thickness (soil-mixed boulders) in the mine area varies between 0.5 m to 5 m (**Plate 5.4.3**). The rebound hardness of rockmass tested using Schmidt hammer was in between 48 to 60 indicating hard rock mass. It was observed that some of the residential houses were located at higher level than the quarry operations.

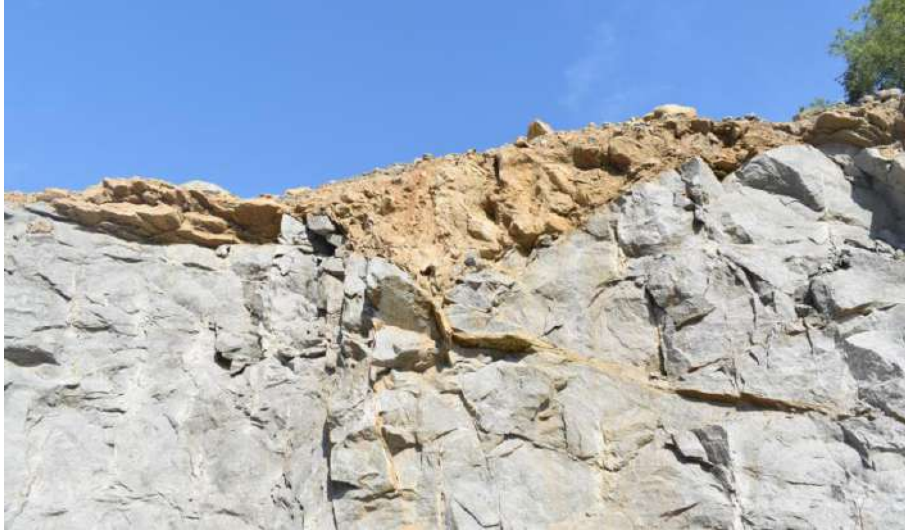
Plate 5.5.4 Variation in top strata matrix at Rubble Stone Quarry

soil and over burden thickness (soil-mixed boulders) in the mine area varies between 0.2 m to 3 m (**Plate 5.5.4**). The rock mass was mostly massive with dominance of two sets of joints. Assessment of rebound hardness and joint mapping in this quarry is shown in **Plate 5.5.5**. The joint spacing varied between 0.5 to more than 3 m and indicating massive rock formation. The rebound hardness of rock mass tested on the fresh rock surfaces using Schmidt hammer was in between 55 to 65 indicating hard rock mass (**Plate 5.5.6**). It was observed that some of the residential houses were located at higher level than the present quarry operations.

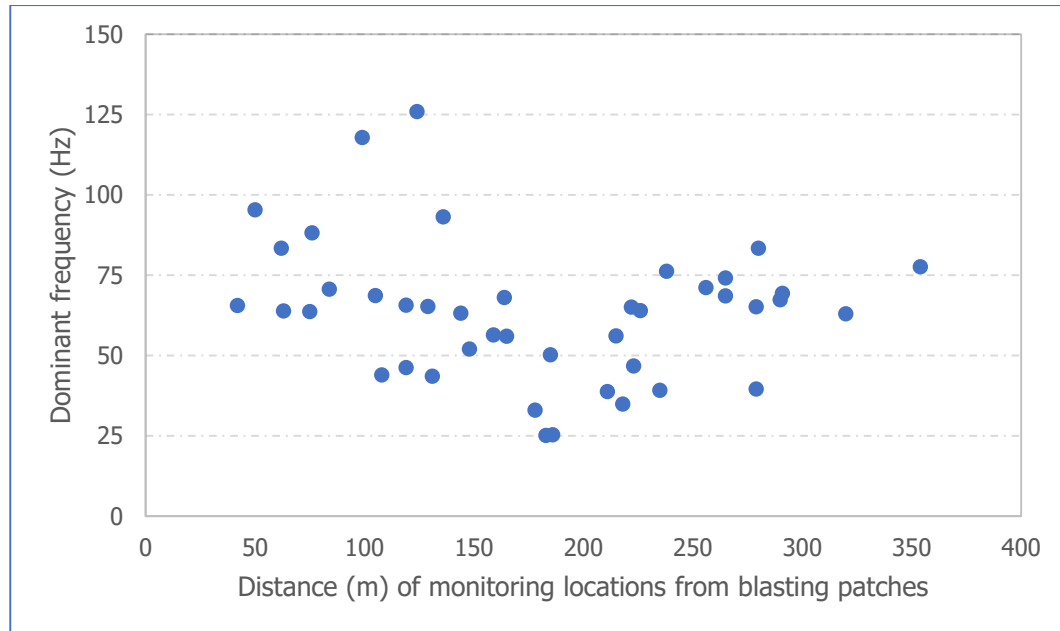
Figure 5.5.13. Plot between dominant frequency and distance of the instruments from the blasting patches

vibration data were carried out to obtain the dominant peak frequency content of the vibration waves. Based on the results of the FFT analysis, it was observed that the dominant peak frequencies of the recorded ground vibration waves ranged between 25.13 and 125.9 Hz. A plot of dominant peak frequencies of recorded ground vibration waves with respect to their concerned monitoring distances are given in **Figure 5.5.13**. The FFT analyses reports of some of the vibration data are given in the **Annexure-5**.

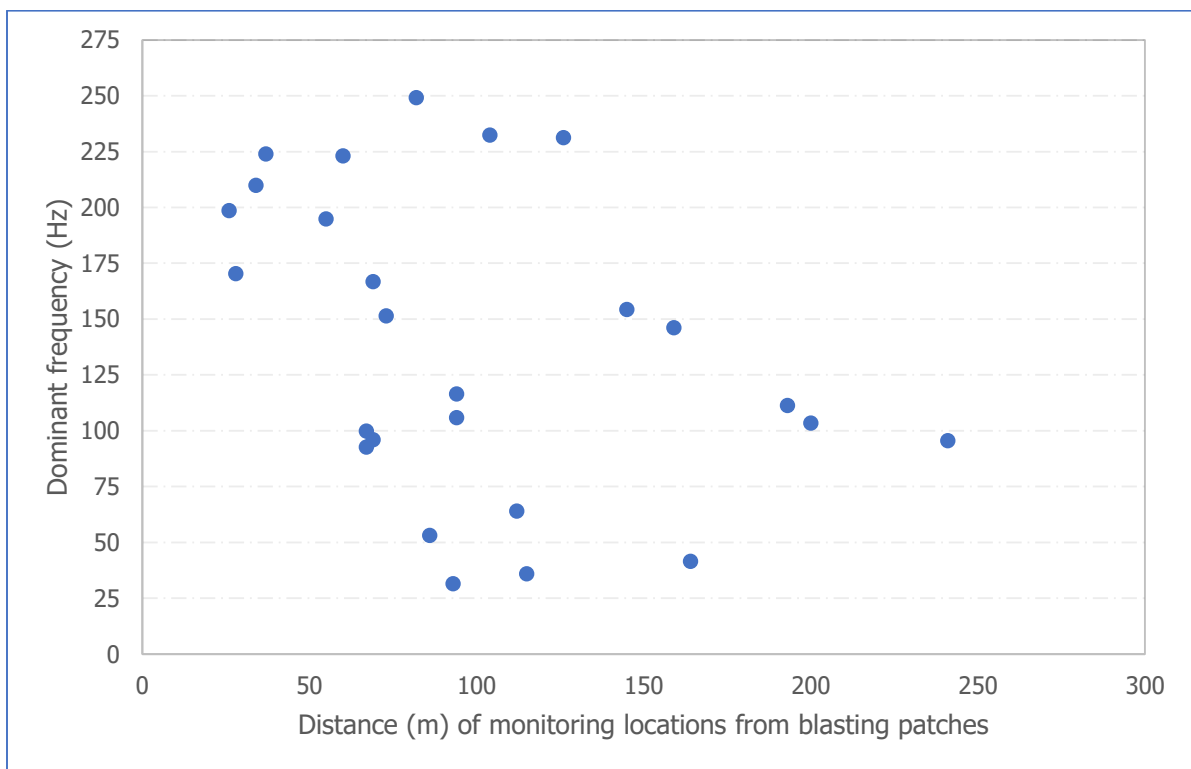
Figure 5.6.14. Plot between dominant frequency of vibration and distances of the seismographs from the blasting patches

recorded at 28 m distance from blast No. B #9 on 5th Bench within quarry. The maximum charge per delay (Q_{\max}) in the blast was 0.5 kg whereas total explosive charge (Q_{total}) detonated in the blasting round was 14.375 kg. With the same blast No. 9, magnitude of vibration recorded at Mr. Joshi's house situated at 200 m was 0.1.024 mm/s. The Fast Fourier Transform (FFT) analyses of all the recorded vibration data were carried out to obtain the dominant peak frequency content of the vibration waves. Based on the results of the FFT analysis, it was observed that the dominant peak frequencies of the recorded ground vibration waves ranged between 31.5 - 249.1 Hz. A plot of dominant peak frequencies of recorded ground vibration waves with respect to their concerned monitoring distances are given in **Figure 5.6.14**. The FFT analyses reports of some of the vibration data are also given in the **Annexure-6**.

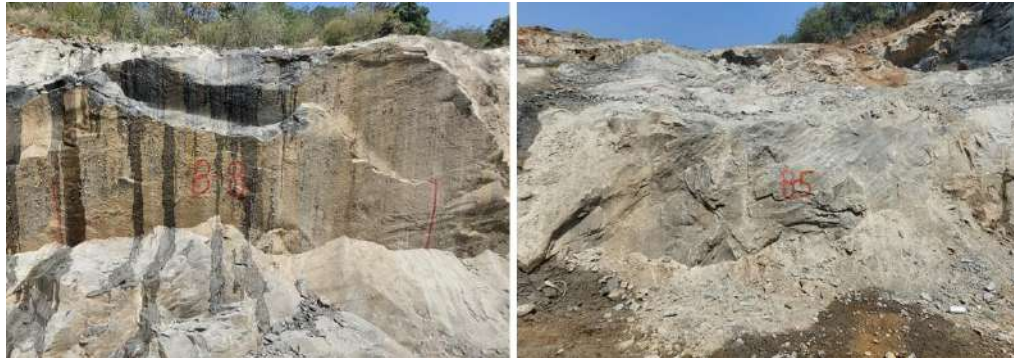
Plate 5.7.1. View of rock deposition in Granite (Building Stone) Quarry of M/S Penta Granites Kizhakkencheri – 2 village, Palakkad District of Kerala State

Studies on the land profile, nature of rock deposit and rebound hardness on the fresh rock surfaces were conducted during the study. The land profile is undulatory as the area is a hilly terrain. The current working benches of the quarry were having elevations between 125 m and 140 m. Two of the houses were located at higher level than the quarry operations at 144 m and 175 m MSL. The rock deposits are found to be massive in nature with limited joints (**Plates 5.7.1 & 5.7.2**).

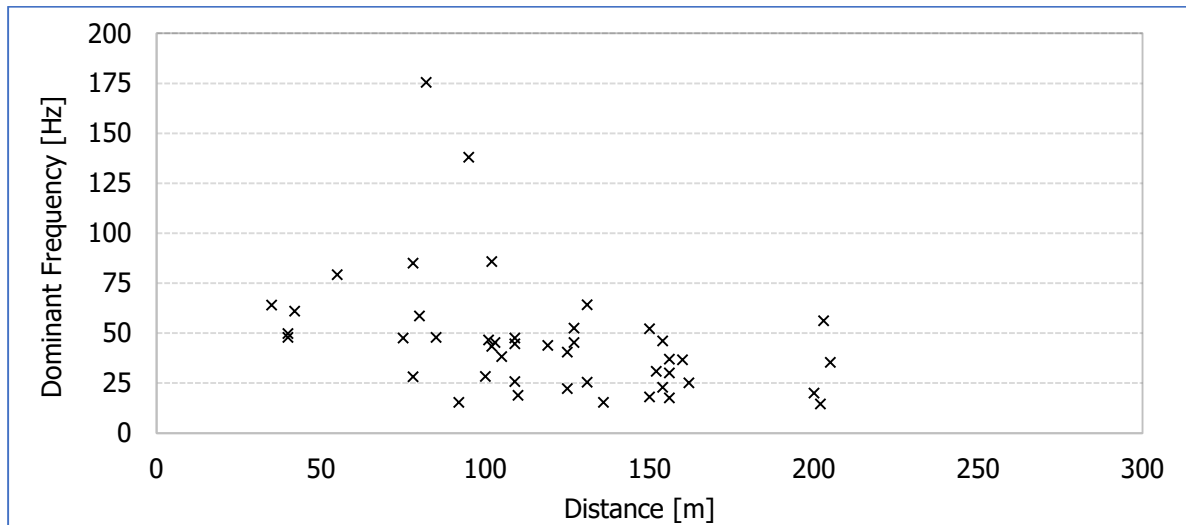
Figure 5.7.15. Plot between recorded frequencies of the ground vibration and distances of seismographs from the blasting patches.

The Fast Fourier Transform (FFT) analyses of all the recorded vibration data were carried out to obtain the dominant peak frequency content of the vibration waves. Based on the results of the FFT analysis, it was observed that the dominant peak frequencies of the recorded ground vibration waves ranged between 14.5 – 174.4 Hz. A plot of dominant peak frequencies of recorded ground vibration waves with respect to their concerned monitoring distances are given in **Figure 5.7.15**. The FFT analyses reports of some of the vibration data are given in the **Annexure-7**.

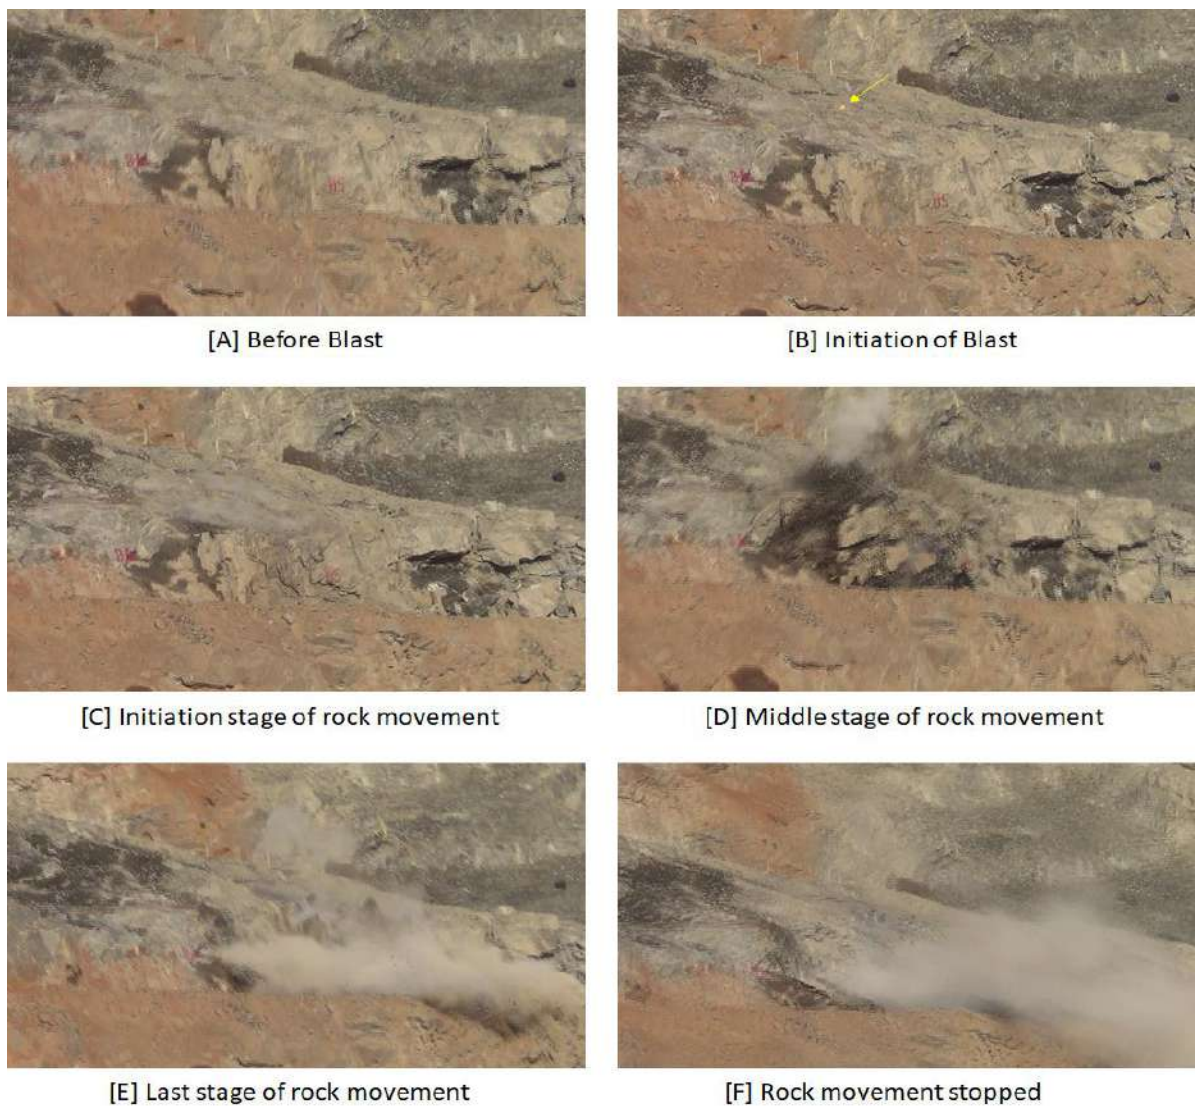
Figure 5.7.17. Sequences of rock movements in the experimental blast B-5.

In order to study and analyze the possible occurrences of flying fragments from the blast holes, all the experimental blasts were recorded using a digital video camera to observe any occurrence of flyrock and its source. In all the trial blasts conducted during study period, no flying fragments were observed or recorded. The throw of blasted materials was controlled and restricted within the blasting area only. The control on flyrock was achieved mainly by the proper blast design patterns and their implementation at the faces, effective stemming of holes and use of Nonel initiation system for bottom initiation of explosive charges. A view of analysis of the rock movements for one of the experimental blast is shown in **Figure 5.7.17**.

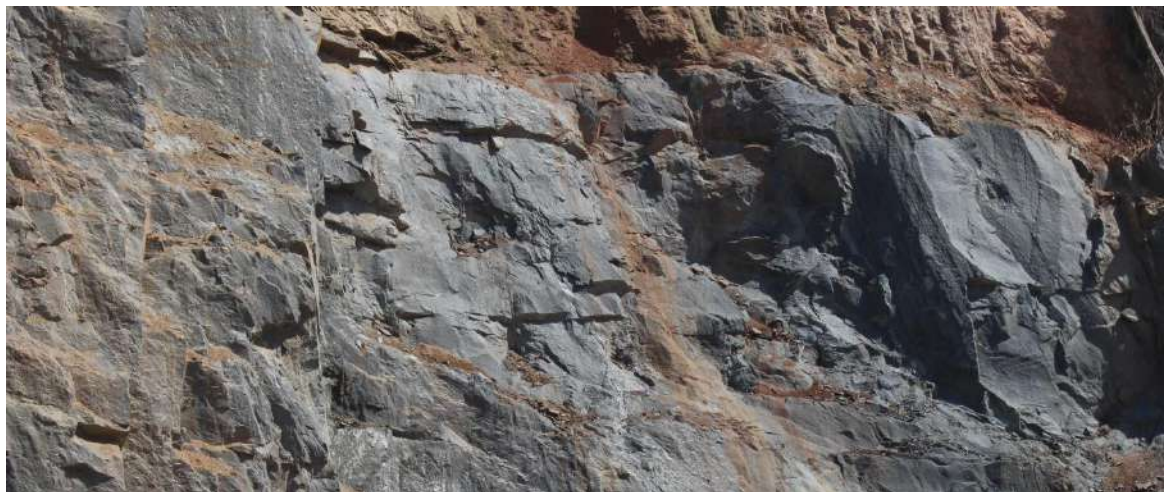
Plate 5.8.2. View of rock deposition in Granite Stone Quarry owned by Sudheesh A. T., Wayanad District of Kerala State

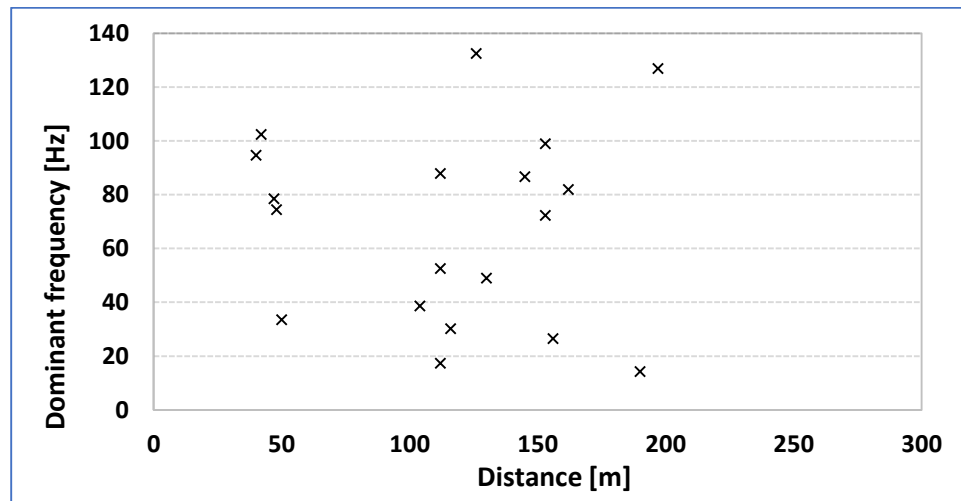
Figure 5.8.13. Plot between frequency of ground vibration and their respective monitoring distances

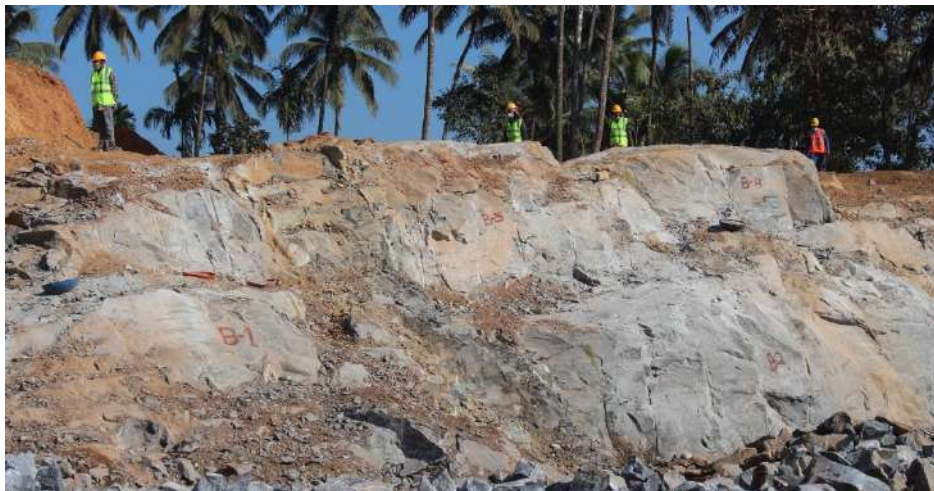
Plate 5.9.1. View showing the nature of rock deposit in Granite Building Stone Quarry owned by P. M. Abdul Rahaman, Kasaragod District of Kerala State

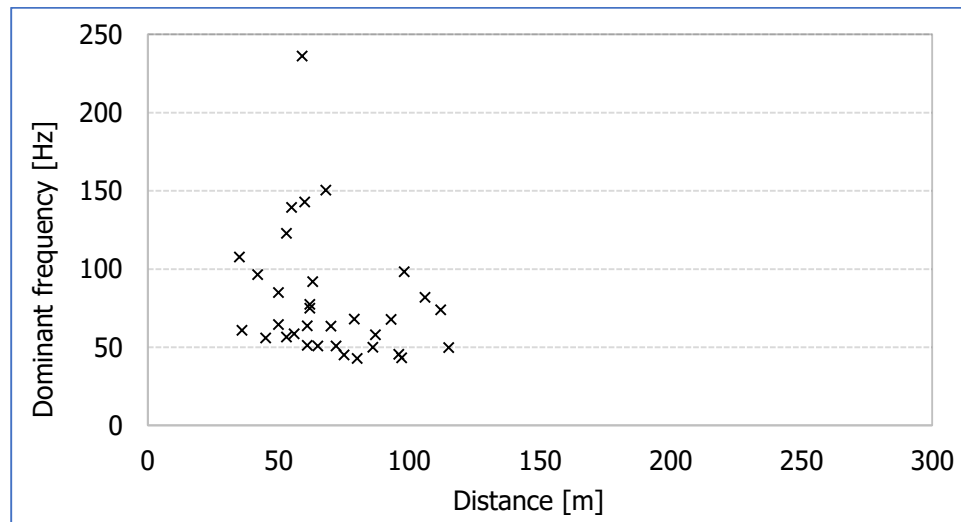
Figure 5.9.14. Plot between recorded frequency and monitoring distances from the blasting patches.

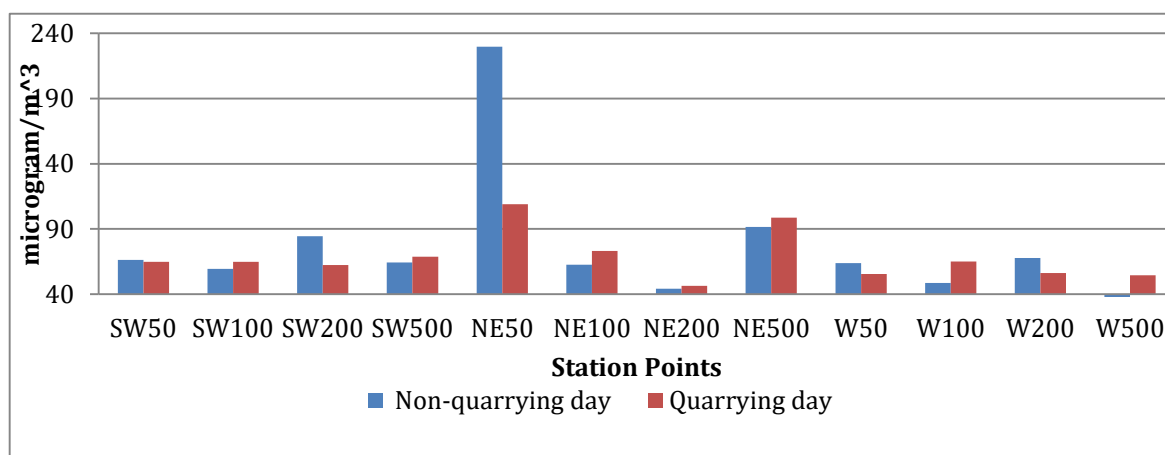
Fig.1: PM-10 values observed during Quarrying and Non-quarrying day

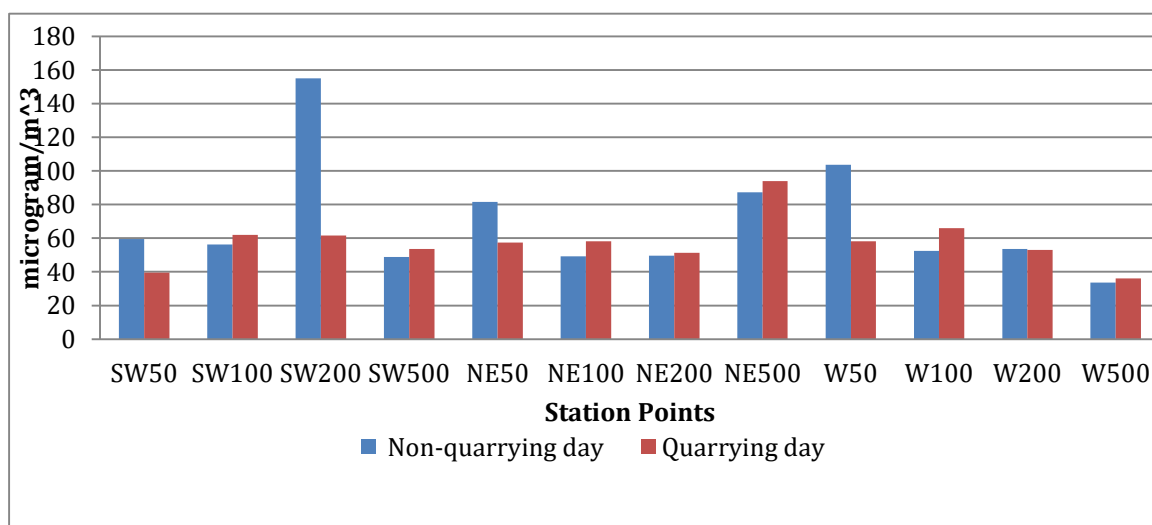
Fig.2: PM-2.5 values during Quarrying and Non-quarrying day

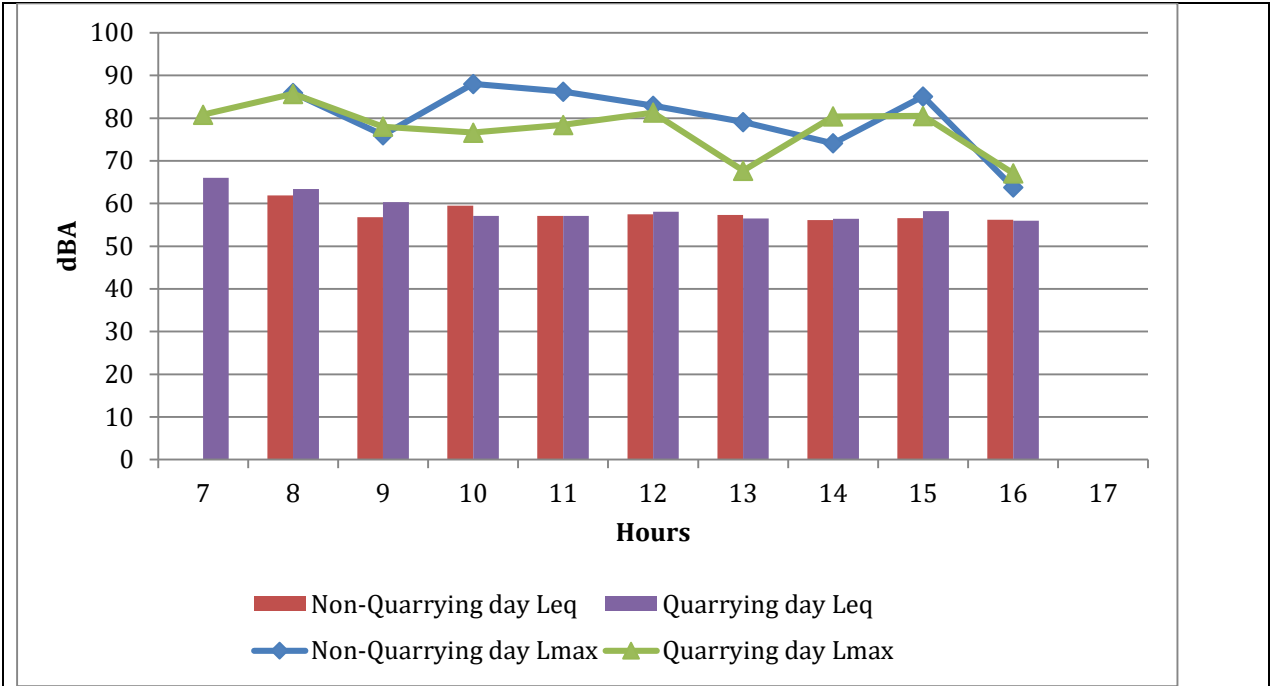
Fig.3: Equivalent values (Leq) and maximum (Lmax) of quarrying and non-quarrying day in West direction 50m

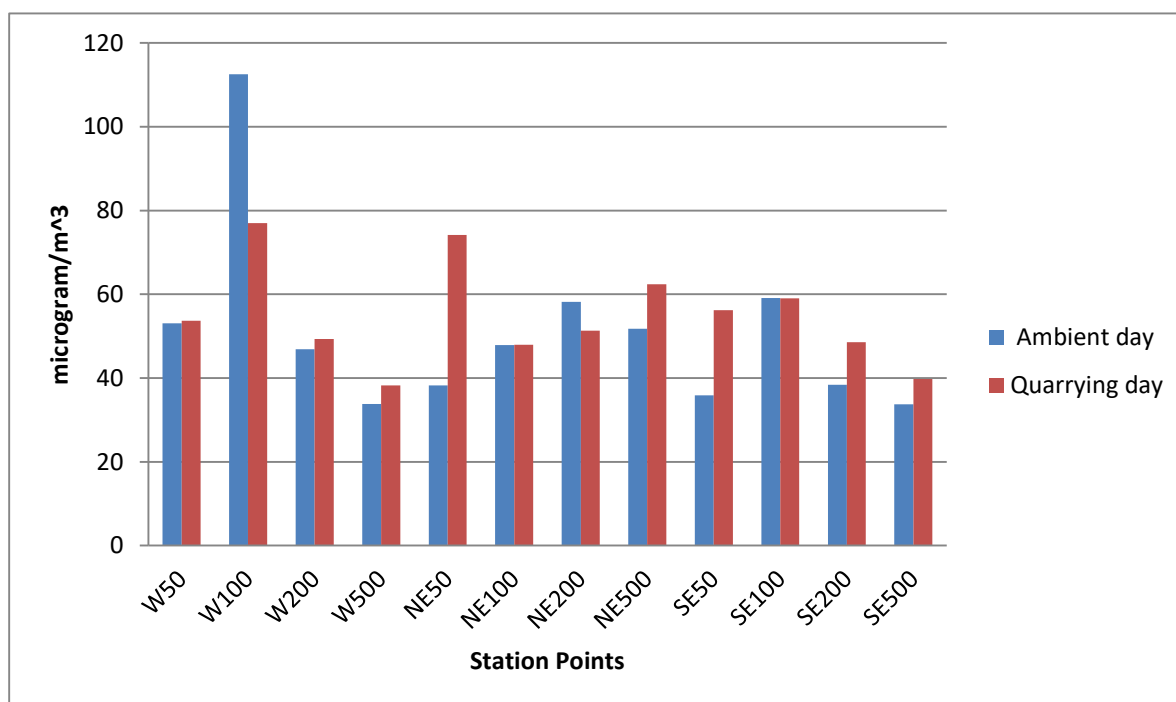
Fig.1: PM10 values observed during quarrying and non-quarrying day

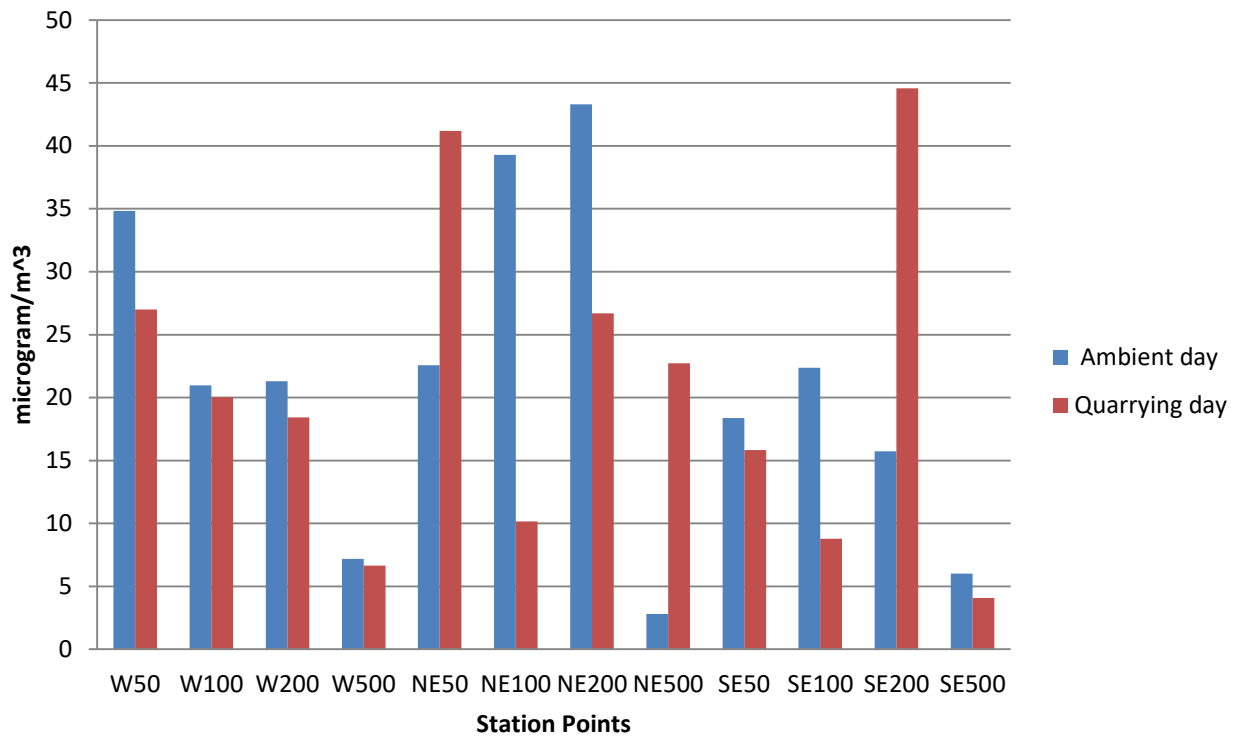
Fig.2: PM2.5 values observed during Quarrying and Non-quarrying day

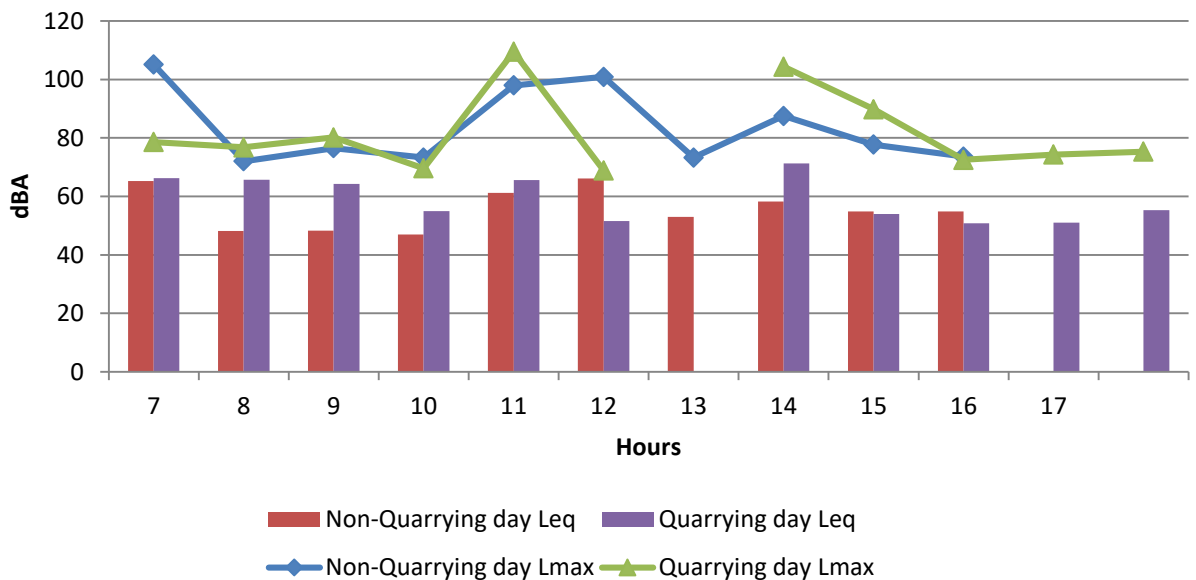
Fig.3: Noise Levels- Equivalent Values (L_{eq}) and Maximum Values (L_{max}) observed on Quarrying and Non Quarrying Day at West Direction 50 m
