**BEFORE THE HON'BLE NATIONAL GREEN TRIBUNAL,
Principal Bench, New Delhi**

O.A. No. 304/2019

S. No.	Particulars	Page No.
1.	Report of the Joint Committee in compliance of orders dated 09-12-2021 & 18-01-2023 in O.A. No. 304/2019, M. Haridasan Vs. State of Kerala & ors.

**BEFORE THE NATIONAL GREEN
TRIBUNAL, PRINCIPAL BENCH,
NEW DELHI**

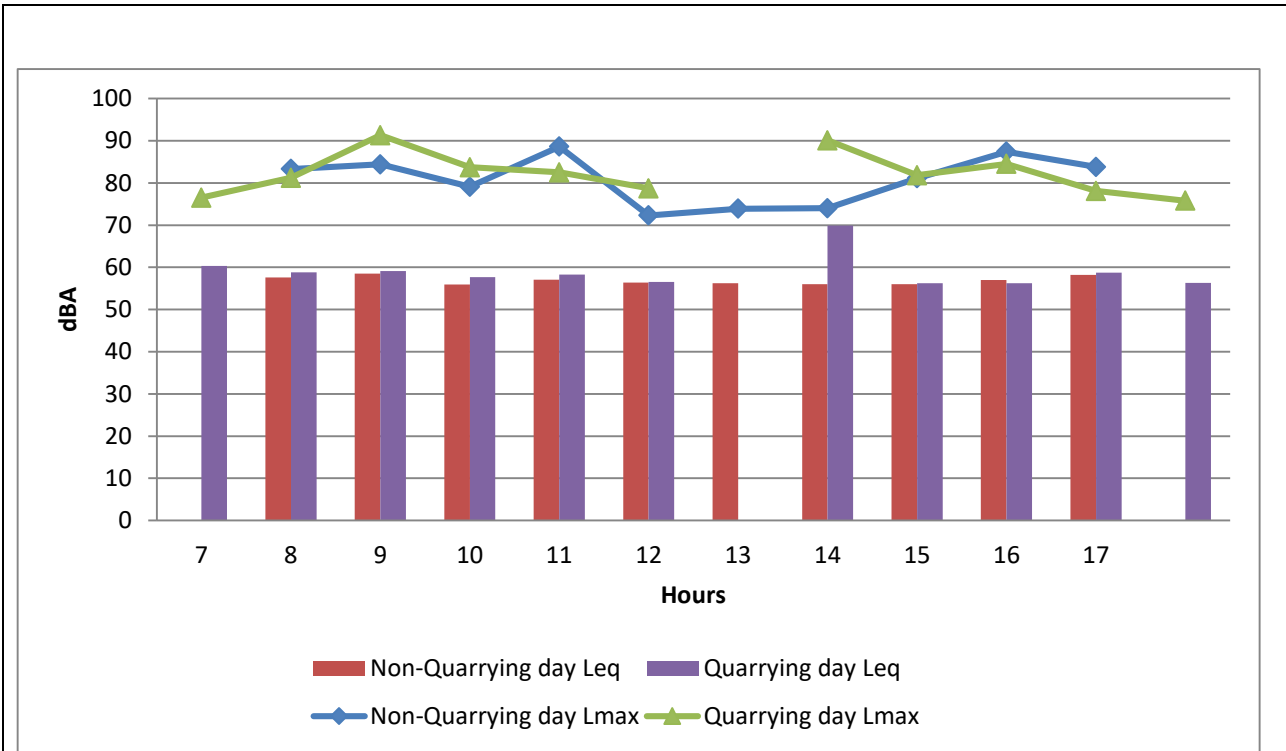
Fig.4: Noise Levels- Equivalent Values (Leq) and Maximum Values (L_{max}) observed on Quarrying and Non Quarrying Day at West Direction 100 m

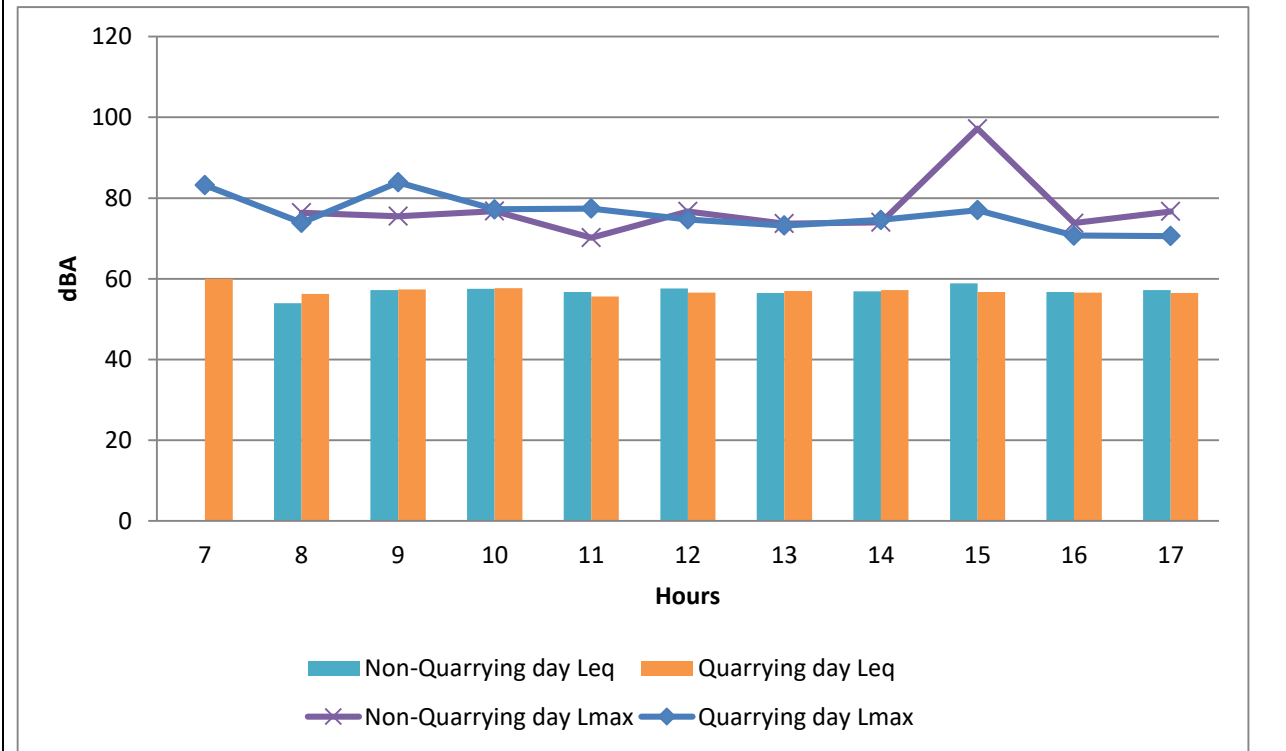
Fig.5: Noise Levels- Equivalent Values (Leq) and Maximum Values (L_{max}) observed on Quarrying and Non Quarrying Day at West Direction 200 m

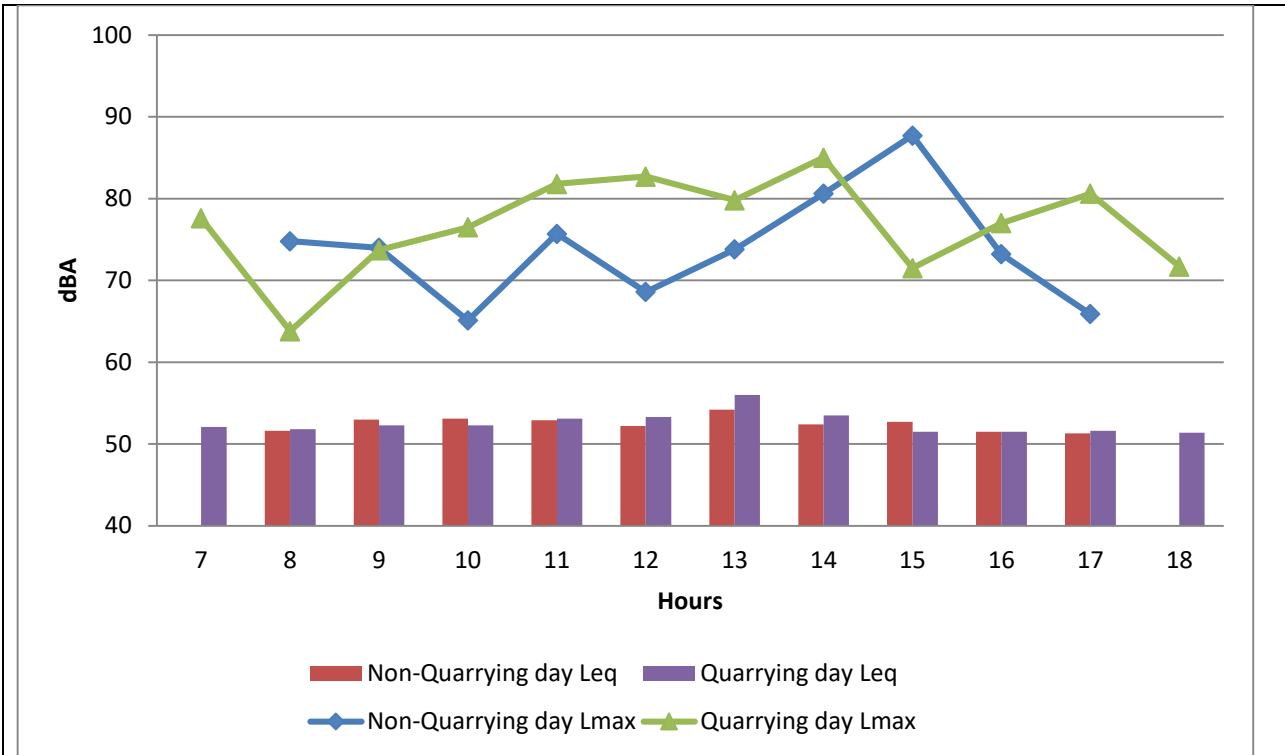
Fig.6: Noise Levels- Equivalent Values (Leq) and Maximum Values (L_{max}) observed on Quarrying and Non Quarrying Day at West Direction 200 m

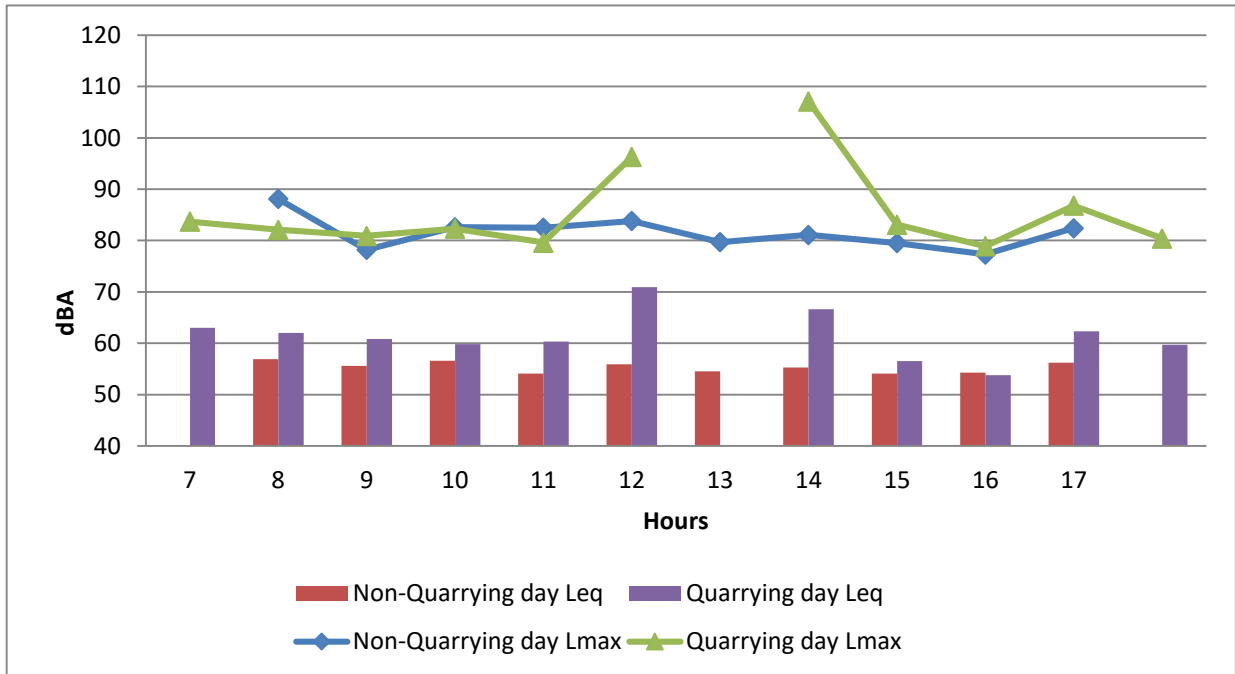
Fig.7: Noise Levels- Equivalent Values (Leq) and Maximum Values (L_{max}) observed on Quarrying and Non Quarrying Day at North East Direction 50 m

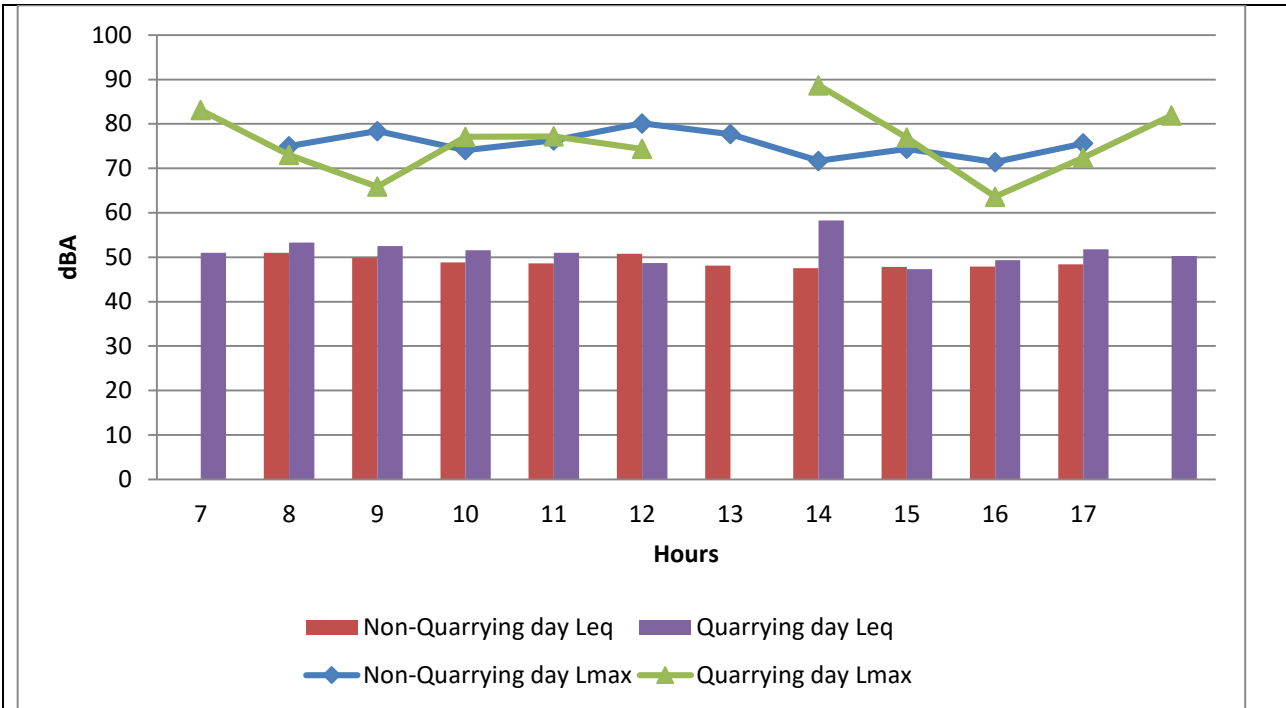
Fig.8: Noise Levels- Equivalent Values (Leq) and Maximum Values (L_{max}) observed on Quarrying and Non Quarrying Day at North East Direction 100 m

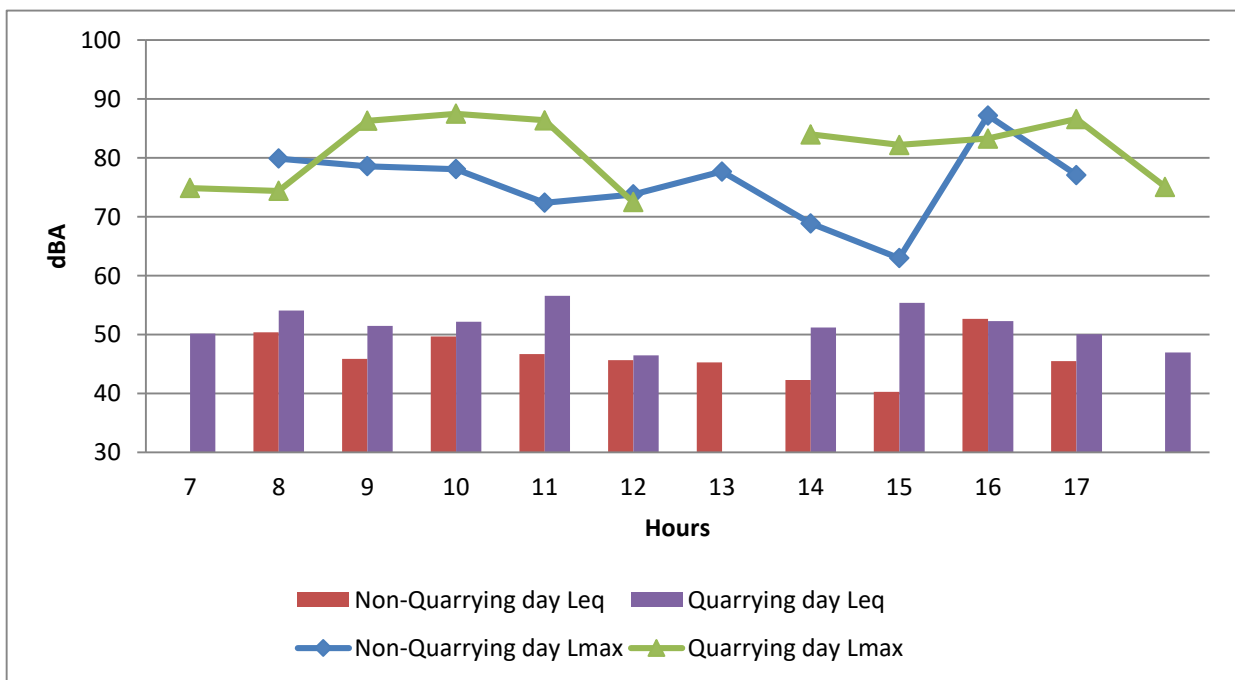
Fig.9: Noise Levels- Equivalent Values (Leq) and Maximum Values (L_{max}) observed on Quarrying and Non Quarrying Day at North East Direction 200 m

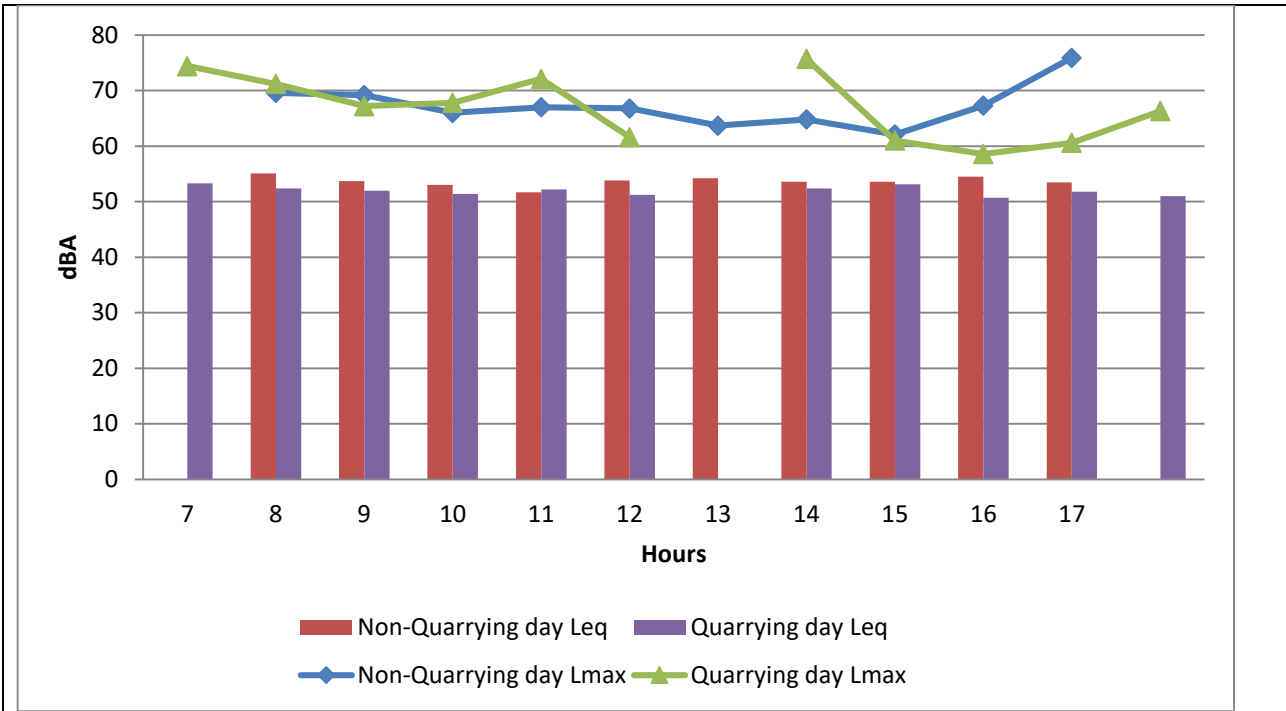
Fig.10: Noise Levels- Equivalent Values (Leq) and Maximum Values (L_{max}) observed on Quarrying and Non Quarrying Day at North East Direction 500 m

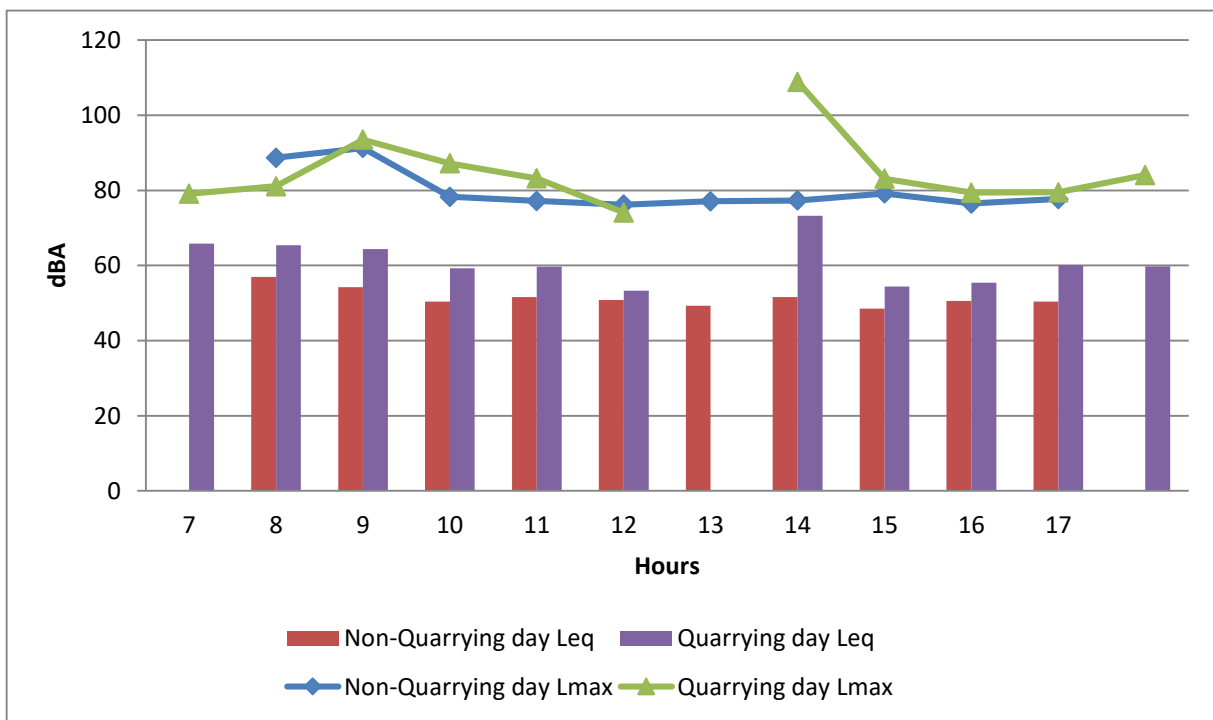
Fig.11: Noise Levels- Equivalent Values (Leq) and Maximum Values (L_{max}) observed on Quarrying and Non Quarrying Day at South East Direction 50 m

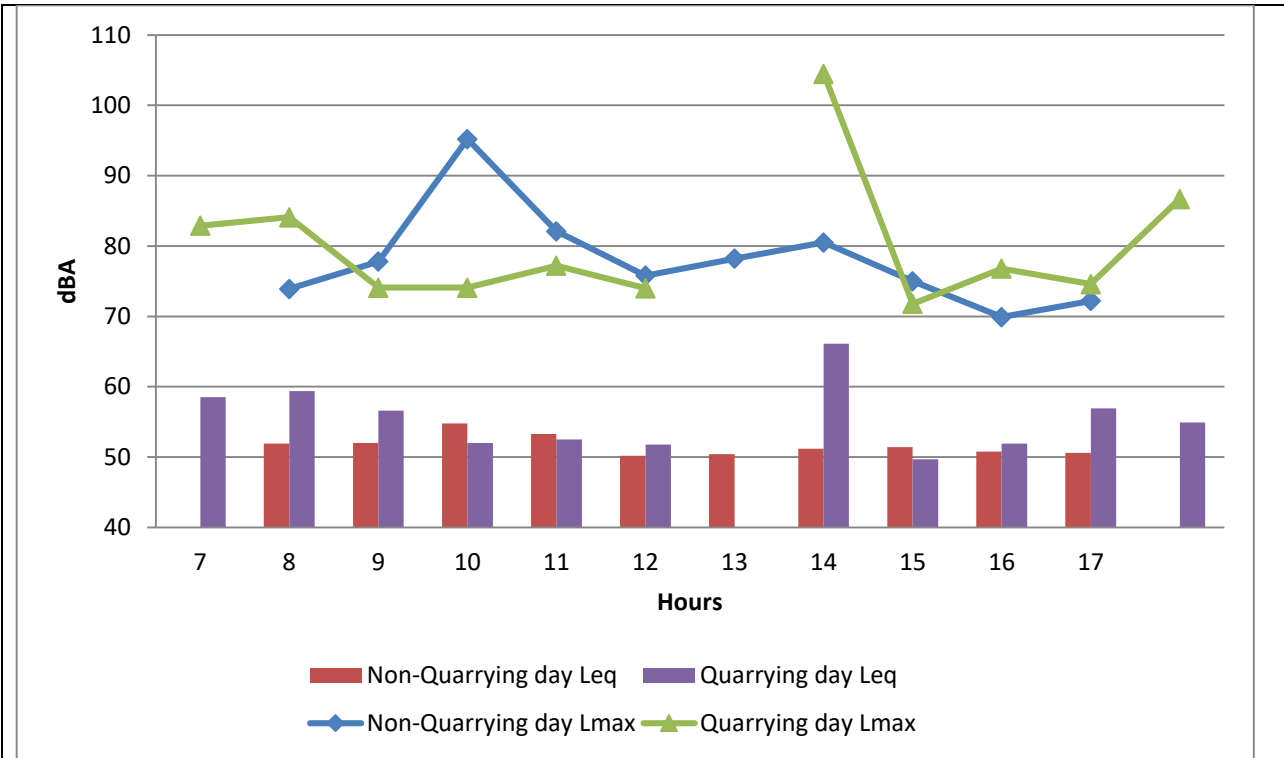
Fig.12: Noise Levels- Equivalent Values (Leq) and Maximum Values (L_{max}) observed on Quarrying and Non Quarrying Day at South East Direction 100 m

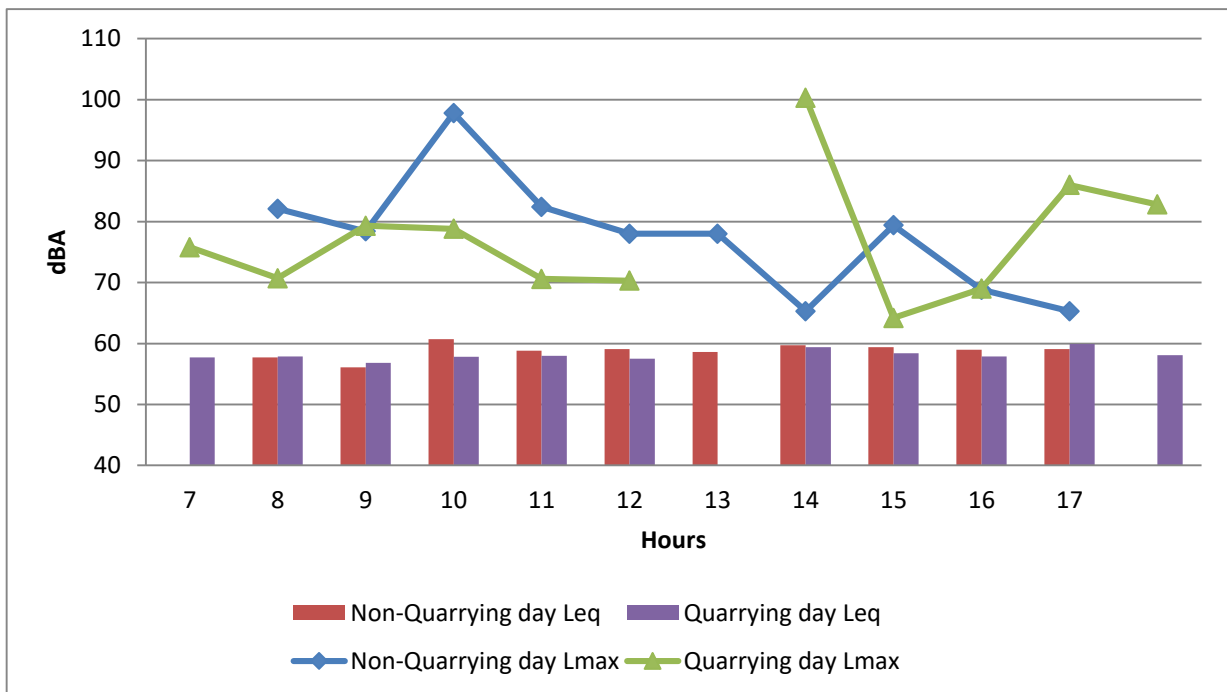
Fig.13: Noise Levels- Equivalent Values (Leq) and Maximum Values (L_{max}) observed on Quarrying and Non Quarrying Day at South East Direction 200 m

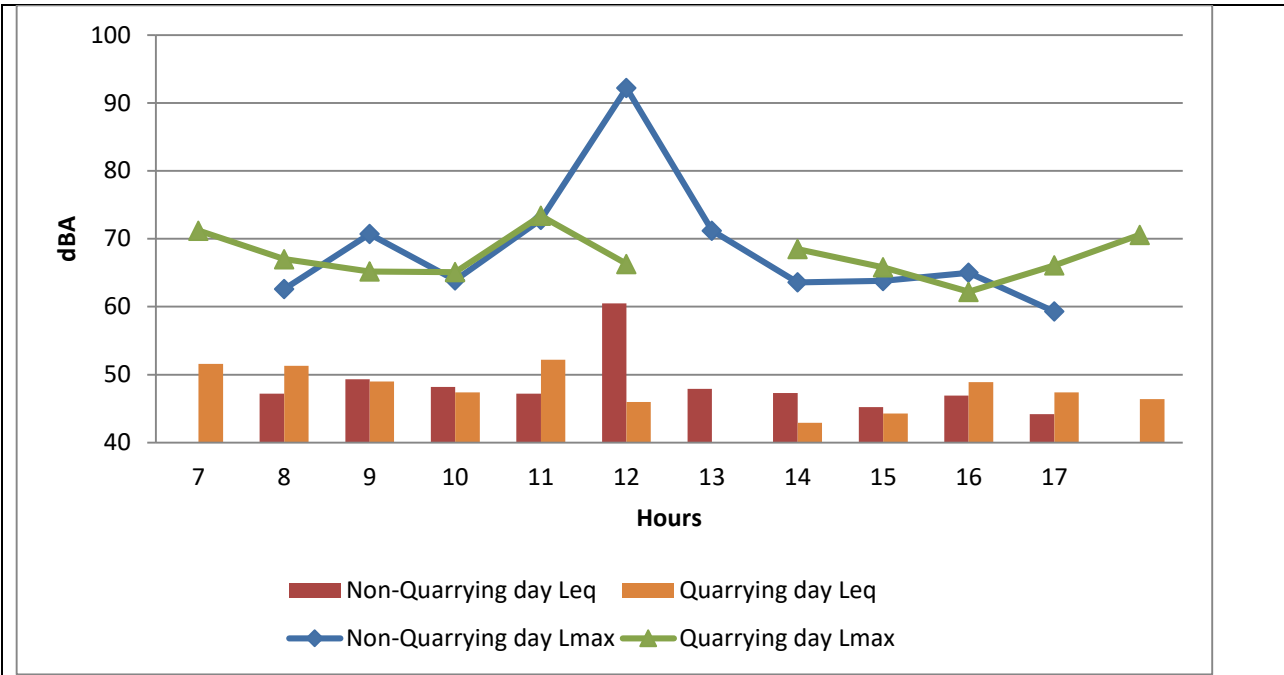
Fig.14: Noise Levels- Equivalent Values (Leq) and Maximum Values (L_{max}) observed on Quarrying and Non Quarrying Day at South East Direction 500 m

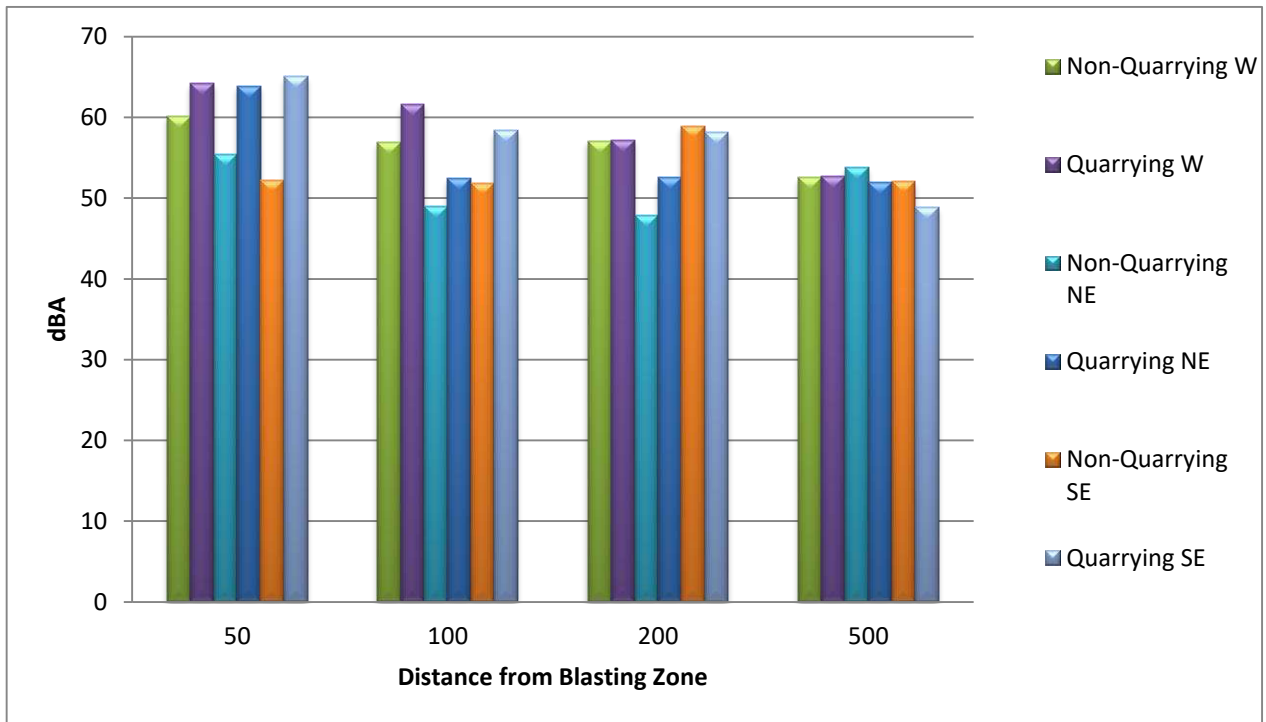
Fig.15: Equivalent values (Leq) of non quarrying and quarrying day

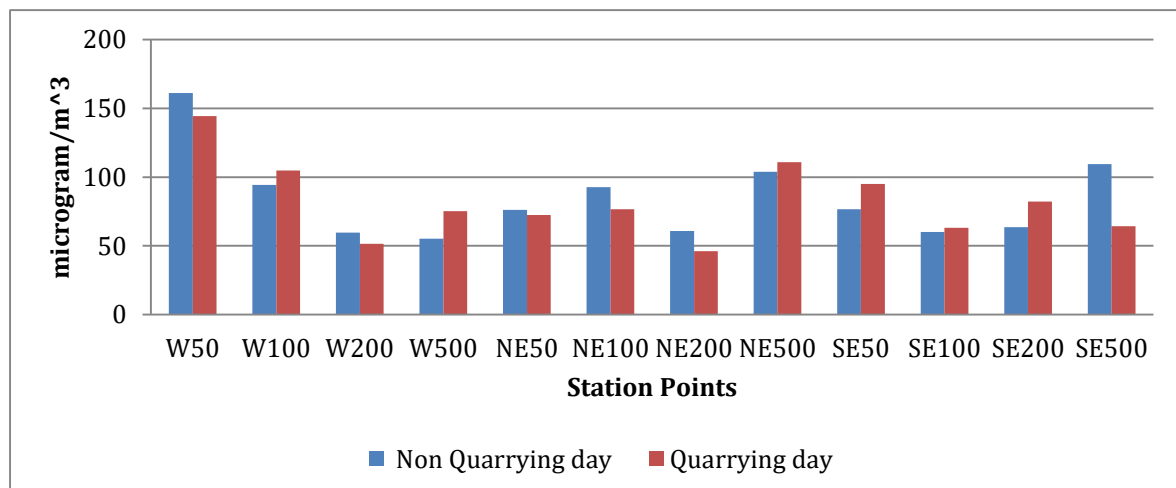
Fig.1: PM-10 values of Quarrying and Non-quarrying days

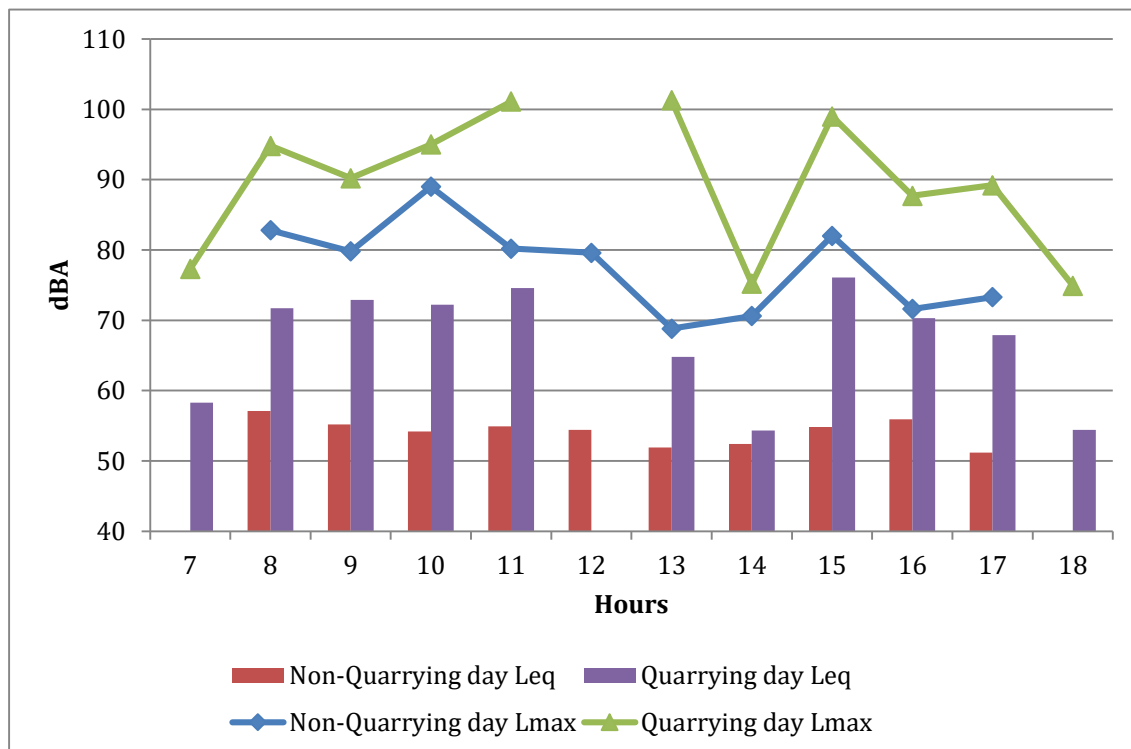
**Fig.3: Equivalent values (L_{eq}) and maximum (L_{max}) Noise levels observed on quarrying and non-quarrying day in West direction 50m**

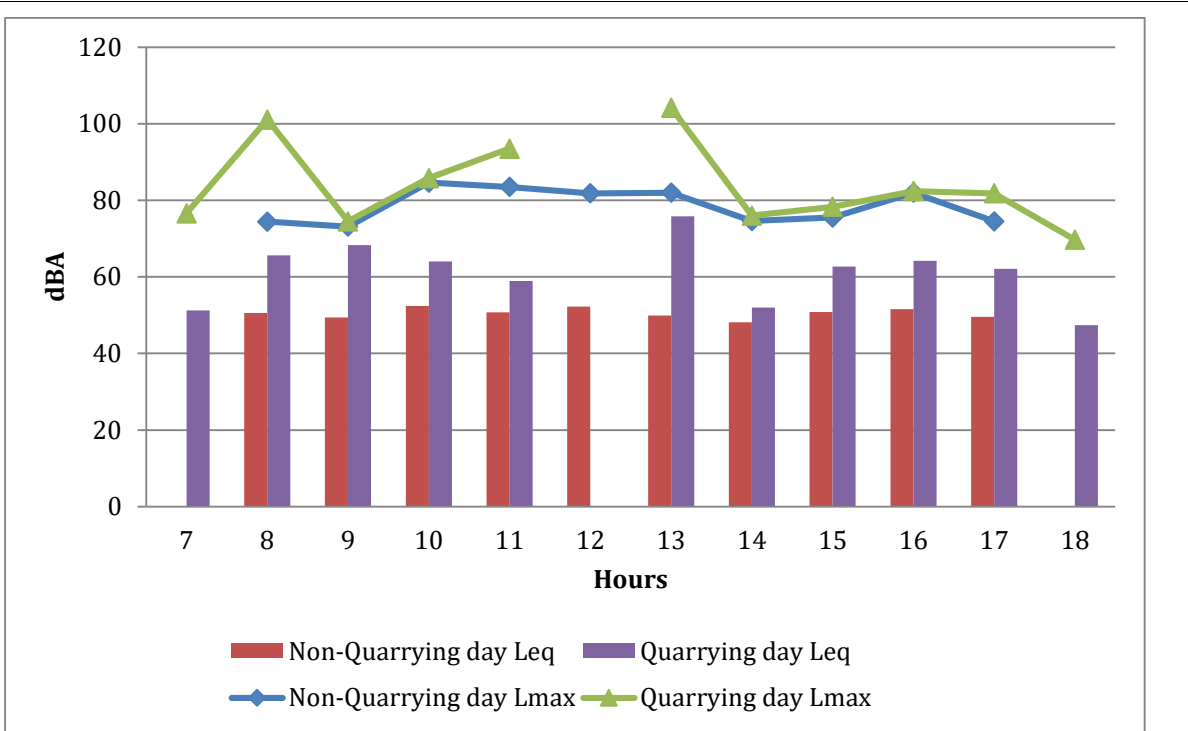
Fig.4: Equivalent values (Leq) and maximum (Lmax) observed on quarrying and non-quarrying day in West direction 100m

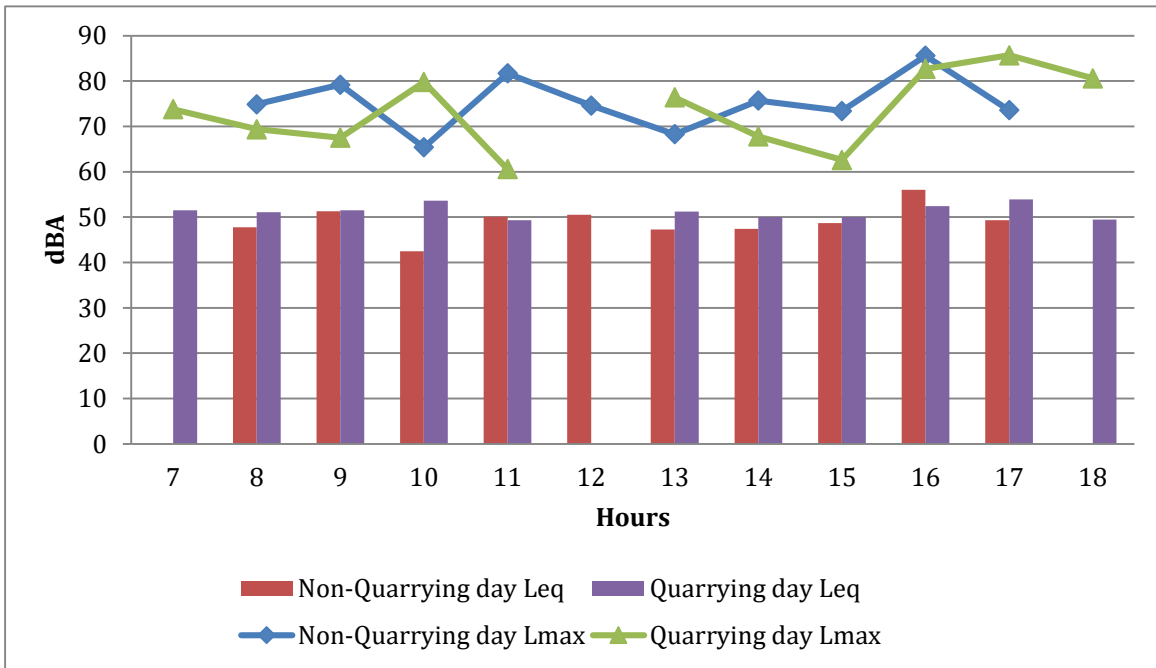
Fig.5: Equivalent values (Leq) and maximum (Lmax) observed on quarrying day and non-quarrying in West direction 200m

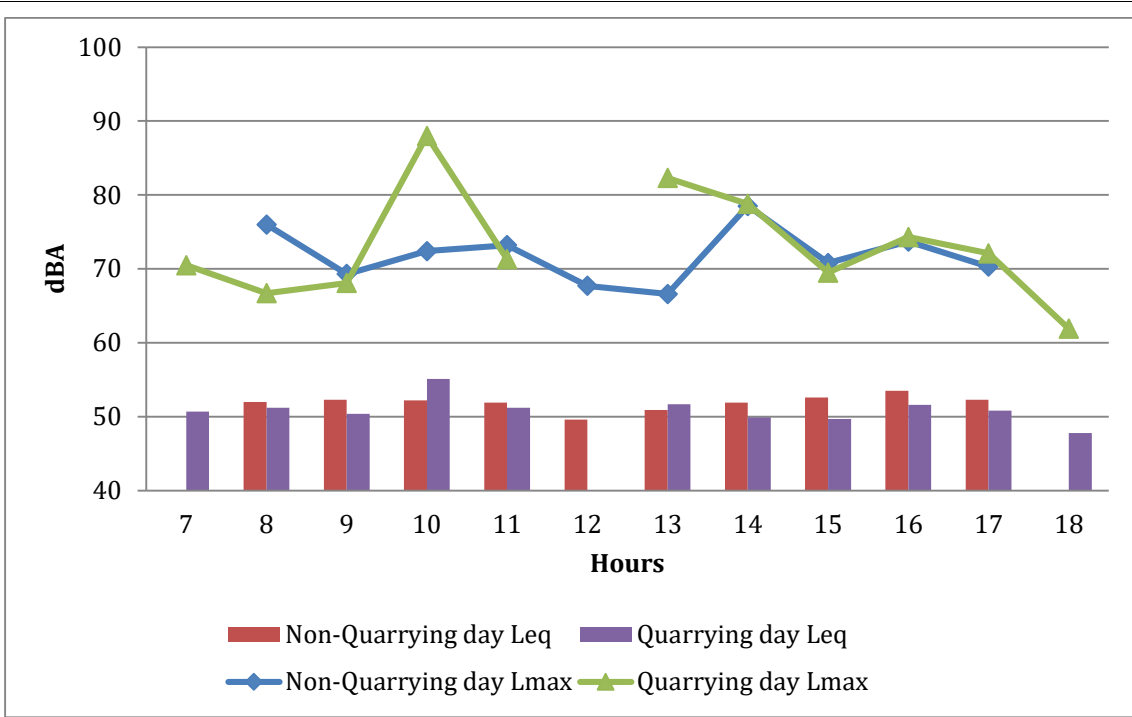
Fig.6: Equivalent values (Leq)and maximum (Lmax) observed on quarrying day and non-quarrying in West direction 500m

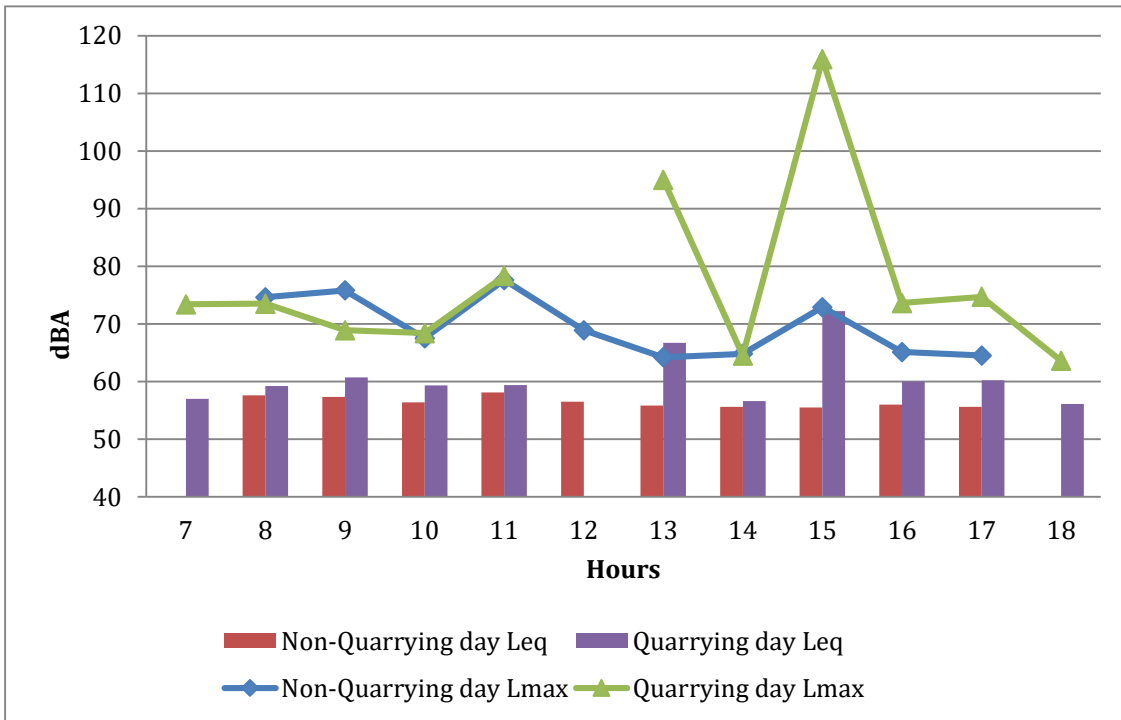
Fig.7: Equivalent values (Leq)and maximum (Lmax) observed on quarrying day and non-quarrying in North-East direction 50m

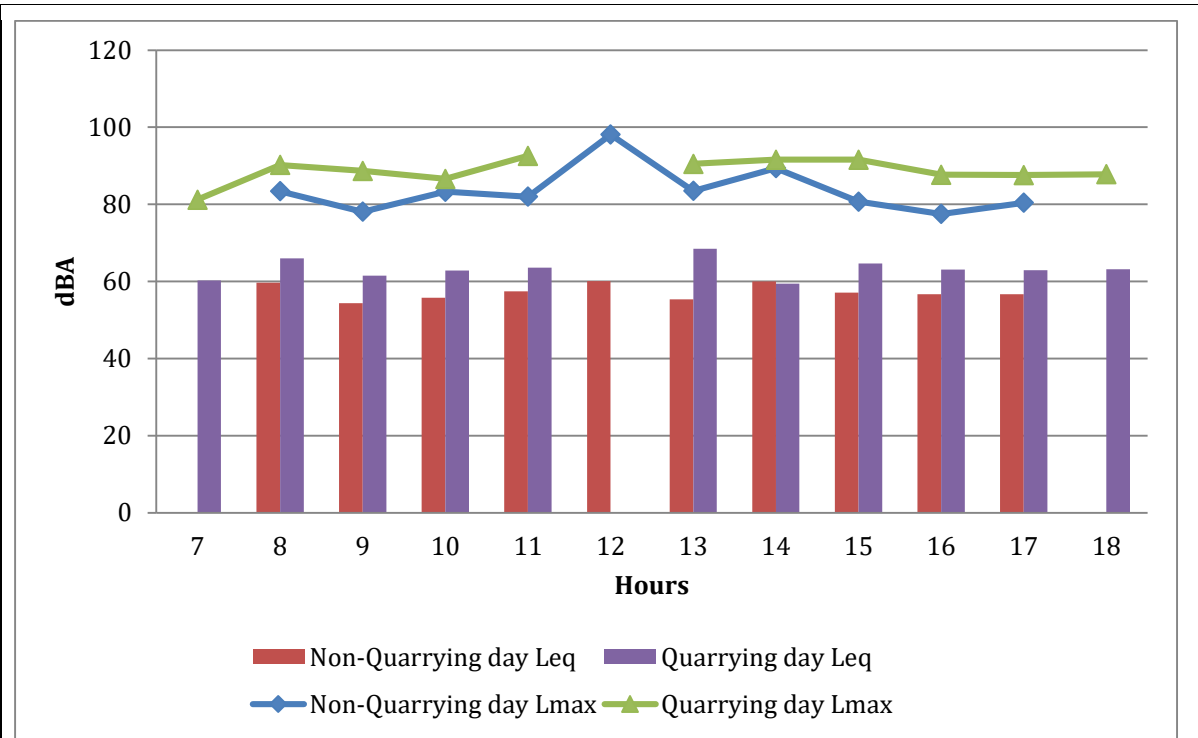
Fig.8: Equivalent values (Leq) and maximum (Lmax) observed on quarrying day and non-quarrying in North-East direction 100m

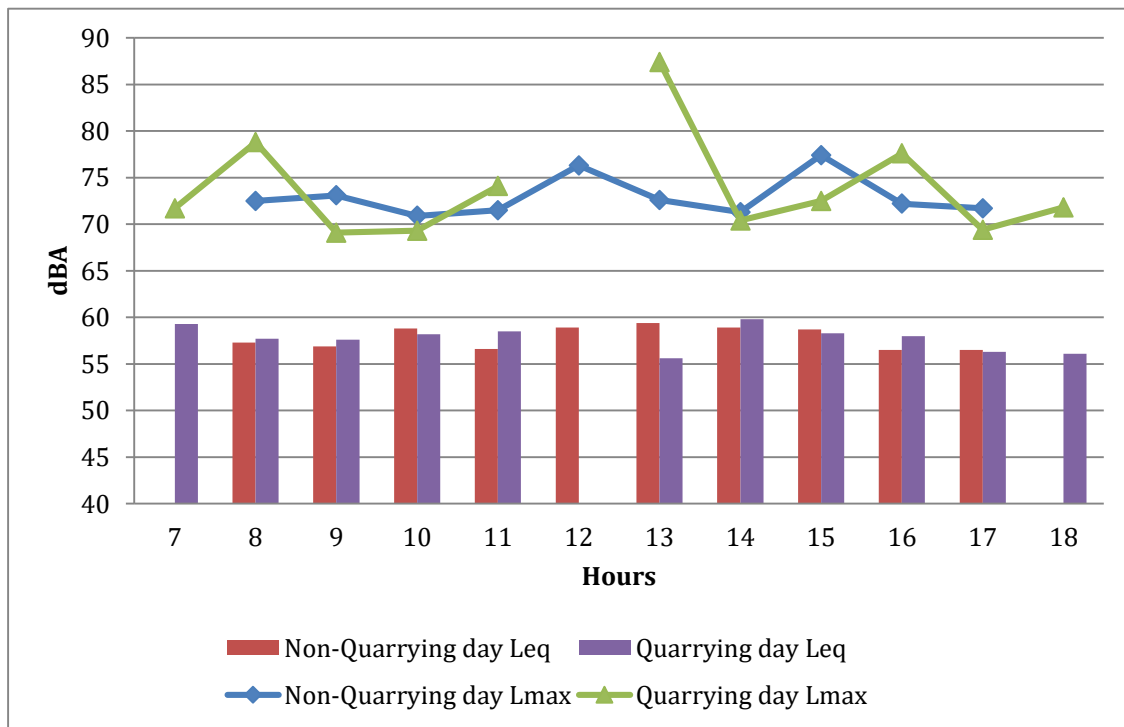
Fig.9: Equivalent values (Leq) and maximum (Lmax) observed on quarrying day and non-quarrying in North-East direction 200m

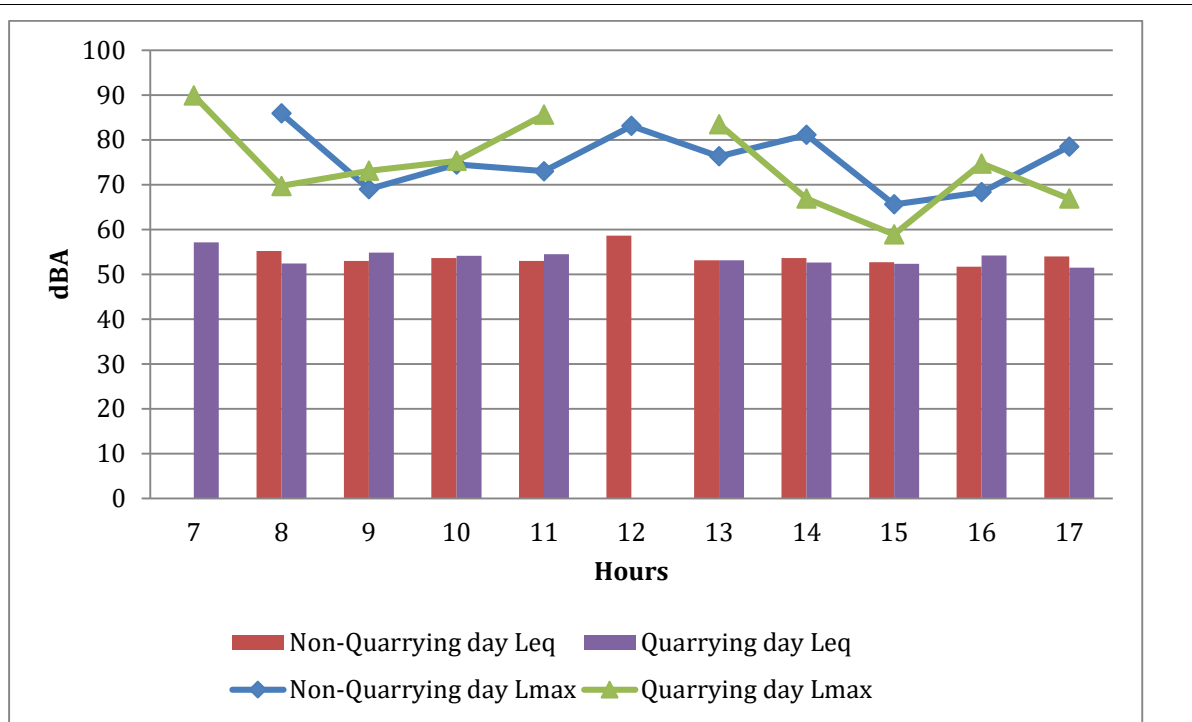
Fig.10: Equivalent values (Leq) and maximum (Lmax) observed on quarrying day and non-quarrying in North-East direction 500m

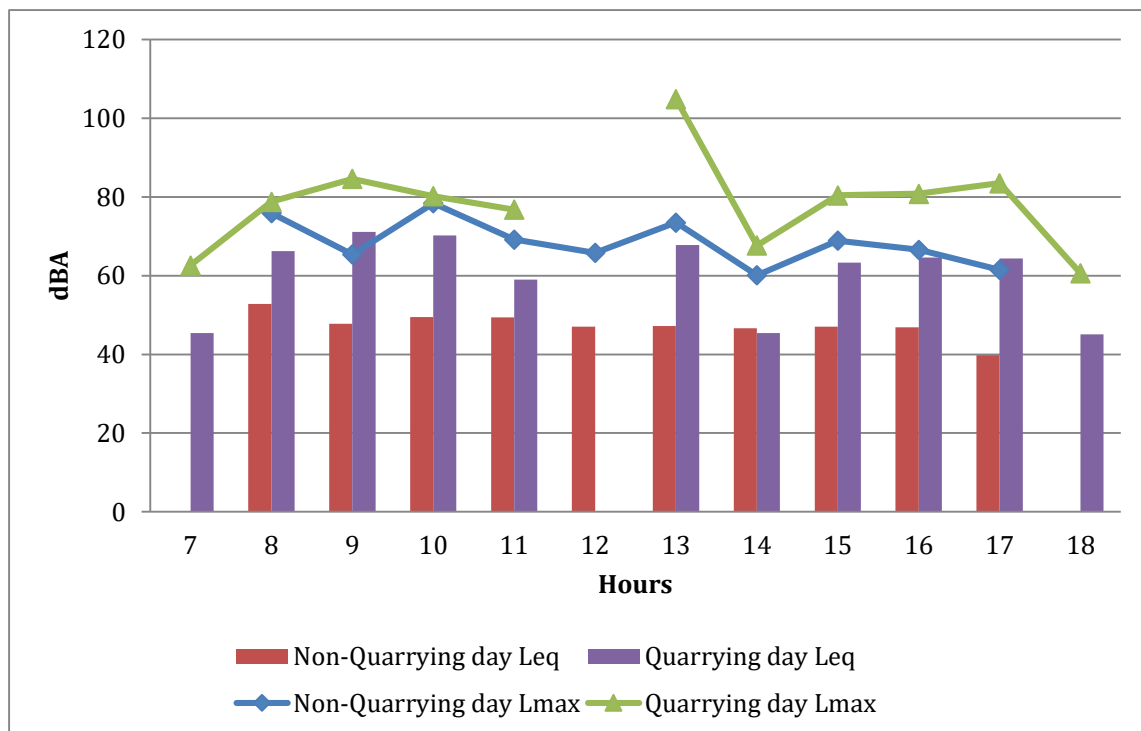
Fig.11: Equivalent values (Leq) and maximum (Lmax) observed on quarrying day and non-quarrying in South-East direction 50m

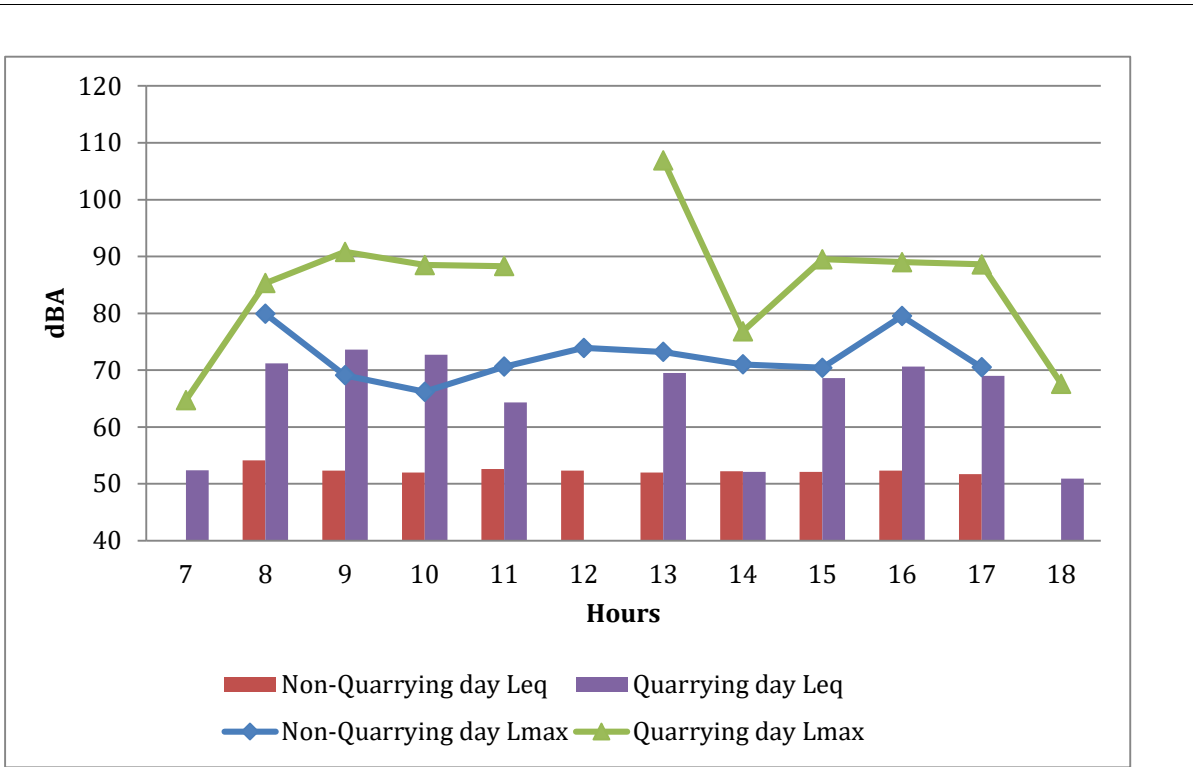
Fig.12: Equivalent values (Leq)and maximum (Lmax) observed on quarrying day and non-quarrying in South-East direction 100m

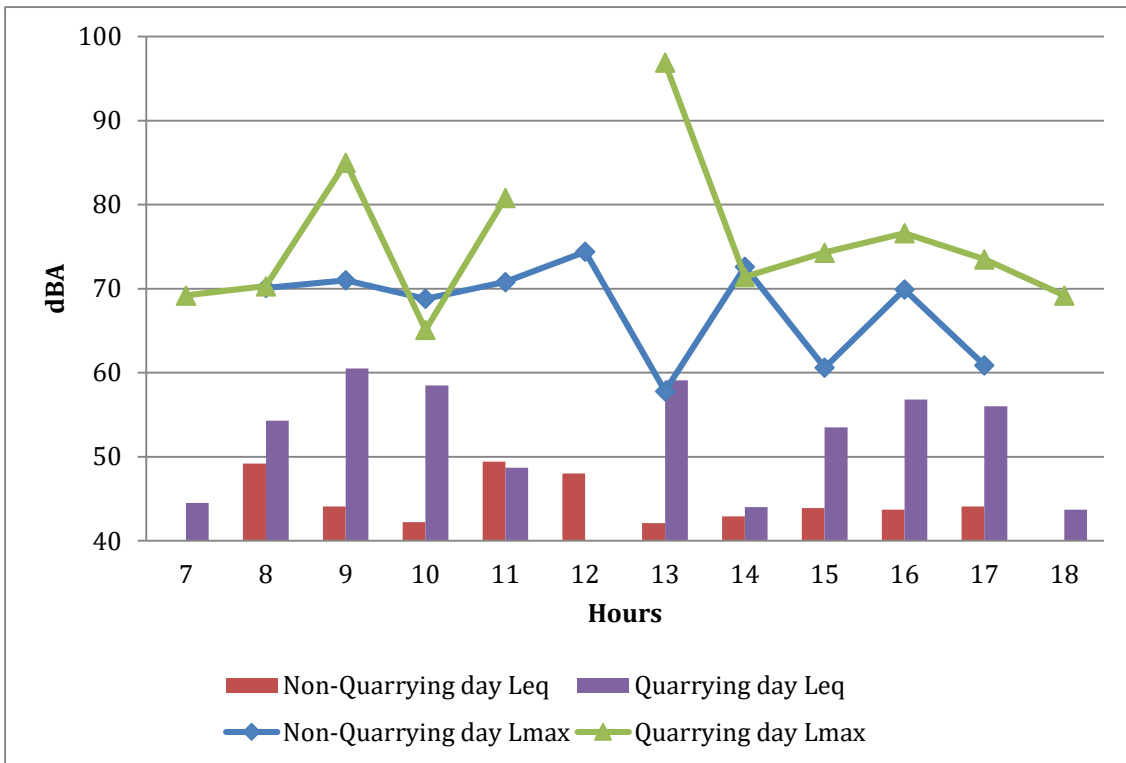
Fig.13: Equivalent values (Leq)and maximum (Lmax) observed on quarrying day and non-quarrying in South-East direction 200m

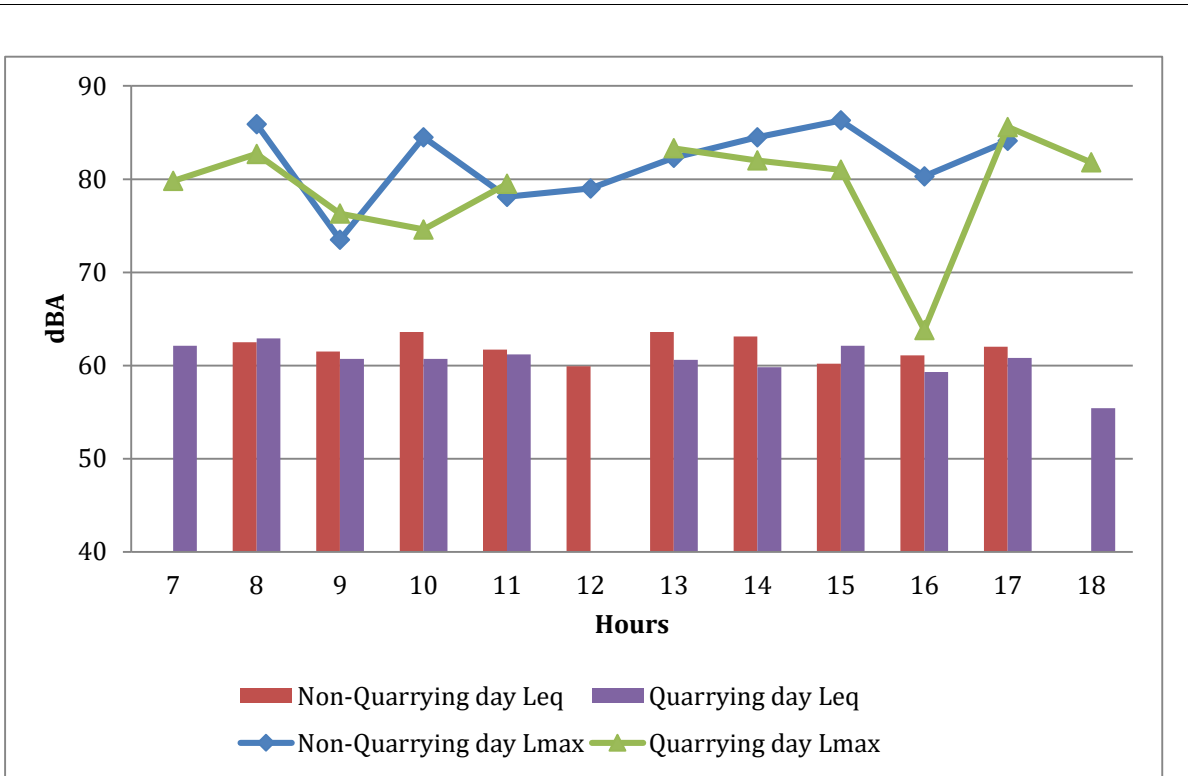
Fig.14: Equivalent values (Leq) and maximum (Lmax) observed on quarrying day and non-quarrying in South-East direction 500m
