**BEFORE THE HON'BLE NATIONAL GREEN TRIBUNAL,
Principal Bench, New Delhi**

O.A. No. 304/2019

S. No.	Particulars	Page No.
1.	Report of the Joint Committee in compliance of orders dated 09-12-2021 & 18-01-2023 in O.A. No. 304/2019, M. Haridasan Vs. State of Kerala & ors.

**BEFORE THE NATIONAL GREEN
TRIBUNAL, PRINCIPAL BENCH,
NEW DELHI**

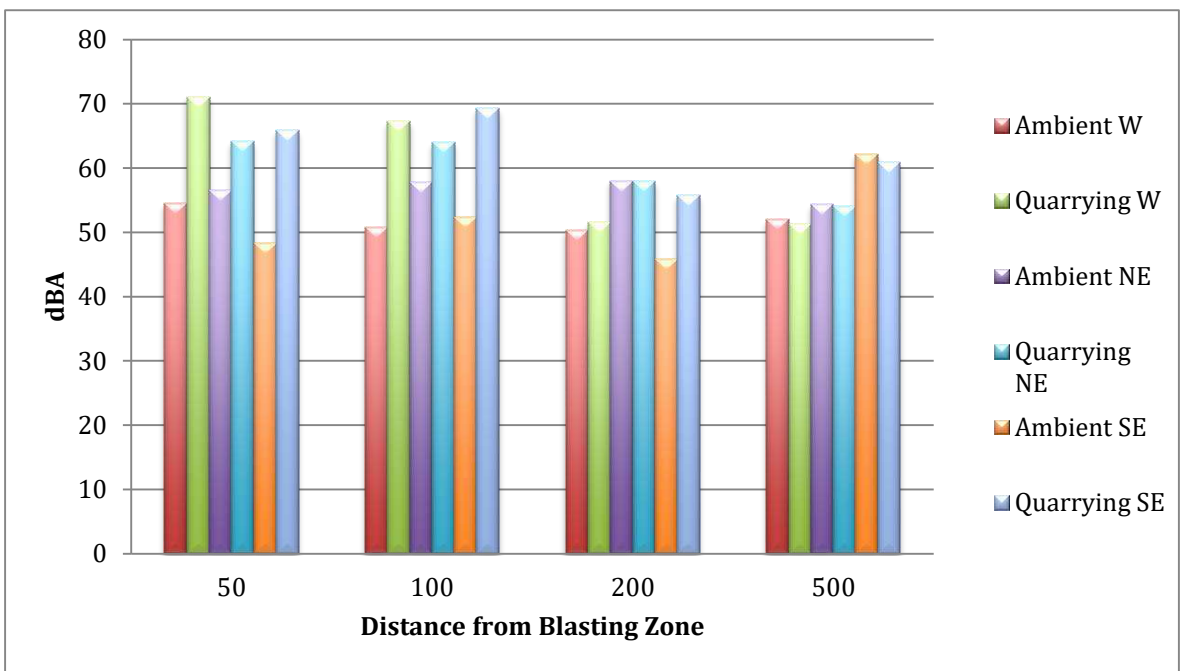
Fig.15: Equivalent values (Leq) observed on non-quarrying and quarrying day
