FATAL INCIDENT DUE TO COLLAPSE OF BIO-DIGESTER AT
M/S. LOKNETE BABURAO PATIL AGRO INDUSTRIES LTD.,
DIST-SOLAPUR, MAHARASHTRA

**FINAL REPORT OF COMMITTEE
IN THE MATTER OF
ORIGINAL APPLICATION NO. 274/2020**

(In Re: News item published in the "Indian Express" dated 23.11.2020 titled
"Maharashtra: Two Killed, eight injured in methane gas leak in sugar factory")
IN COMPLIANCE WITH ORDER DATED 18.12.2020 & 16.08.2021 OF

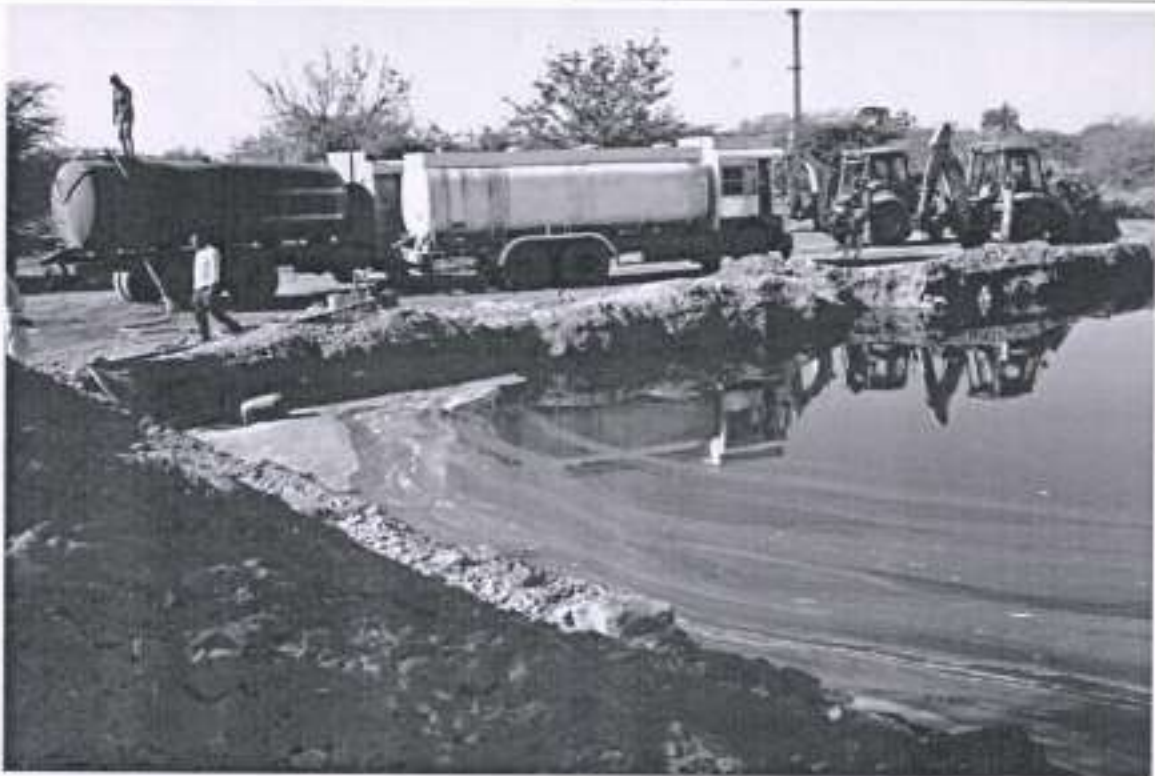
Kaccha Pits I – (This spent wash filled tanker and borough to the 30 days storage tank.)

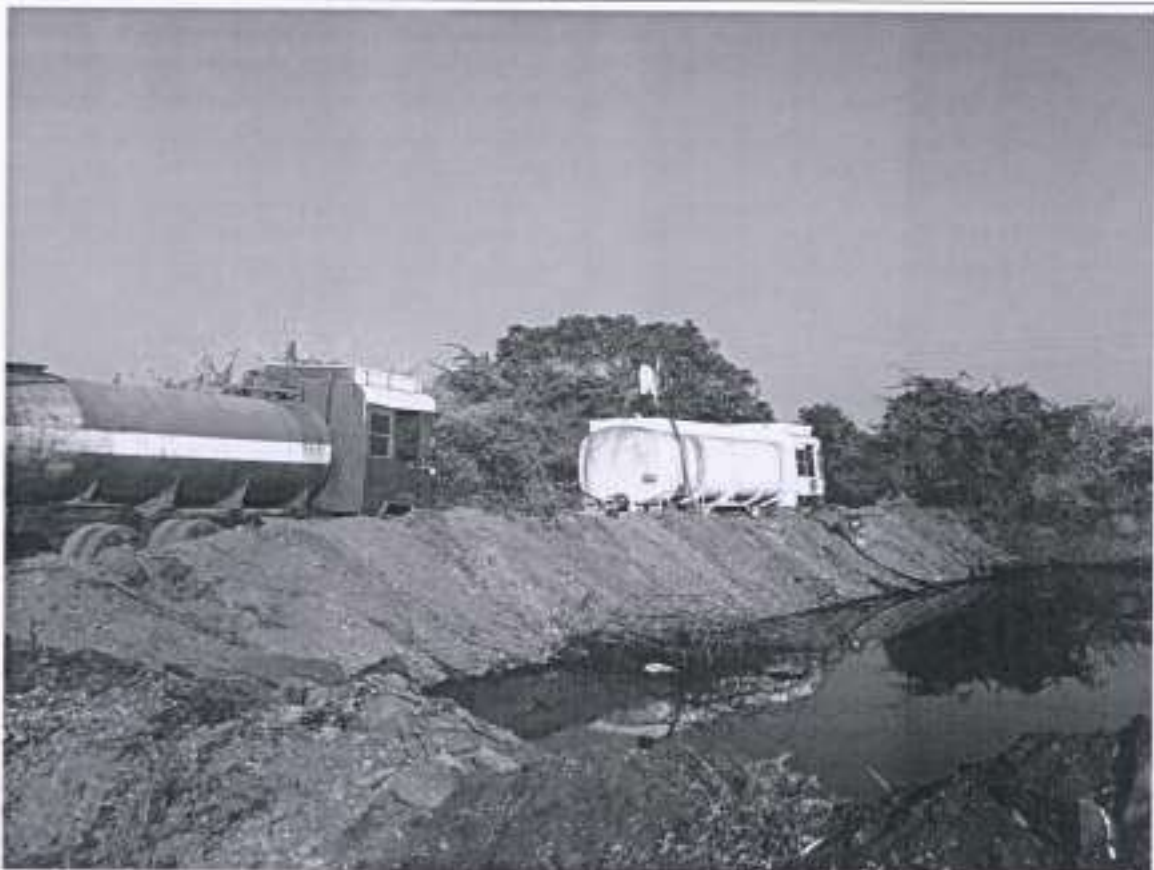
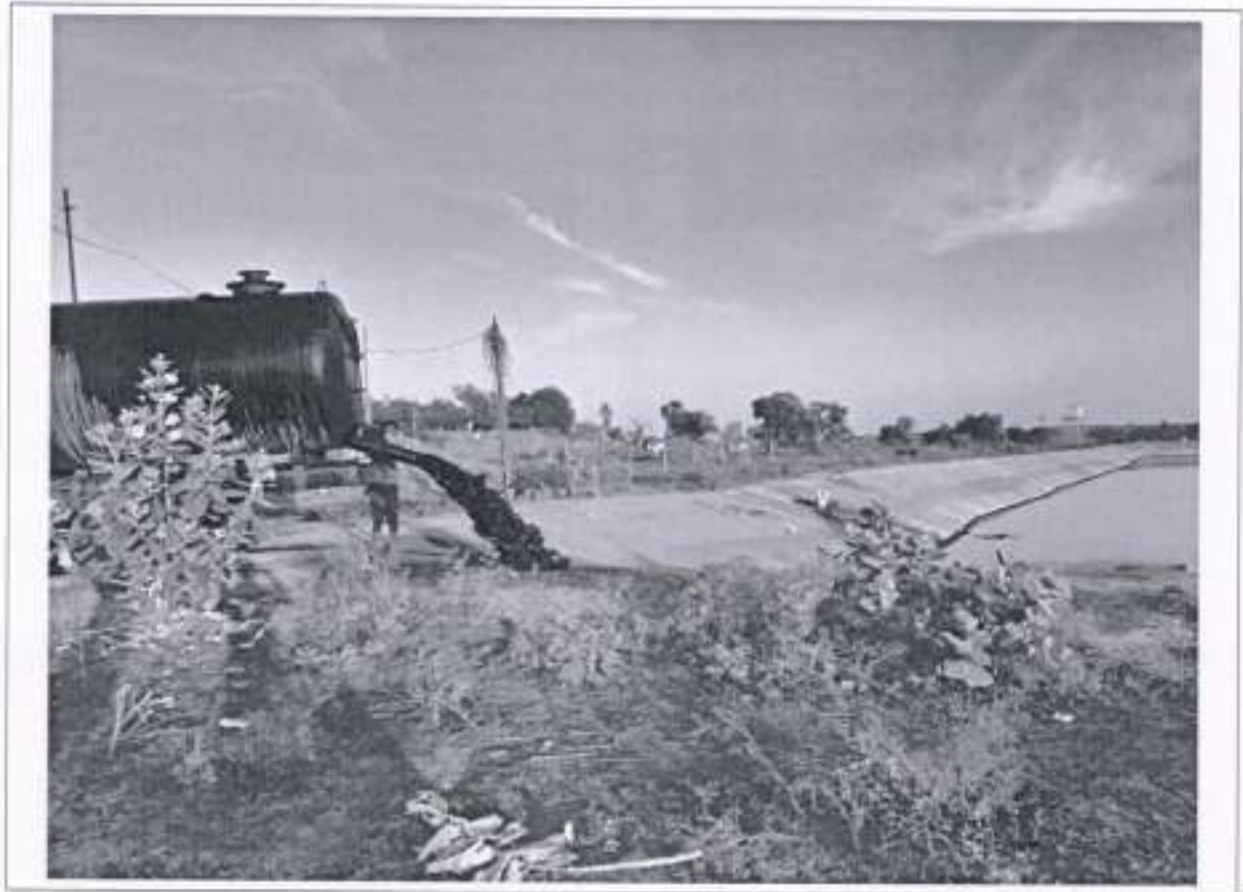
Kacha pits –II (This spent wash filled tanker and borough to the 30 days storage tank.)

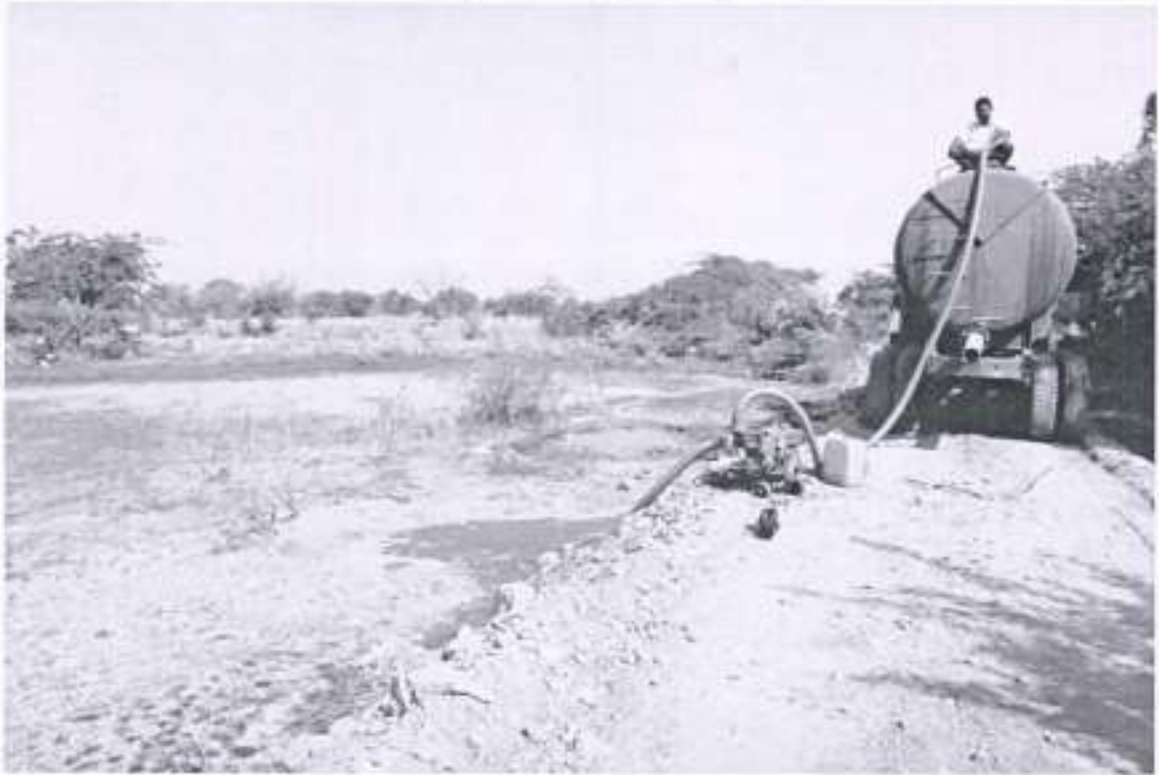
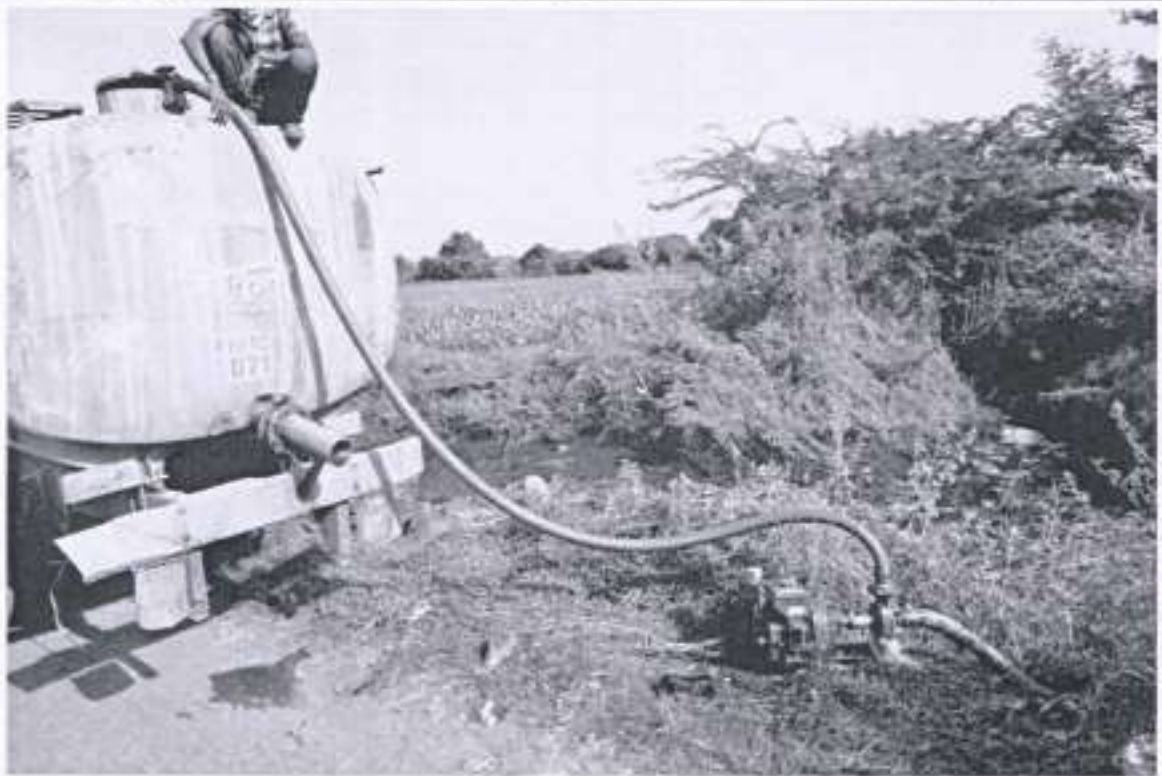
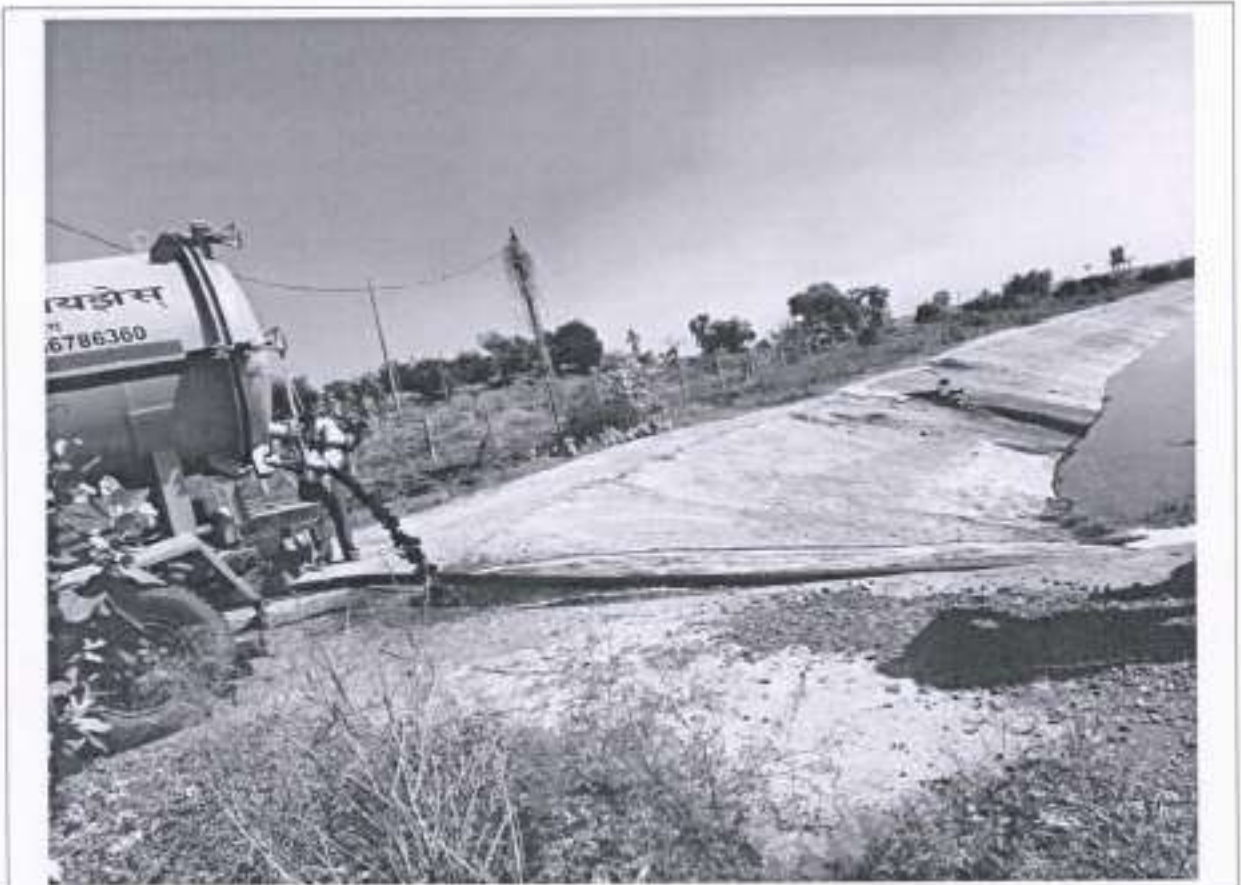
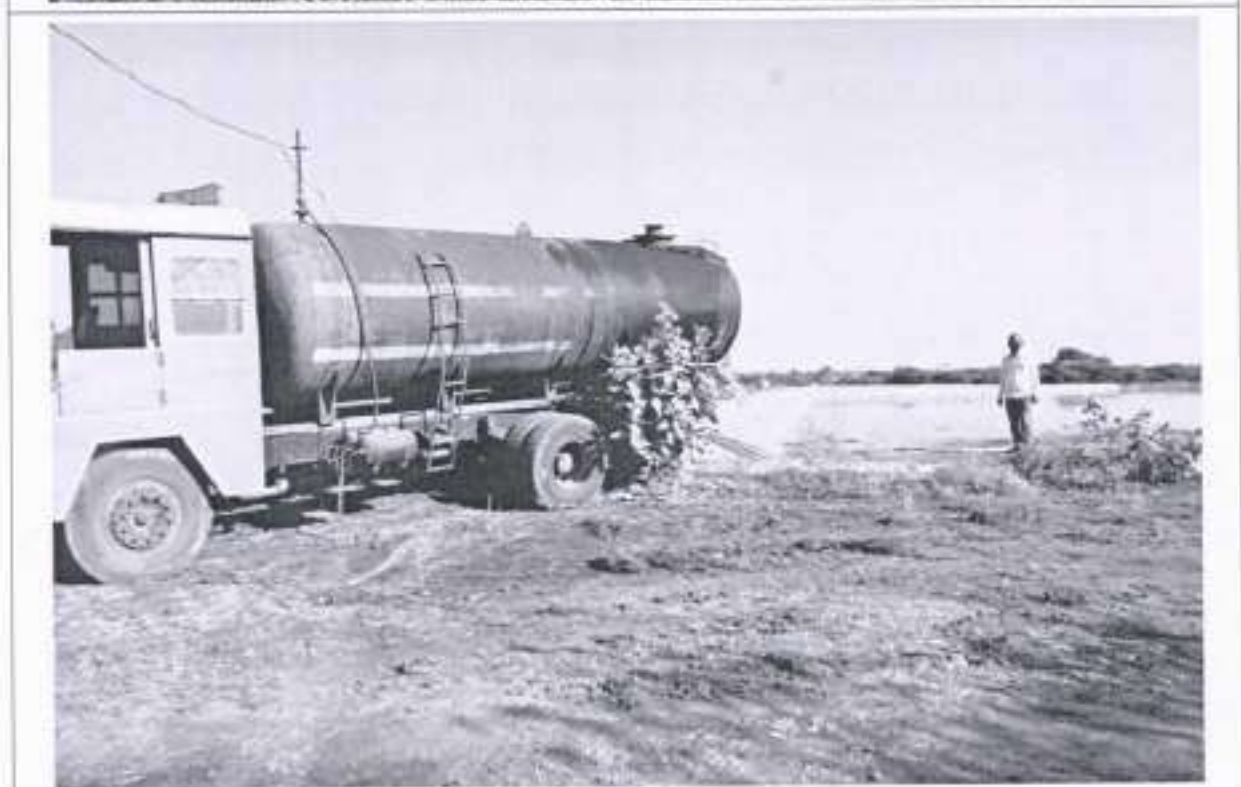
Kachabhandhara (This spent wash filled tanker and borough to the 30 days storage tank.)

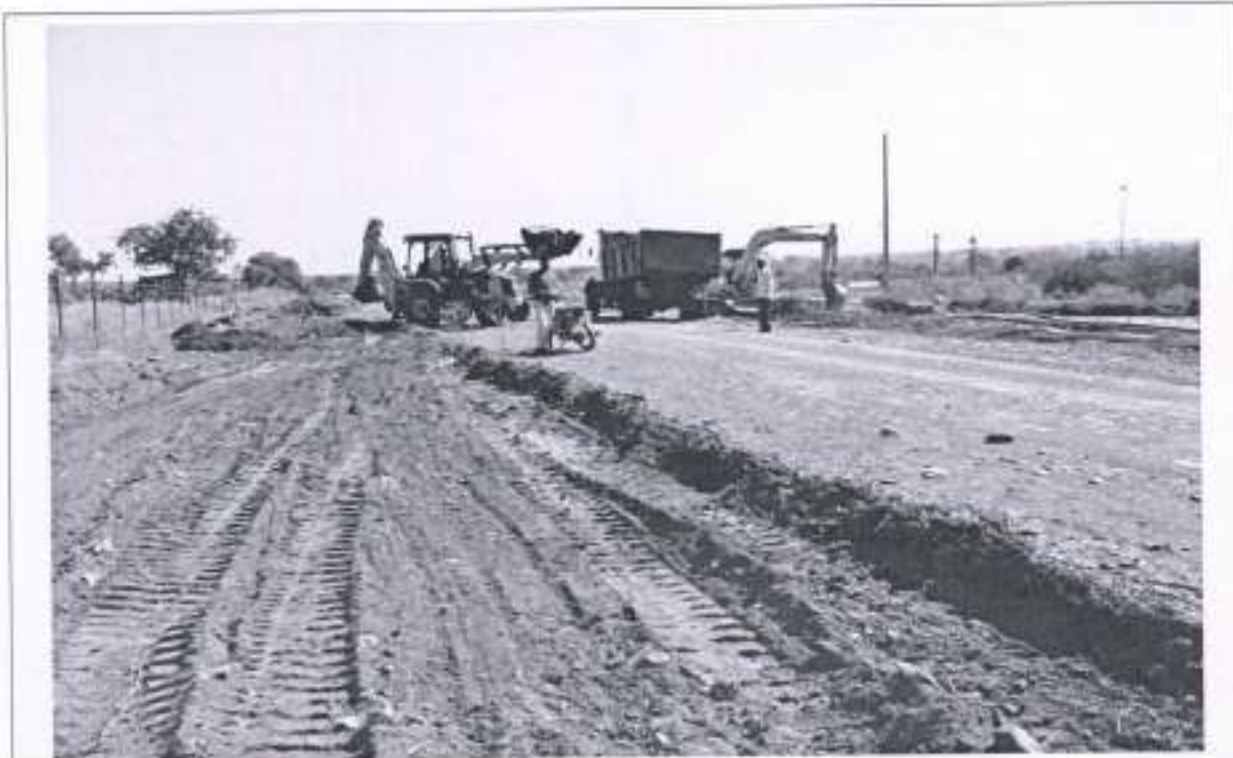
Annexure - III Soil Scrapping Collection . (Near Plant)

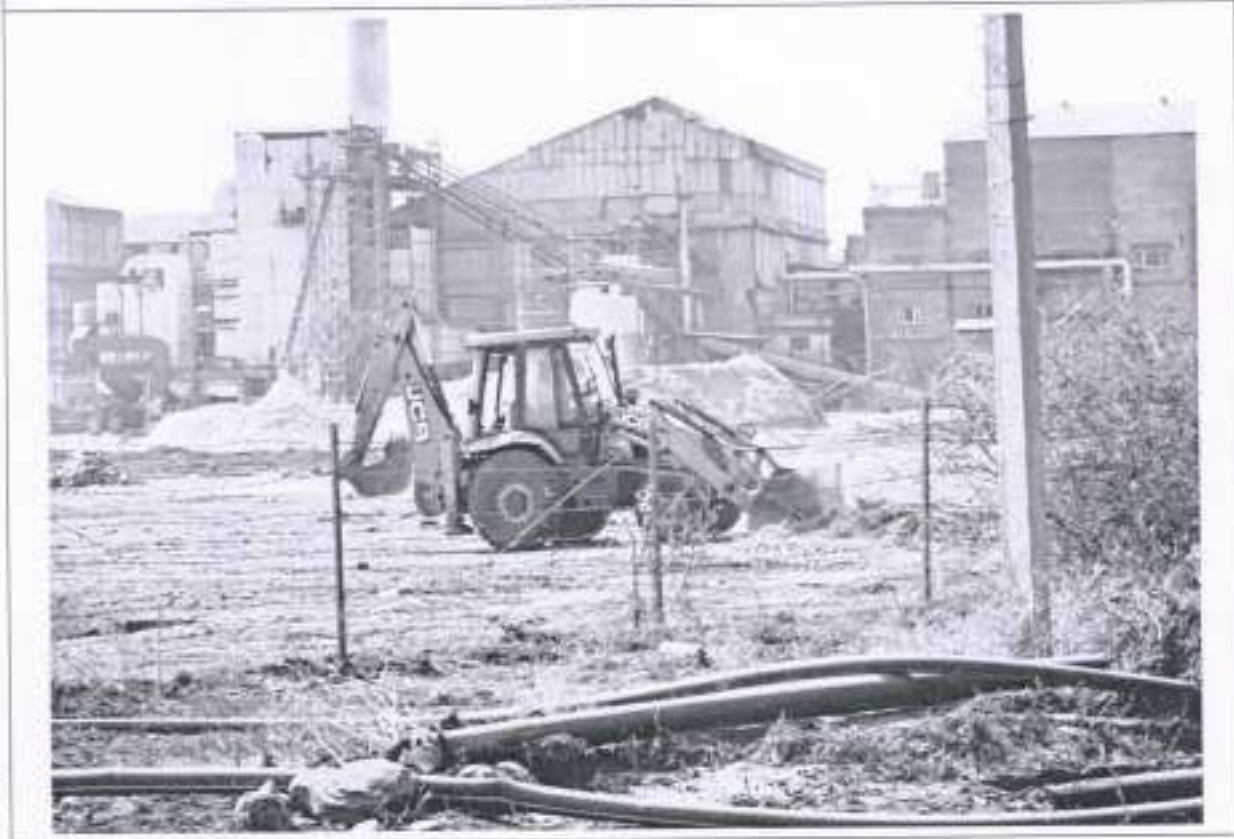
Annexure - III Soil Scrapping Collection . (Near Plant)

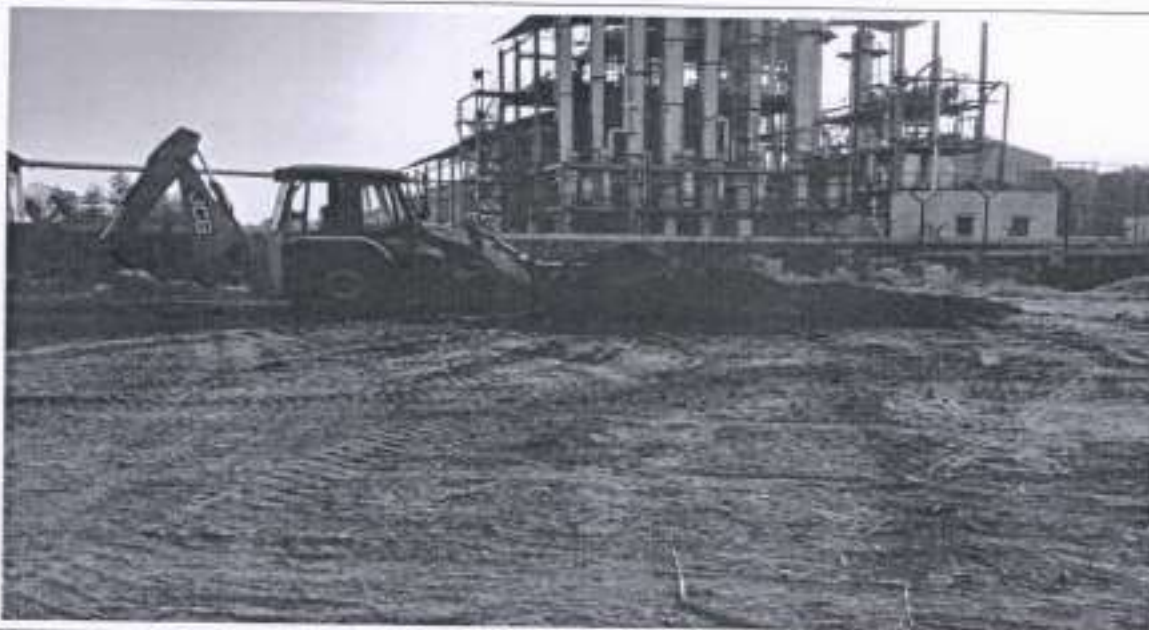
Soil Scrapping Collection . (Cane Yard)

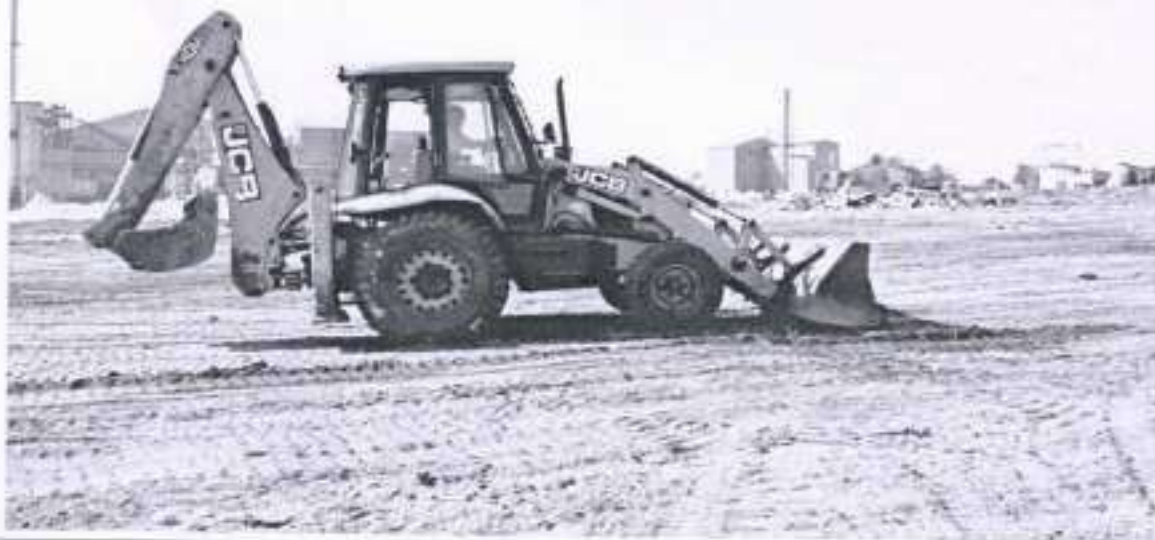
Annexure - III Soil Scrapping Collection . (Campus area)

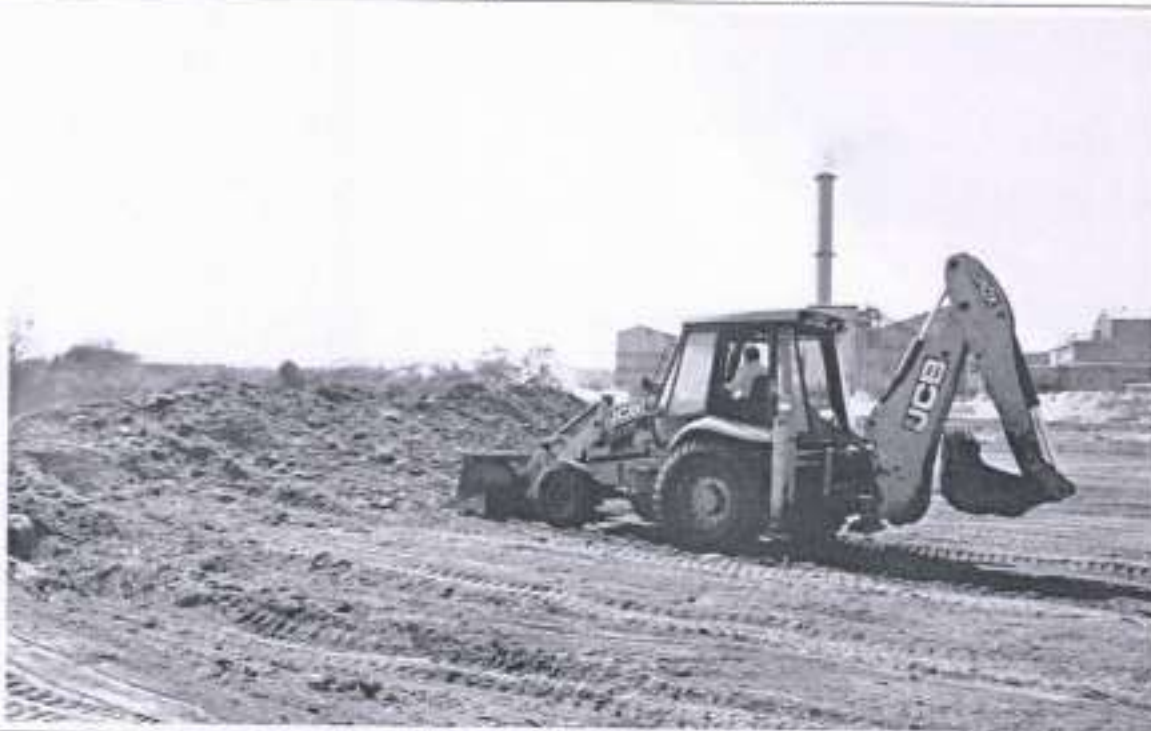
Annexure - III Baggas Collection . (Baggas Yard)

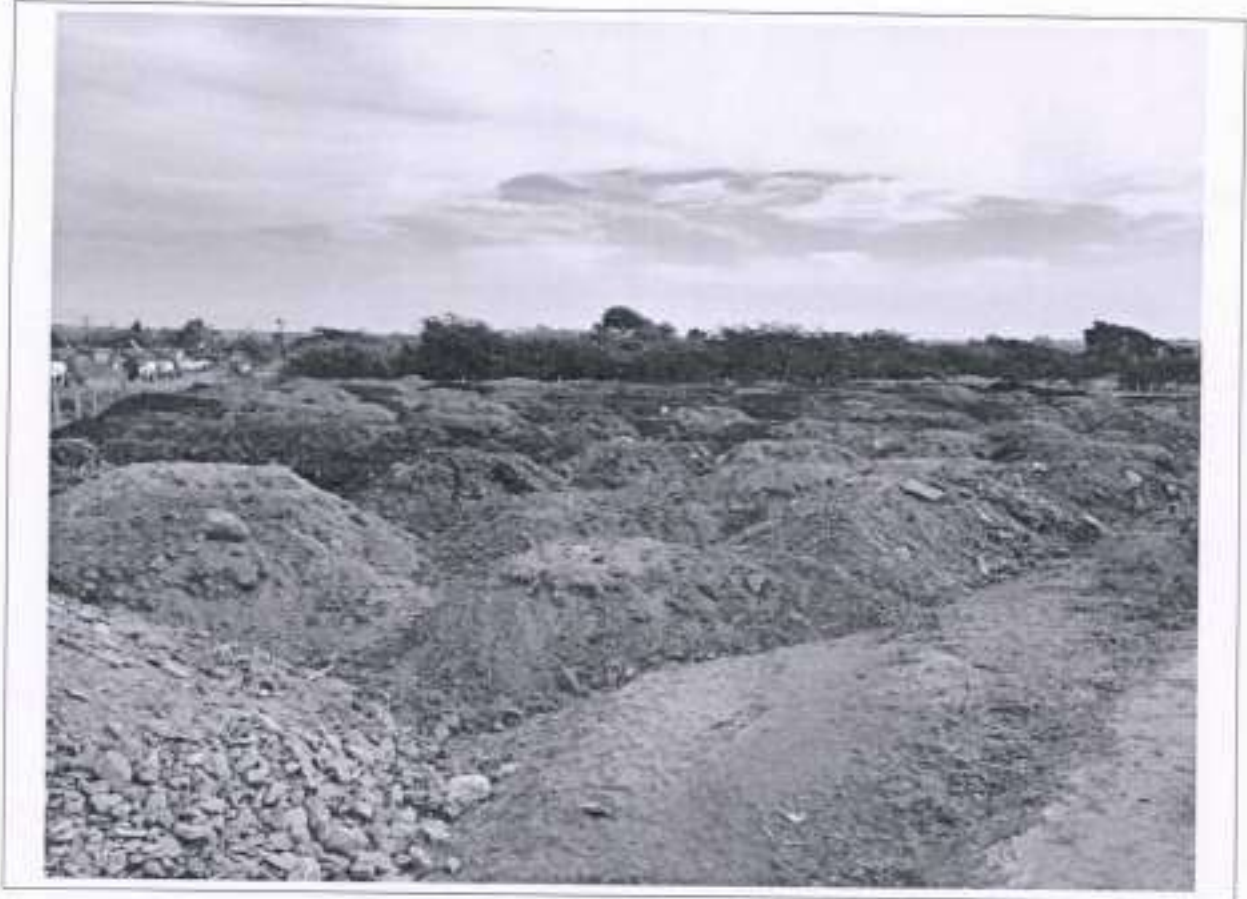
Annexure - III Total Collected Scrapping soil in compost yard.
