**INSPECTION REPORT ON
M/S EVB TECHNOLOGIES PVT. LTD.,
CBWTF, KANAVARAM,
PALLAKADIUM VILLAGE,
RAJANAGARAM MANDAL,
EAST GODAVARI DISTRICT,
ANDHRA PRADESH**

**ZONAL
OFFICE (SOUTH),
BENGALURU**

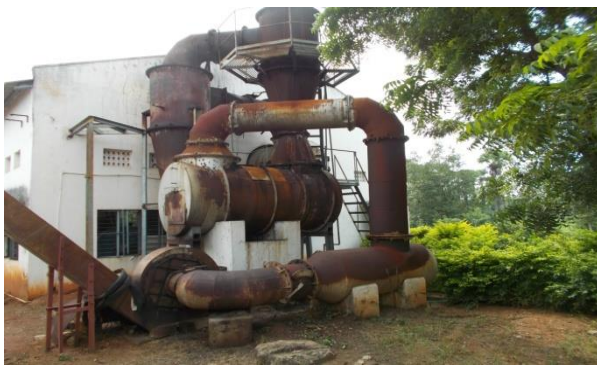
<p>pressure.</p> <ul style="list-style-type: none"> • Scrubbing medium was not used with Venturi & Wet Scrubbers due to damage occurred in scrubber tank. To replace the scrubber and cyclone dust collector, the facility has already placed the work order and a copy of which was shown during inspection. • No provision for mechanical feeding exists with the autoclave. Autoclave record shows that it records only date, time and temperature. There is no facility to record load identification number and pressure details. Pressure Gauge found not working
--	---

Fig 5: View of APCDs attached with incinerator

26.0	<p>RECOMMENDATIONS:</p> <p>The facility should be directed:-</p> <ul style="list-style-type: none"> — To take control measures to maintain the pH of discharged effluent from ETP within the limit as prescribed in the consent order immediately. — To install the devices to measure negative draft in primary chamber, air flow rate in the incinerator chamber and pressure drop across venturi scrubber attached with the incinerator. — To have flue gas analyzer to measure CO, CO₂ and O₂ levels in stack gases daily. — To make provision with the autoclave for mechanical feeding. — To upgrade the existing facility of the autoclave in order to record pressure details and load identification number along with date, time and temperature. — To subject the waste in the autoclave to i) a temperature of not less than 121 °C and pressure of 15 psi per an autoclave residence time of not less than 45 minutes or ii) a temperature of not less than 135 °C and pressure of 31 psi per an autoclave residence time of not less than 30 minutes in the case of vacuum autoclave possessed by the unit. — To carry out the stack emission monitoring of the incinerator stack for PM, HCl, NO_x, CO, CO₂, O₂ & CE, also, the volatile organic matter in the incinerator ash, validation test of autoclave and applicable parameters for liquid effluent, if discharged, through approved laboratory and submit the quarterly report to SPCB. — To provide acoustic barrier with the D.G. Set and installation of stack as per norms of Emission Regulation Part – IV. — To make provision in the primary chamber to measure the water column pressure as minimum negative draft of 1.27 to 2.54 mm of water column to be maintained to avoid leakage of gaseous emissions from the chamber and also for safety reasons. — To replace the scrubber and cyclone dust collector at the earliest and not to allow to

<p>operate the system without scrubbing medium.</p> <p>— To display an identification board of durable material covering the name of the facility, the name, address and telephone number of the operator and the prescribed authority, the hours of operation and the telephone numbers of personnel to be contacted in the event of an emergency along with hazardous waste generation & its disposal details, standards prescribed in the combined consent order etc. at the entrance of the facility.</p>
