Inspection report on status of implementation of CEPI Action Plans at Ranipet, Vellore District, Tamil Nadu

**South Zonal
Office,
Bangalore**

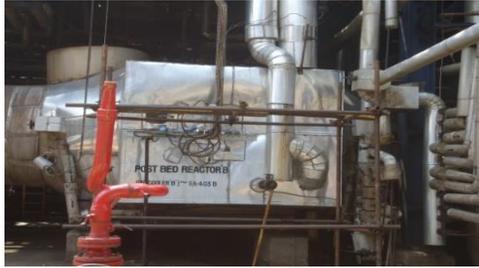
Fig 1: Post Bed Reactor

<p>generation to reduce effluent quantity from 220 kld to 195 kld.</p> <ul style="list-style-type: none"> • Installation of post bed reactor at the phthalic Anhydride plant to reduce Tarry distillation Residue. • Physical, chemical and biological followed by ZLD system to be provide 	<p>Post bed reactor is installed and claiming that Tarry distillation is reduced from 15 tons/year to 13.5 T/y.</p> <p>Installed physical, chemical, biological followed by R.O. system. R.O reject is being stored in the enhanced solar evaporation.</p>	<ul style="list-style-type: none"> ➤ No provisions are made available to verify the same. ➤ The unit claims that their R.O. is operating at 85 % efficiency and generating R.O. reject of 30 kld. The R.O permeate is being used as cooling tower make up and R.O. reject is being sent to solar evaporation pond of size 2250 m². During inspection, the nozzles of the pan were found to be choked and the pan was filled with the R.O. reject and it was found to be overflowing.

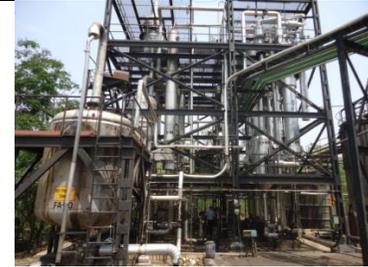
Fig 3: MEE

CEPI Action Plan	Implementation Status	Observation of the Inspection Team
Waste water: <ul style="list-style-type: none"> • Installation of Multi Effect Evaporator at source of effluent 	The unit has installed Multi effect evaporator and claiming that the effluent generation is in the tune of 195 kld	➤ No flow meter was available to verify the effect of installation of MEE.

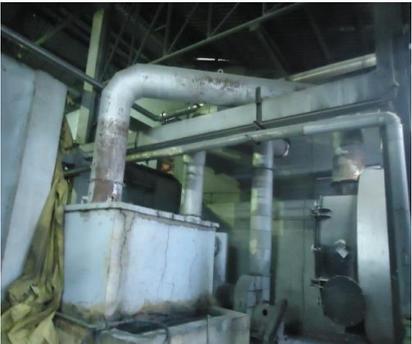
<p>Fig 9: Dust Collector System</p>

<p>acres to achieve ZLD.</p>	<p>condensate is using as boiler make up and remaining is being used for plantation in the premises.</p>
<p>Source Emission :</p> <ul style="list-style-type: none"> To install Wet Scrubber, Dust collectors. Online monitoring system for VOC to be connected. 	<p>The unit has installed Wet Scrubber in synthetic process section. Dust collector is provided in the wood fired boiler to control SPM.</p> <p>Online VOC monitoring system is installed to monitor VOC concentration in ambient</p>	<ul style="list-style-type: none"> ➤ The team has made physical verification, for working condition of control measures, in- depth monitoring is required. ➤ At the time of inspection, the Online monitoring system for VOC was showing zero reading and the same has been connected to TNPCB Care Air centre.

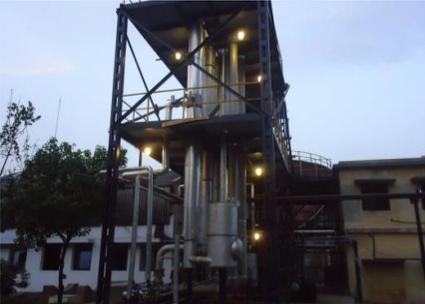
<p>Fig 13: Multi effect evaporator</p>

CEPI Action Plan	Implementation Status	Observation of the Inspection Team
<p>Waste Water:</p> <ul style="list-style-type: none"> To install Primary treatment, Bio-reactor, R O plant, multiple effect evaporator and Bio-composting. 	<p>The unit has installed bio-methanation plant followed by R.O. plant and 02 Multi effect evaporators of 05 effects and 03 effects to concentrate effluent followed by bio composting plant in 1.23</p>	<p>➤ The unit is claiming that they are reducing effluent quantity from 120 KLD to 30-40 KLD and utilising concentrated effluent for making bio compost by using press mud as filler material. The R.O. permeate is being utilised for cooling tower make up and part of MEE</p>

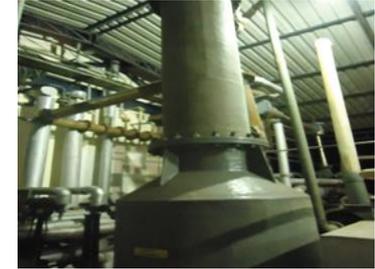
Fig 18: Wet Scrubber

<p>Source Emission :</p> <ul style="list-style-type: none"> To install Wet Scrubber, Dust collectors. Online monitoring system for VOC to be connected. 	<p>The unit has installed Wet Scrubber in the process section. No Dust collector is provided in the boiler.</p> <p>Online VOC monitoring system is installed to monitor VOC concentration in ambient</p>	<ul style="list-style-type: none"> ➤ The unit claims that since furnace oil is used as fuel no dust collector is installed at boiler. The team has made physical verification, for working condition of control measures, in- depth monitoring is required. ➤ At the time of inspection the online monitoring system for VOC was showing zero reading and the same has been connected to TNPCB Care Air centre.

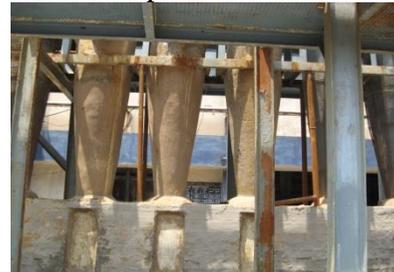
Fig 25: Cyclone Separator

integrated cyclone system in the Sulphonation process.

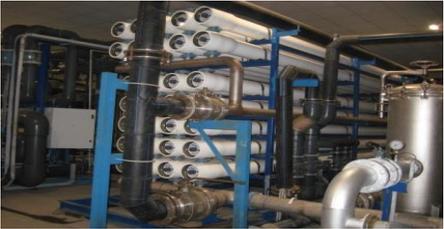
<p>Fig 35: R.O. under trail run</p>

8.	<p>M/s Ranipet SIDCO Phase-I (CETP), Ranipet: The CETP is receiving the effluent in the range 1100 - 1300 m³/day against the designed capacity of 2500 m³/day. It is informed that the CETP is being operated in the range of 45-55% of capacity since some of their member units are not operating tannery at full capacity</p>		
CEPI Action Plan	Implementation Status	Observation of the Inspection Team	
<p>Waste Water:</p> <ul style="list-style-type: none"> To install physical, chemical, biological treatment followed by ZLD system to prevent ground water, surface water and soil 	<p>The CETP has installed physical, Chemical biological treatment system followed by Ultra filtration system, and R.O. plant. Multi Effect</p>	<p>➤ The CETP is operating Physical, Chemical, biological treatment system regularly. They installed U.F & R.O. plant of capacity 2500 kld and same was found under trail run.</p>

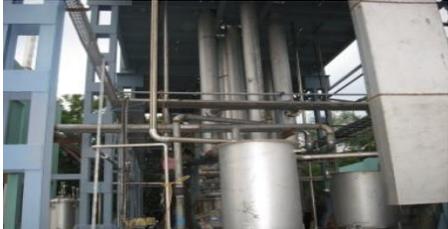
<p>Fig36: MEE under commissioning</p>

<p>pollution.</p>	<p>Evaporator and boiler under commissioning stage.</p> <p>The CETP has constructed Secured Land Fill(SLF) of capacity 4000 m³ to dispose their ETP sludge and to dispose hazardous waste generated from their member units</p>	<ul style="list-style-type: none"> ➤ Erection of MEE (7 effect) and Boiler were found under progress. ➤ Presently secondary treated effluent being discharged to drain which ultimately joins the Palar River. ➤ The SLF was found half filled with hazardous waste, but no proper approach /ramp is made for uniform disposal. In the absence of proper approach/ramp, the Hazardous waste is found dumped adjacent to SLF. It is informed that temporarily HW is being dumped adjacent to SLF and same is being disposed to SLF with the help of tipper. Stagnated water was found in many pockets of SLF. No proper leachate collection system is provided. ➤ The surface runoff from temporary dumping of hazardous waste adjacent to SLF may cause ground water as well as surface water pollution in the surrounding area.

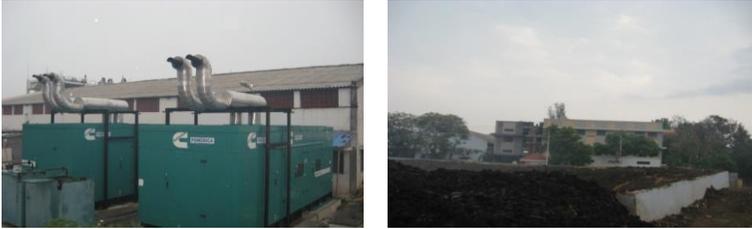
<p>To install DG Sets :</p> <ul style="list-style-type: none"> • To install adequate DG sets at CETP and at pumping stations to avoid over flow of untreated effluent during power failure. 	<p>The CETP has installed DG sets of capacity 250 KVA (01 no.) and 600 KVA (01 no.)</p>	<ul style="list-style-type: none"> ➤ The CETP has installed DG sets with acoustic enclosures and exhaust system.

<p>Fig 37: DG sets</p> <p>Fig 38: SLF</p>

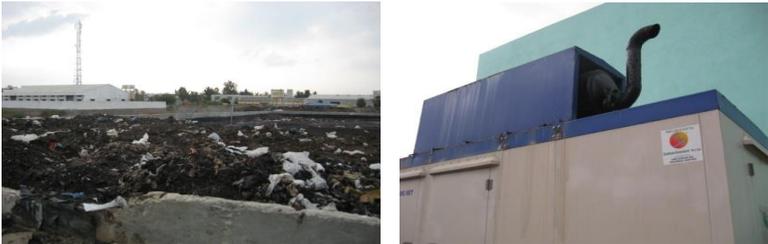
<p>Fig 41: SLF</p> <p>Fig 42: DG set</p>

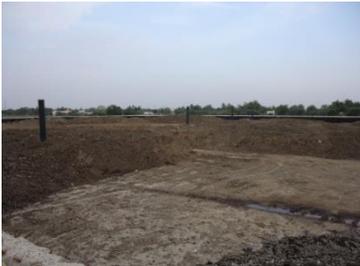
<p>Fig 45: SLF</p>

<p>Stagnated water was found in many pockets of SLF. No proper leachate collection system is provided.</p> <p>➤ The surface runoff from temporary dumping of hazardous waste adjacent to SLF may cause ground water as well as surface water pollution in the surrounding area.</p>
<p>To install DG Sets :</p> <ul style="list-style-type: none"> To install adequate DG sets at CETP and at pumping stations to avoid over flow of untreated effluent during power failure. 	<p>The CETP has installed DG sets of capacity 600 KVA of 03 no's and 380 KVA of 01 no.</p>	<p>➤ The CETP has installed DG sets with acoustic enclosures and exhaust system.</p>

- (vi) Issues like leachate collection system in SLF's, end treatment of RO reject viz a viz, MBR,MEE are to be looked into, since the end treatment is not complete, the entire concept of ZLD will backfire and may reflect in the CEPI index.

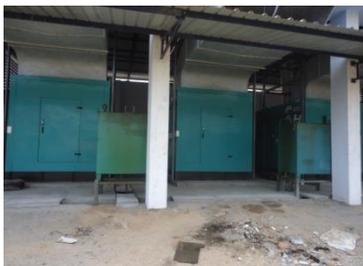
<p>Fig 46: DG sets</p>
<p>2.</p>	<p>M/s. Melvisharam Tanneries Effluent Treatment Co. Ltd.,(CETP) : The CETP has 14 active members and receiving the effluent in the range 150-200 m³/day against the designed capacity of 550 m³/day. It is informed that the CETP is being operated in the range of 27-36% of capacity since some of their member units are not operating tannery at full capacity.</p>

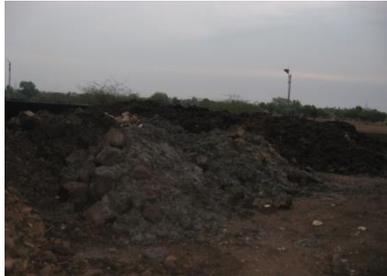
<p>The CETP has constructed Secured Land Fill(SLF) of capacity 15000 m³ to dispose their ETP sludge and to dispose hazardous waste generated from their member units</p>	<ul style="list-style-type: none"> ➤ The SLF was found half filled with hazardous waste, but no proper approach/ramp is made for uniform disposal. In the absence of proper approach/ramp, the Hazardous waste is found dumped adjacent to SLF. It is informed that temporarily HW is being dumped adjacent to SLF and same is being disposed to SLF with the help of tipper. Stagnated water was found in many pockets of SLF. No proper leachate collection system is provided. ➤ The surface runoff from temporary dumping of hazardous waste adjacent to SLF may cause ground water as well as surface water pollution in the surrounding area.
<p>To install DG Sets :</p> <ul style="list-style-type: none"> • To install adequate DG sets at CETP and at pumping stations to avoid over flow of untreated effluent during power failure. 	<p>The CETP has installed DG sets of capacity 500 KVA of 01 no. and 380 KVA of 01 no.</p>	<ul style="list-style-type: none"> ➤ The CETP has installed DG sets with acoustic enclosures and exhaust system.

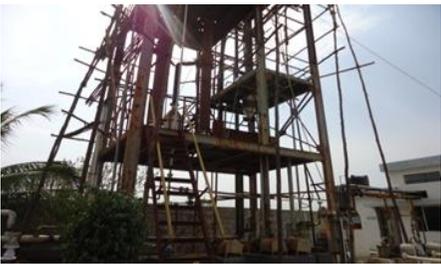
<p>Fig 55: Crystalliser under repair</p>

CEPI Action Plan	Implementation Status	Observation of the Inspection Team
<p>Waste Water:</p> <ul style="list-style-type: none"> To install physical, chemical, biological treatment followed by ZLD system to prevent ground water, surface water and soil pollution. 	<p>The CETP has installed physical, Chemical biological treatment system (MBR) followed by Ultra filtration system, R.O. plant and Multi effect Evaporator.</p>	<ul style="list-style-type: none"> ➤ The CETP is operating Physical, Chemical, biological treatment system and Ultrafiltration followed by. R.O. plant. The R.O. permeate is being sent back to their member units and R.O. reject is being concentrated through MEE. ➤ During inspection MEE was not in operation, it is informed that due to mechanical problem MEE operation was stopped since 45 days and R.O. reject is being discharged into nearby drain which ultimately joins the Palar river. ➤ The CETP has no dedicated SLF. It uses Ambur Tannery Effluent Treatment Co. Ltd., Thuthipet sector, Ambur for Sludge disposal.

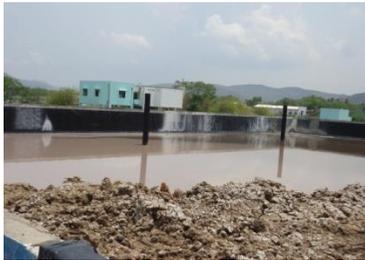
Fig 65: SLF Fig 66: DG Set

The CETP has constructed Secured Land Fill (SLF) of capacity 20000 m ³ to dispose their ETP sludge and to dispose hazardous waste generated from their member units.	required. ➤ Stagnated water was found in many pockets of SLF, no proper leachate collection system is provided.
To install DG Sets : • To install adequate DG sets at CETP and at pumping stations to avoid over flow of untreated effluent during power failure.	The CETP has installed DG sets of capacity 320 KVA of 01 no. and 125 KVA of 01 no.	➤ The CETP has installed DG sets with acoustic enclosures and exhaust system.

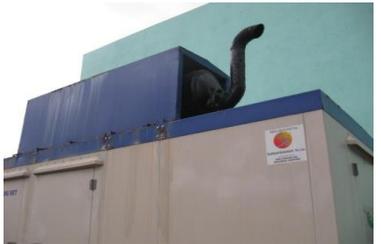
<p>Fig 41: SLF</p> <p>Fig 42: DG set</p>

<p>To install DG Sets :</p> <ul style="list-style-type: none"> To install adequate DG sets at CETP and at pumping stations to avoid over flow of untreated effluent during power failure. 	<p>The CETP has installed DG sets of capacity 1110 KVA of 02 no. and 380 KVA of 01 no.</p>	<p>➤ The CETP has installed DG sets with acoustic enclosures and exhaust system.</p>

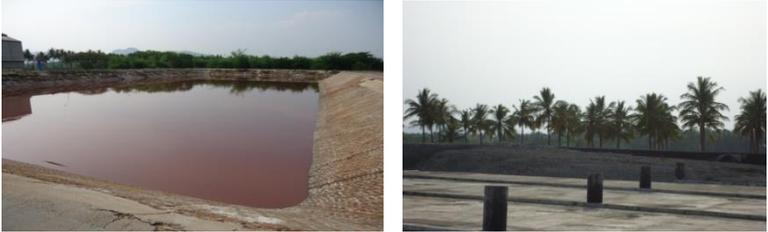
<p>Fig 53: R.O. reject stored in Lagoon</p> <p>Fig 54: SLF</p>

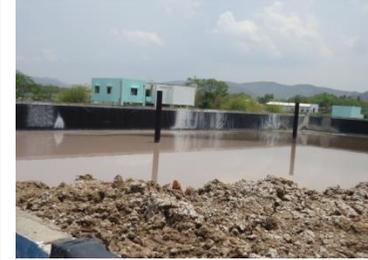
Fig 65: SLF

4.	Pernambut Tannery Effluent Treatment Co. Ltd., Bakkalapalli sector, Pernambut: The CETP has 36 active members and receiving the effluent in the range 500-600 m ³ /day against the designed capacity of 01 MLD. It is informed that the CETP is being operated in the range of 50-60% capacity since some of their member units are not operating tannery at full capacity due to lean season.	
CEPI Action Plan	Implementation Status	Observation of the Inspection Team
Waste Water: <ul style="list-style-type: none"> To install physical, chemical, biological treatment followed by ZLD system to prevent ground water, surface water and soil pollution. 	<p>The CETP has installed physical, Chemical, biological treatment system followed by Ultra filtration system, R.O. plant and Multi effect Evaporator.</p> <p>The CETP has constructed Secured Land Fill (SLF) of capacity 20000 m³ to dispose their ETP sludge and to dispose hazardous waste generated from their member units.</p>	<ul style="list-style-type: none"> ➤ The CETP is operating Physical, Chemical, biological treatment system and Ultra filtration system regularly. R.O. plant was found under trail run and erection of MEE was under progress. ➤ Presently part of secondary treated effluent being treated through R.O., the reject is being mixed with part of secondary treated effluent and discharging into drain which ultimately joins the Palar River. ➤ The team has made physical verification, for working condition of control measures, in- depth monitoring is required. ➤ Stagnated water was found in many pockets of SLF, no proper leachate collection system is provided.

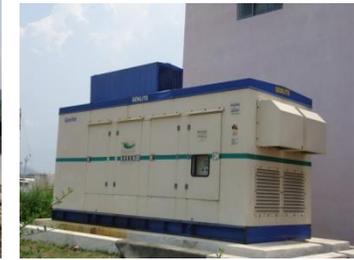
Fig 66: DG Set

To install DG Sets : <ul style="list-style-type: none"> To install adequate DG sets at CETP and at pumping stations to avoid over flow of untreated effluent during power failure. 	<p>The CETP has installed DG sets of capacity 320 KVA of 01 no. and 125 KVA of 01 no.</p>	<ul style="list-style-type: none"> ➤ The CETP has installed DG sets with acoustic enclosures and exhaust system.
