**Central Pollution Control Board  
South Zone Office, Bengaluru-560079**

COMMENTS AND FOLLOW - UP

The following observations have been made during visit at **Tamilnadu**. State Pollution Control Board **Salem Advanced Environmental** Laboratory from **CPCB, South Zonal Office Bangalore**.

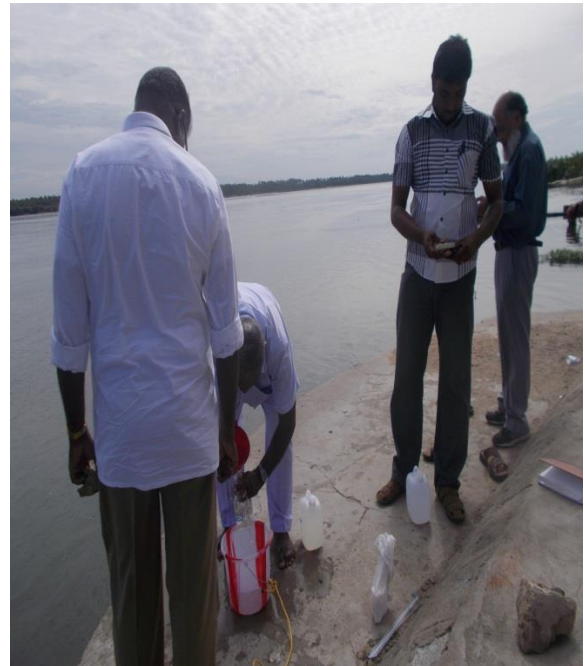
**Fig. no.1 : NWMP Location located in Pugalur ( SC-3015) – near to this station activities such as washing of cloths, irrigation diversion head and drinking water intake well were found.**

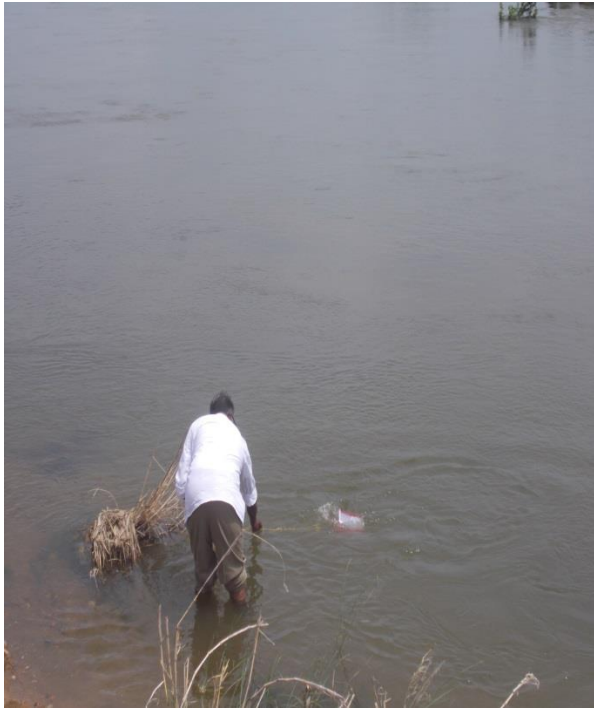
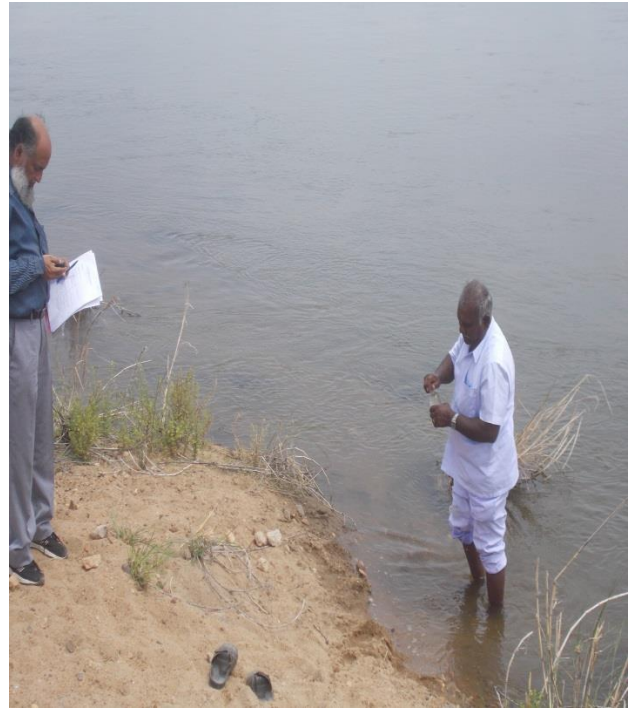
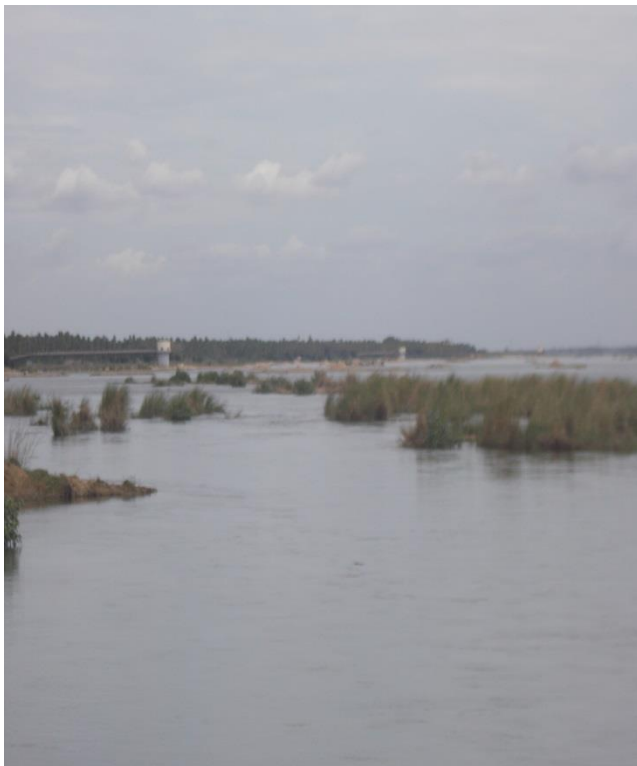
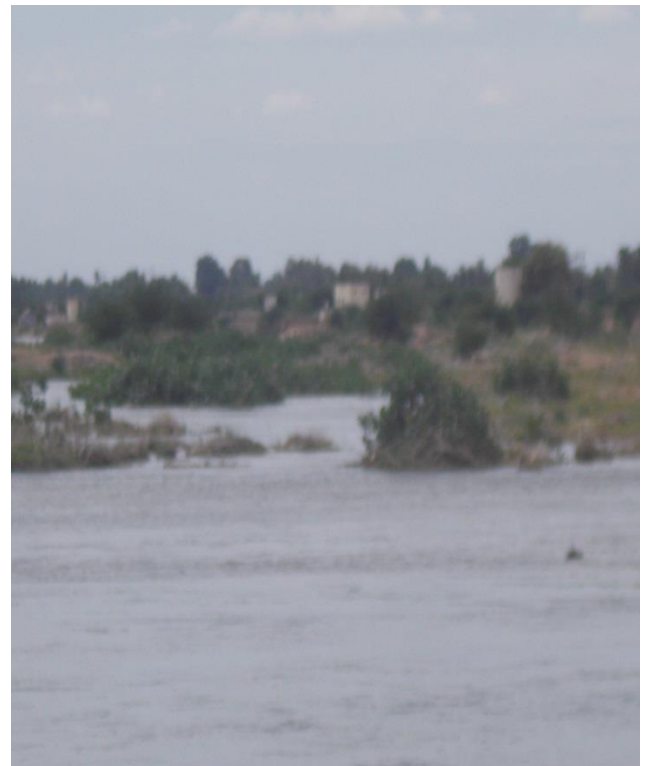
**Fig. no.2 : NWMP Location located in Thirumukudal ( SC-14515) – activities such as drinking water intake well were found upstream of this station and near to this confluence of Amaravathi river which is carrying karur treated/untreated sewage was found.**
