**ENVIRONMENTAL QUALITY MONITORING OF CRITICALLY POLLUTED AREA
– CHANDRAPUR, MAHARASHTRA**

1.0 OBJECTIVE OF THE VISIT

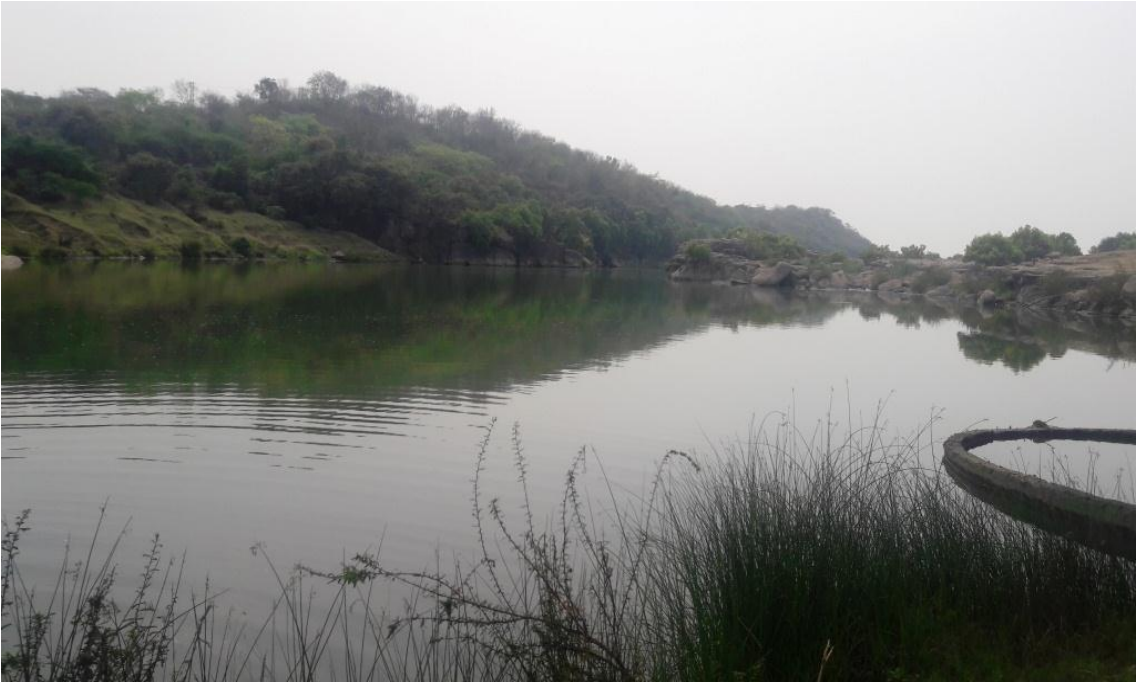
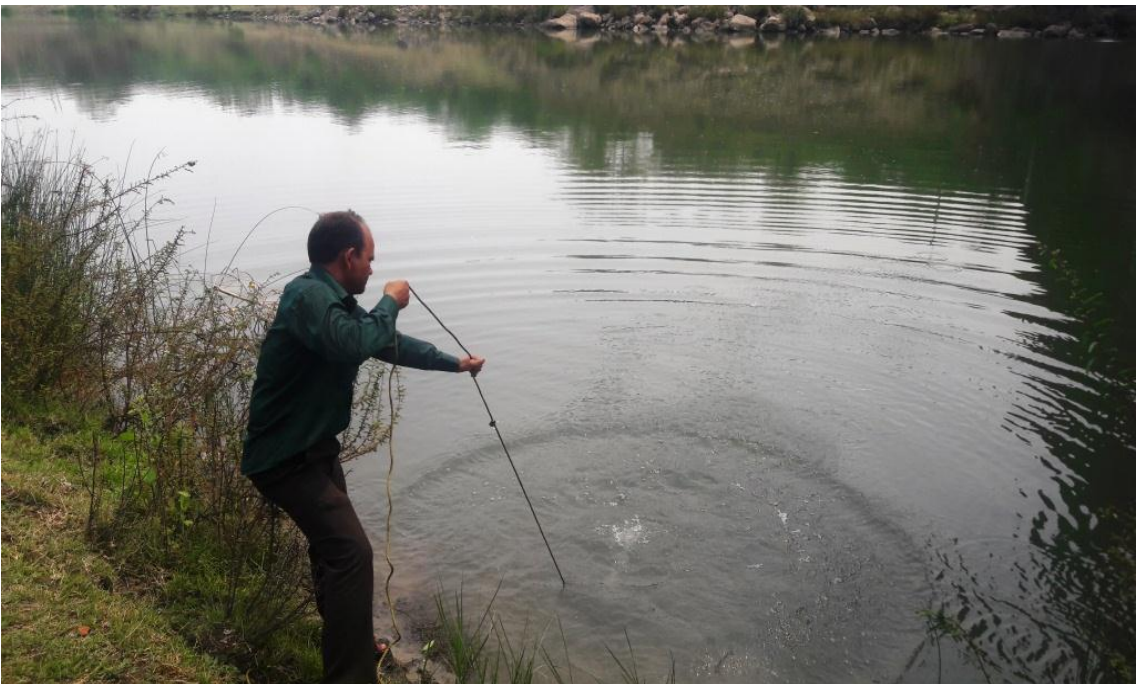
Photographs-3 &4: SWQM location-2

- SWQM location-2 (Wardha River, Near High flood level observation office, Ghuggus – Wani bridge, Niagoan) there were visual evidences of growth of aquatic plants like grass & sedges at river banks and no human interference activities was observed during sampling (**Photographs-3 & 4, Annexure-I**).

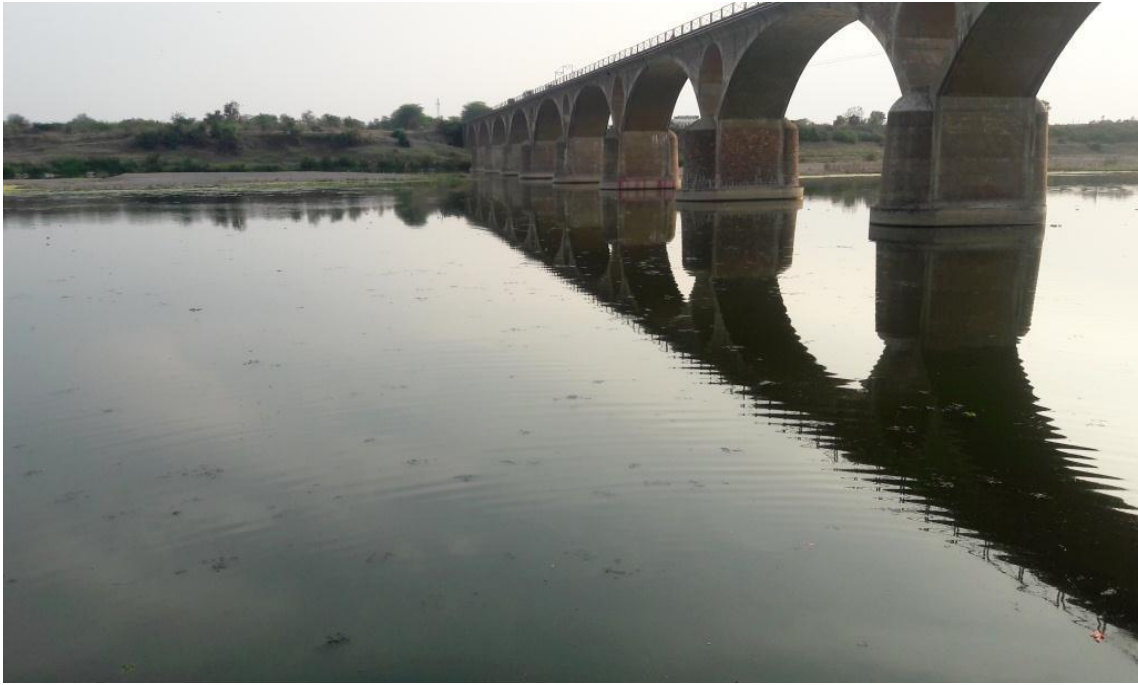
Photographs-7 & 8: SWQM location-4

- SWQM location-4 (Wardha River at Ballarpur Fort, Near Intake Well of M/s BILT, Ballarpur) there were visual evidences of abundance growth of vegetation at river banks and across the river. Also, dumping of plastic wastes and floral wastes i.e. religious wastes were observed near river banks. Apart from this fishing and cloth washing activities were observed at river banks (**Photographs-7 & 8, Annexure-I**).
