POLLUTION STATUS OF RIVER GHAGGAR

CENTRAL POLLUTION CONTROL BOARD
(Ministry of Environment and Forest, Govt. of India)
Parivesh Bhawan, East Arjun Nagar
Delhi – 110032

The study was conducted by CPCB to assess the pollution potential of Ghaggar basin. The report provides an overview of the pollution problem of the river, measures for its control, the recommendations and action taken by CPCB to ensure pollution mitigation of river Ghaggar.

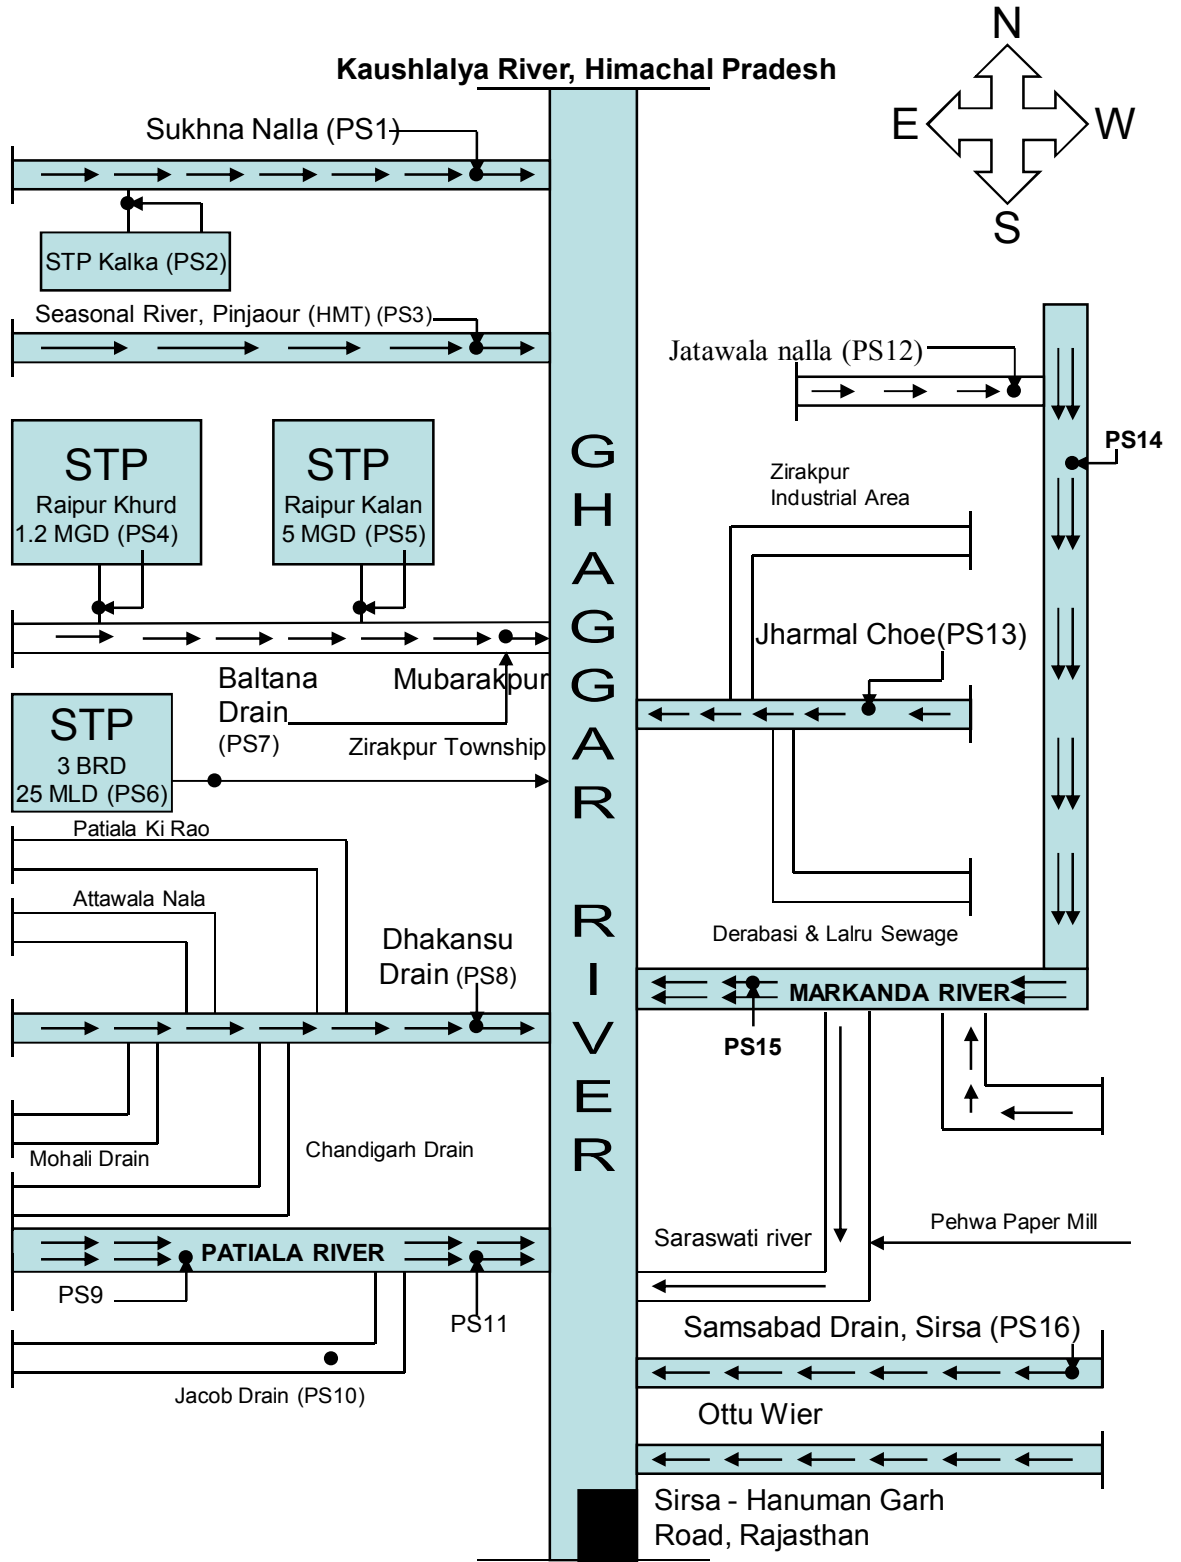
FIG 2: SCHEMATIC DIAGRAM OF POINT SOURCES IN GHAGGAR RIVER

During the five days of field study, the team monitored all the major point sources of River Ghaggar. The list of point sources are given in Table 2. The team also conducted a survey of the Ghaggar basin as per the Schematic Diagram given in Fig.2:

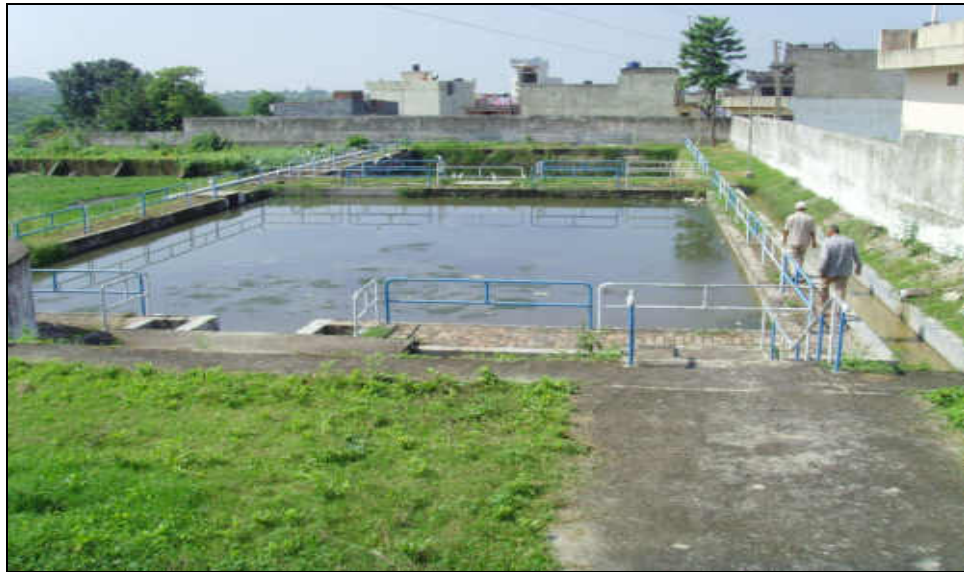
Pic.1: Kalka STP

4.2.2 Kalka (PS2): Sewage Treatment Plant (STP) at Kalka was found non-operational and effluent was directly used for irrigation purpose. The effluent quality indicates high concentration of BOD and COD i.e. 393 mg/l and 921 mg/l respectively. The estimated BOD load was observed as 1500 kg/day. Pic.1 shows the shabby conditions of STP Kalka.

STP at Kalka, Haryana and Diggian Mohali, Chandigarh need to be efficiently operated. The effluent quality of these STPs do not conform to the prescribed standards for BOD and TSS.

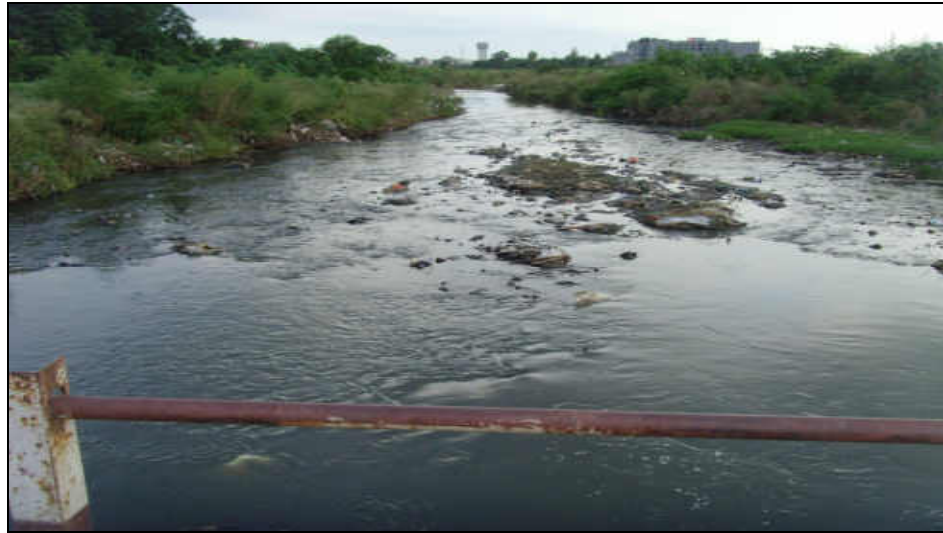
Pic.2: Baltana Drain at Chandigarh

4.2.6 Baltana Drain (PS7): Baltana Drain carries wastes (sewage & industrial) from Chandigarh and Panchkula (Haryana). It was observed that the sewage from Raipur Kalan STP, with a capacity of 5 MGD for treatment of sewage from Panchkula, Chandigarh and Punjab was being by-passed without any treatment to Baltana Drain. BOD load of Baltana Drain was assessed very high as 57 mg/l and other parameters were also above the prescribed standards. Pic.2 shows the water condition of Baltana Drain.

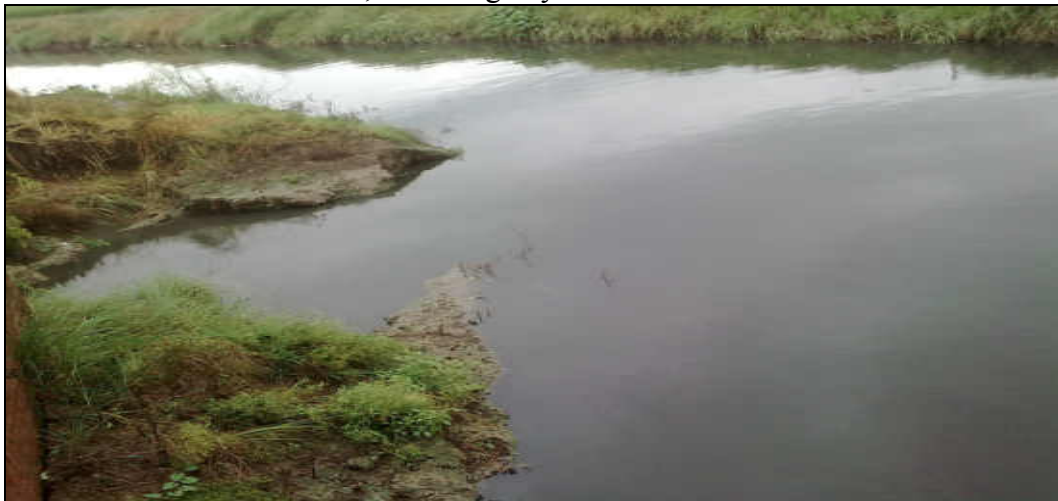
Pic.3: Patiala River D/S, Dhanor Village, Patiala

4.2.9 Patiala River (PS11): A number of subsidiary rivulets join the Ghaggar River, the most important one being Patiala River. Patiala River meets the Ghaggar River at the upstream of Jharmal choe. This River also falls in the category of semi-arid region. At Patiala River, high BOD load was observed i.e. 32,228.26 kg/day.

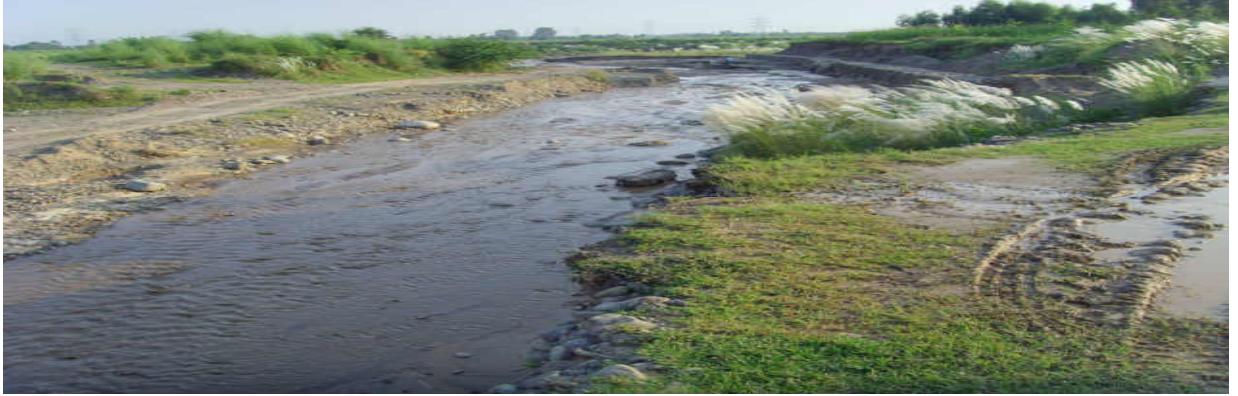
Pic. 4: Jatawallah Nallah, Haryana

4.2.10 Jatawallah Nallah (PS12): Sample was collected at downstream of Jatawallah Nallah, Kala Amb-Himachal. In Kala Amb, Himachal Pradesh, there are more than 200 industries comprising M/S Ruchira Paper Mills Ltd. (RPL), Steel Rolling mill, Pharmaceutical Units etc. Industrial wastes alongwith untreated sewage of Kala Amb area falls directly into **Jatawala Nallah** which ultimately meets the River Markanda. BOD load at Jatawala Nalla was very high i.e. 1270.08 kg/day. BOD and TSS concentration was observed as 84 mg/l and 1930 mg/l, respectively.

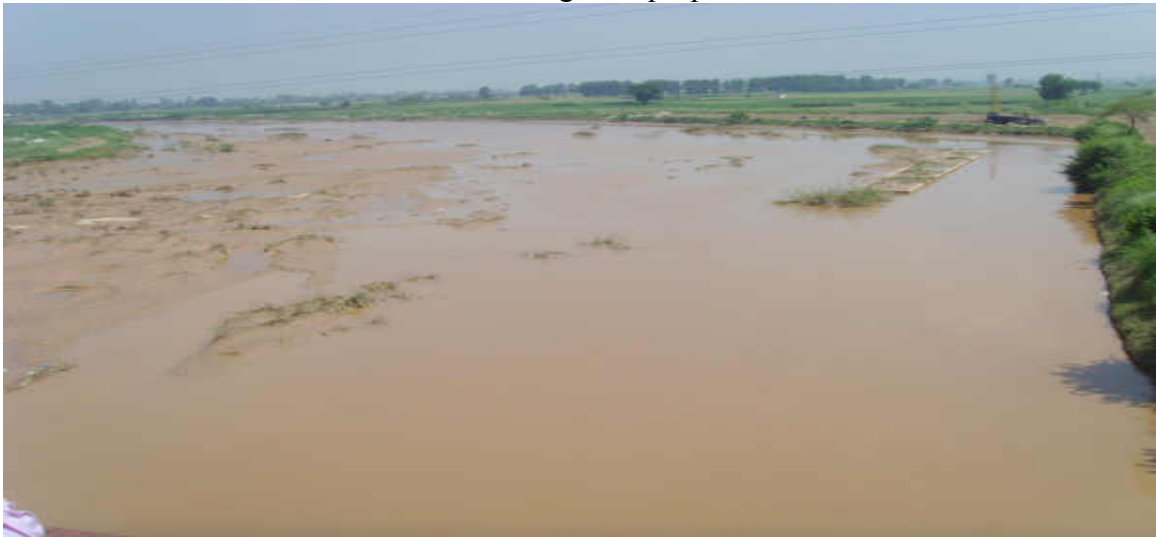
Pic. 5: Markanda River at Narayangarh

Markanda River at Narayangarh River Markanda is polluted due to Jatawallah Nala. The BOD load at this point was observed as 1764.24 kg/day, but the flow at the sampling point was high, thus the BOD concentration was found 4.6 mg/l. The flow of River at Shahbad was not observed due to abstraction of water for irrigation purpose.

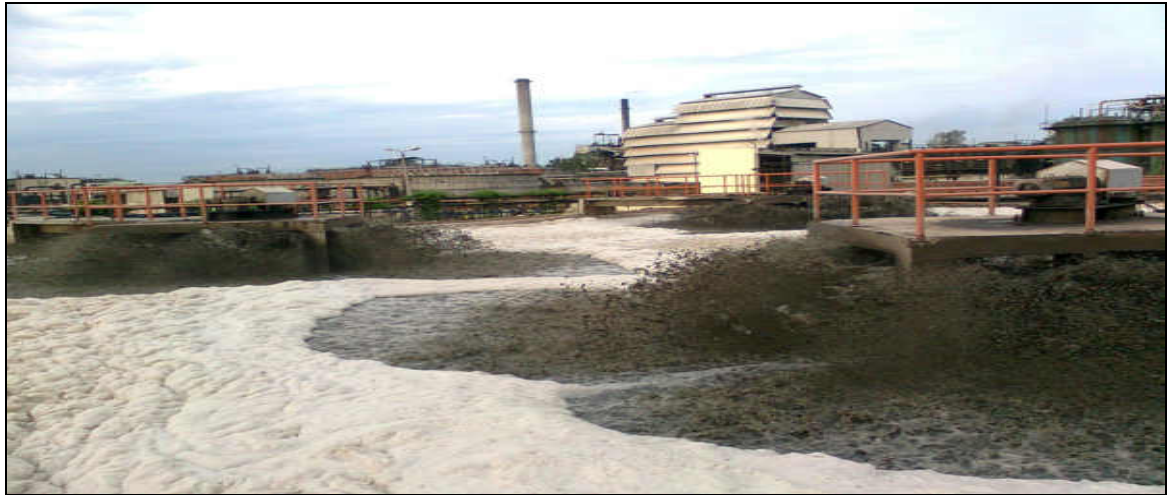
Pic.6: Aeration tank of Chandigarh Distillery

4.5.1 M/S Chandigarh Distilleries and M/S Surya Pharmaceuticals (IS4 and IS6): The quality of effluent generated from M/S Chandigarh Distillery and M/S Surya Pharmaceuticals is not satisfactory. TSS, BOD, COD level of Surya Pharmaceuticals is not meeting the prescribed standards. Wastewater generated from M/S Surya Pharmaceuticals is 43 kld and in-house maintenance of the ETP is very poor as shown in Pic.7. The nearest drain to these industries is Jankpura. However, both the industries have installed storage tanks and are using their effluents for irrigation. In-house maintenance of M/S Chandigarh Distilleries is also poor as shown in Pic. No.6

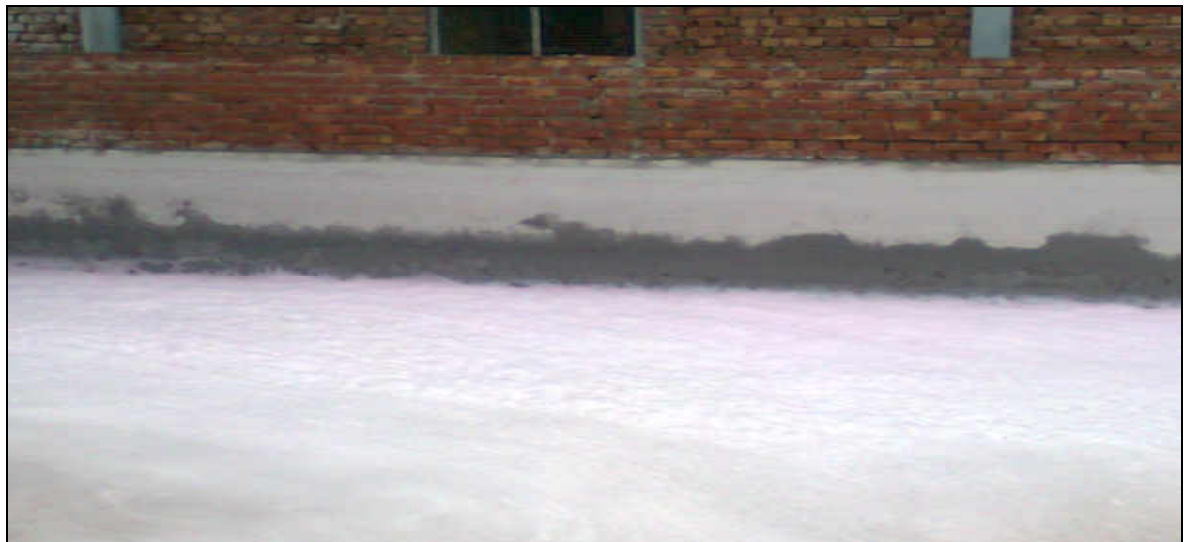
Pic.8: Figure showing condition of treated effluent of Vishal Paper Mills

4.5.2 M/S Vishal Paper Mills and Industry Pvt. Ltd (IS9): BOD, TSS, COD level of M/S Vishal Paper Mills are exceeding the prescribed standards. The nearest drain to the industry is Jacob Drain.

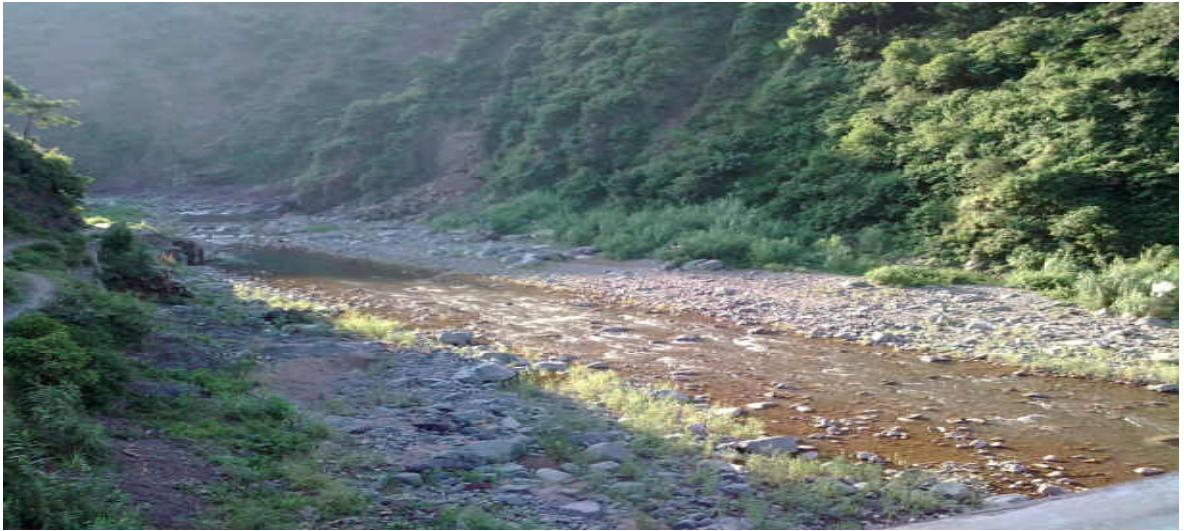
Pic. 9 : Kaushlalya River, H.P

5.1.1 Kaushlalya River, Parwanoo, H.P (RP1): Parwanoo is an industrial town and around 80% of its local population is engaged in the different kinds of industries located in the vicinity. There are about 200 industries running in the area. Parwanoo has an estimated population of 8609, as per census 2001. At Kaushlalya River, BOD level was observed as 1 mg/l and load was also low i.e. 37.78 kg/day. The image of Kaushlalya River is shown in Pic. 9.

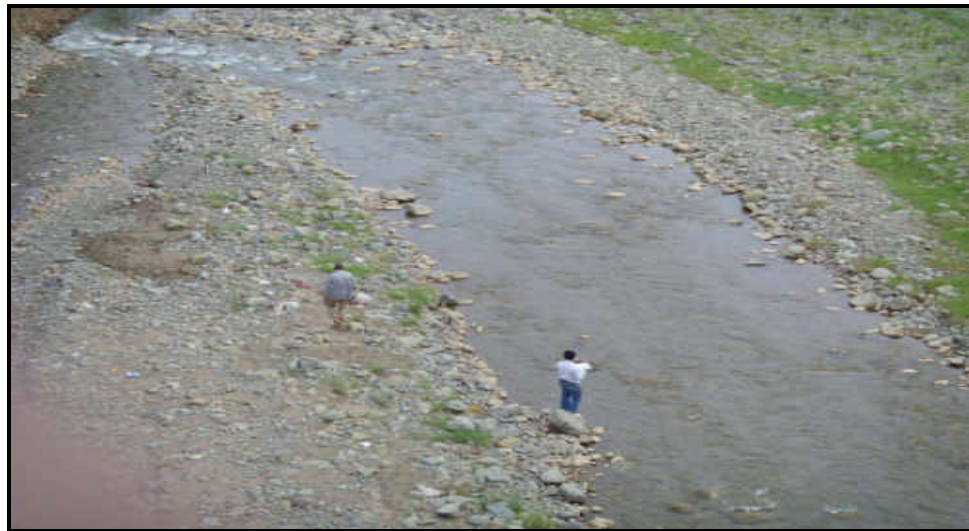
Pic.10: Ghaggar River at Amravati Enclave

5.1.2 Ghaggar River at Amravati Enclave (RP2): The River has good flow at Amravati and BOD load at this point is 127.27 kg/day as BOD level is only 1 mg/l.

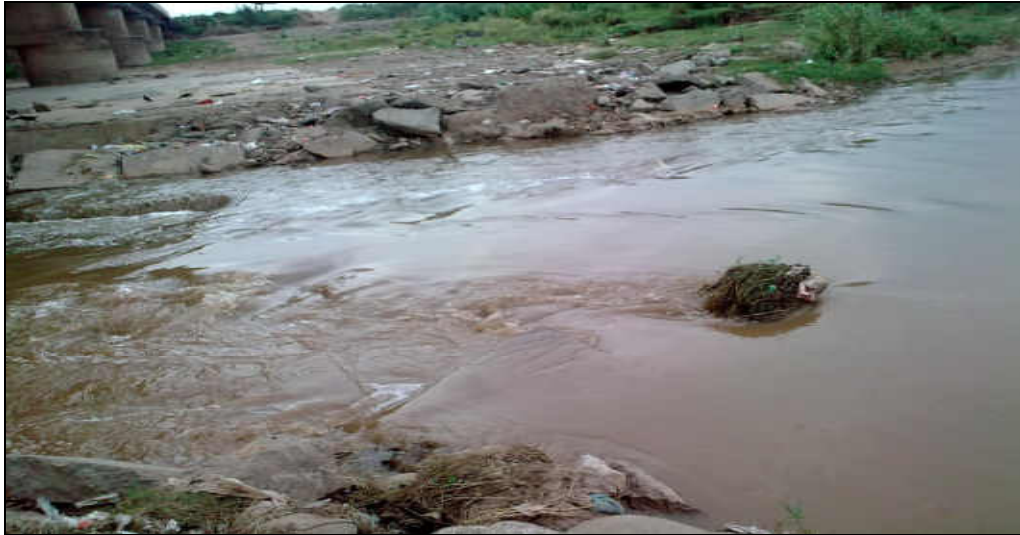
Pic.11: River Ghaggar at Mubarakpur

5.1.3 Ghaggar River at Mubarakpur (RP3): BOD load suddenly increased at Mubarakpur (1783.18 kg/day) due to discharge of Baltana Drain carrying wastes (sewage & industrial) from Chandigarh and Panchkula (Haryana). It was observed that the STP at Raipur Kalan having capacity of 5 MGD was not functioning and the untreated sewage was bypassed to Baltana Drain.

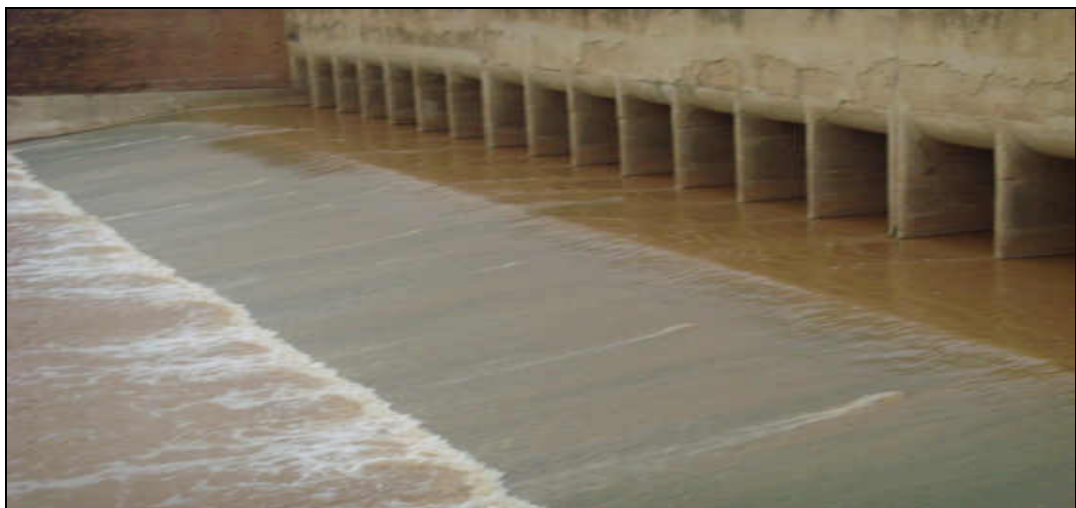
Pic. 12: River Ghaggar at Chandrapur Siphon, Haryana

5.1.5 Ghaggar at Chandrapur Siphon (RP5): BOD concentration was above the prescribed standard i.e. 3.4 mg/l and BOD load was 8063.11 kg/day. The image of Ghaggar River at Chandrapur Siphon is shown in pic. 12.

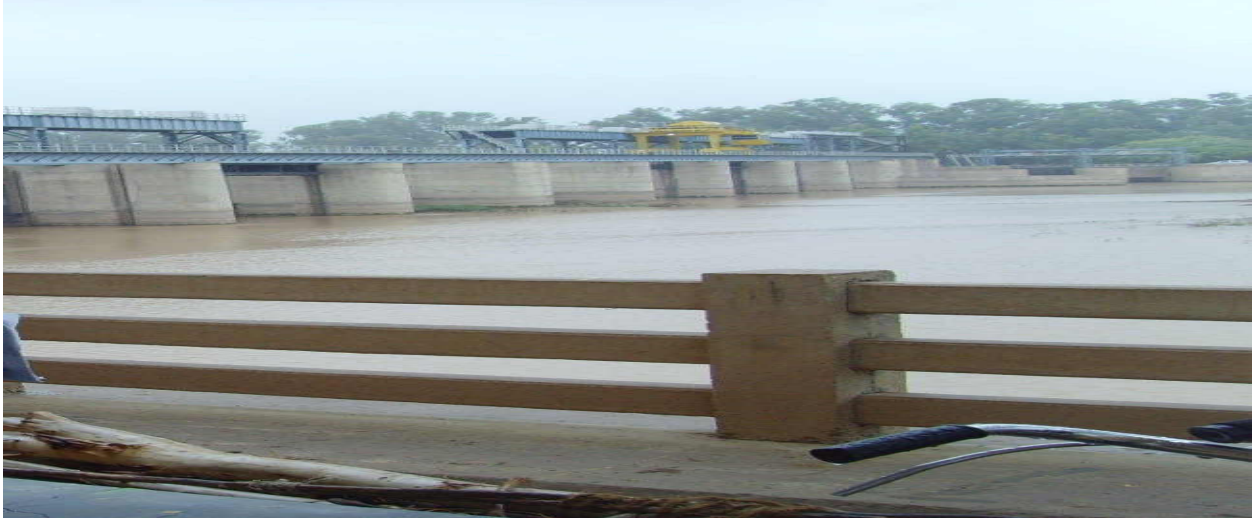
Pic.13: River Ghaggar at Ottu Weir

5.1.7 Ghaggar at Ottu Weir: The river water is blocked at weir, as such the river does not have any water downstream. All river water was diverted to canal in Haryana. The BOD and DO level at this point was observed as 13 mg/l and 2.8 mg/l respectively.

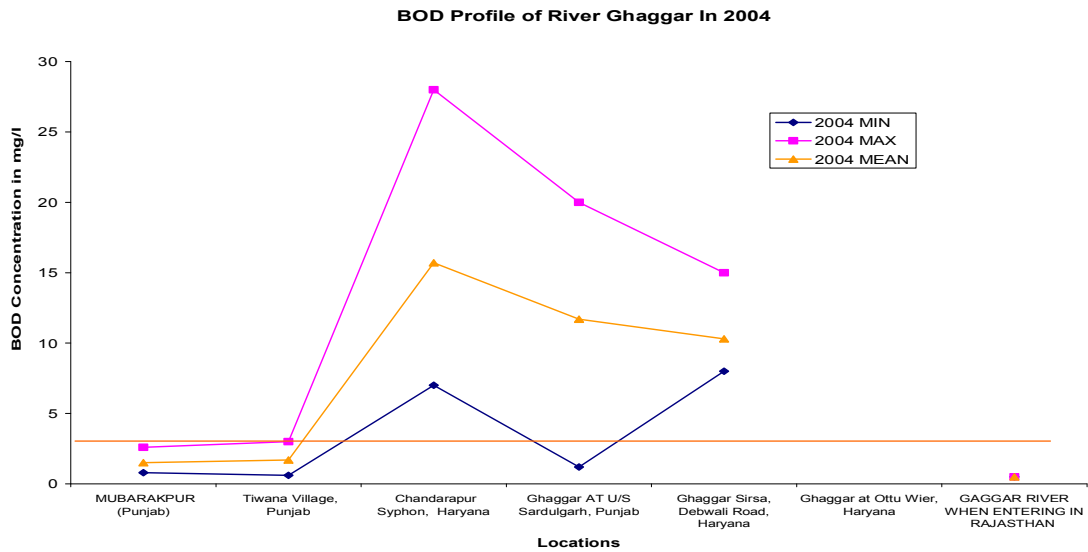
Fig 4: BOD Profile of River Ghaggar in 2004

Maximum BOD concentration was observed at Chandrapur Siphon. Maximum and mean value of BOD, show the same trend, as concentration drops down at Debawali Road, Sirsa, whereas the minimum value increasing after Sardulgarh, Punjab.

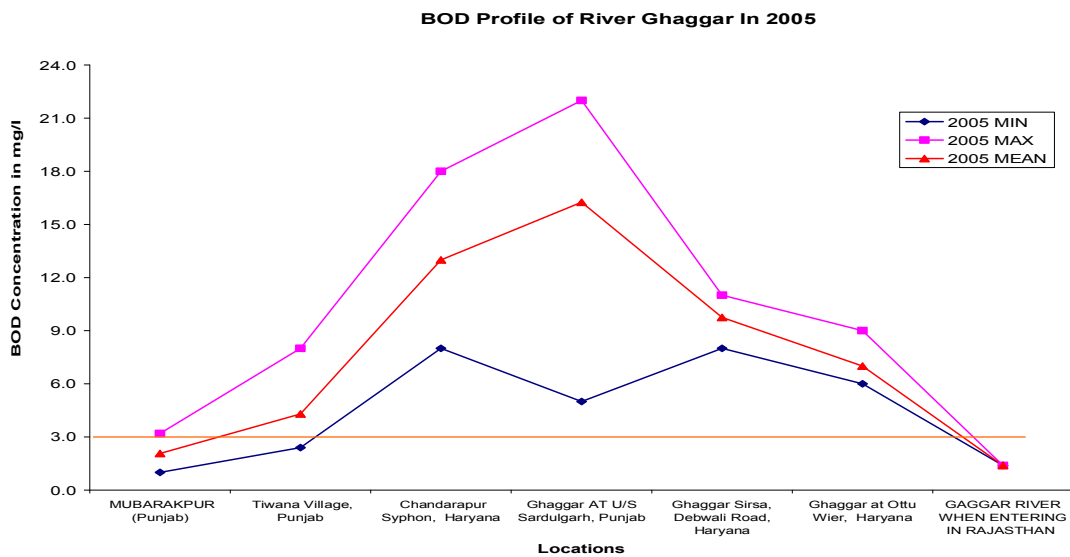
Fig 5: BOD Profile of River Ghaggar in 2005

In 2005, an upward trend was observed in terms of Maximum and Mean concentration of BOD in the stretch of Mubarakpur, Punjab to Sardulgarh, Punjab; whereas a different trend was observed for Minimum value of BOD. At Mubarakpur, Punjab BOD concentration was found below the prescribed standard.

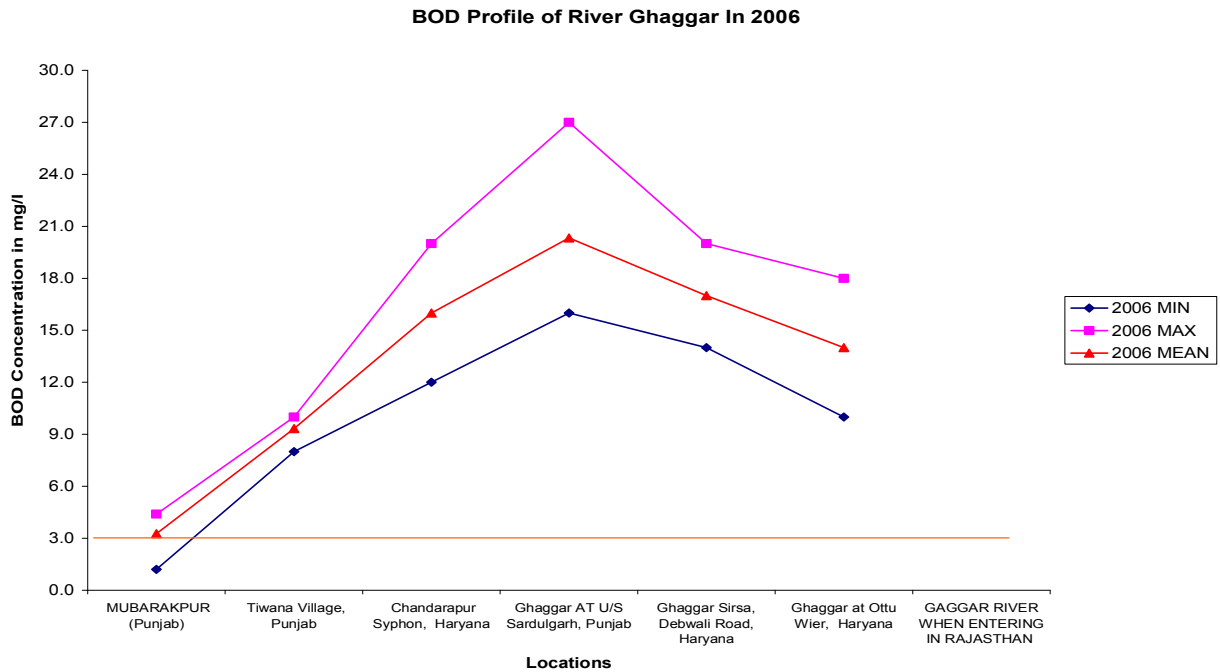
Fig 6: BOD Profile of River Ghaggar in 2006

In 2006, Maximum concentration was observed at Sardulgarh, Punjab. Maximum and Mean values of BOD were always above the prescribed standard.

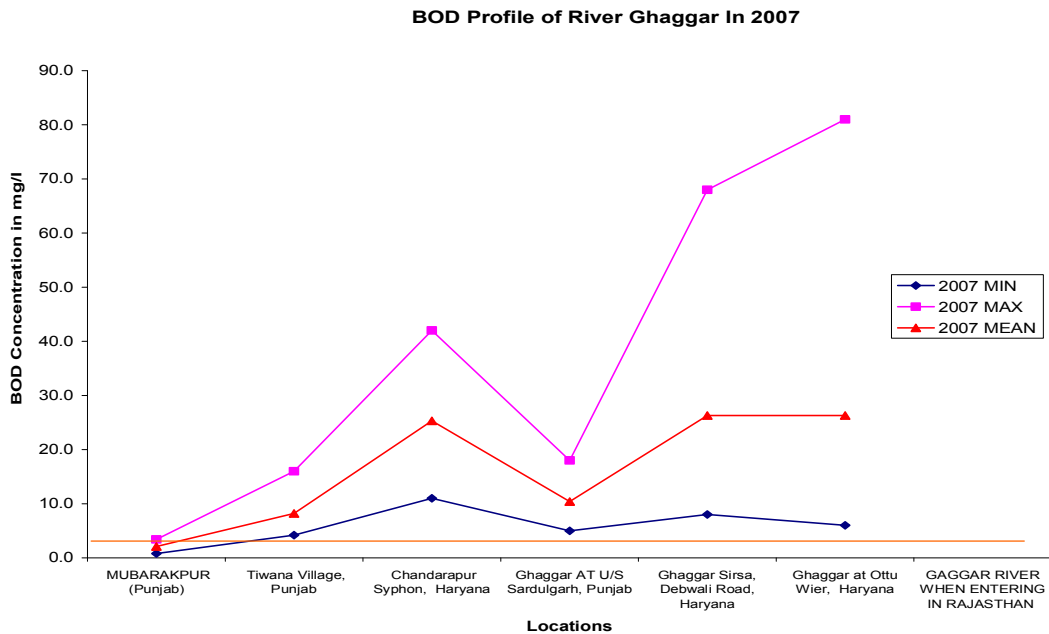
Fig 7: BOD Profile of River Ghaggar in 2007

In 2007, different variations were observed. Peak values were found at Ottu Weir, Haryana. However, beyond Chandrapur Syphon, BOD concentration drops down after Sardulgarh, Punjab.

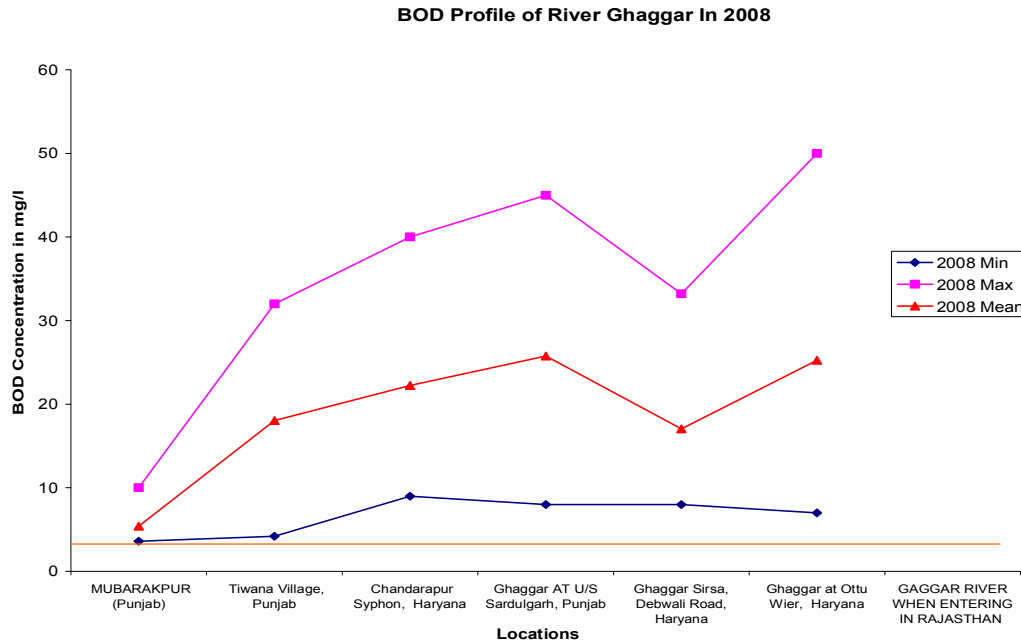
Fig 8: BOD Profile of River Ghaggar in 2008

In 2008, peak concentration of BOD was observed at Ottu Weir. All values were always found above the prescribed standards. Similar pattern was observed in all locations.

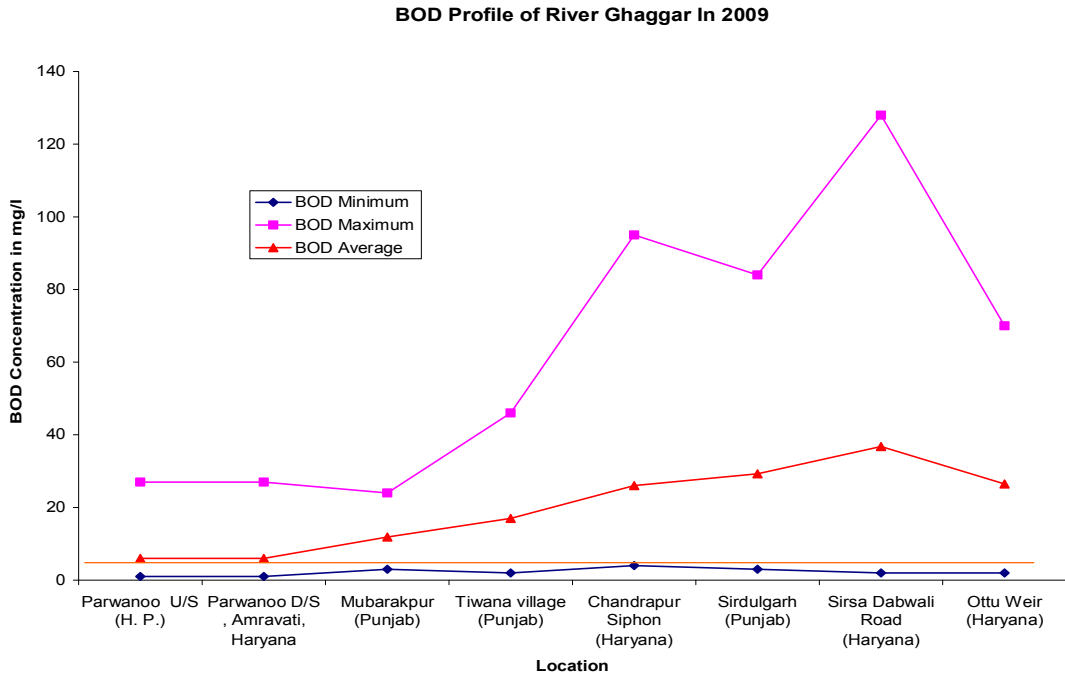
Fig 9: BOD Profile of River Ghaggar in 2009

It may be revealed from the above that in Sardulgarh, Punjab BOD concentration was maximum during 2005-09 except 2007 and in Chandrapur Siphon, Haryana Maximum concentration was observed during 2004. The main problem of pollution arised after Parwanoo downstream, Amravati, Haryana.

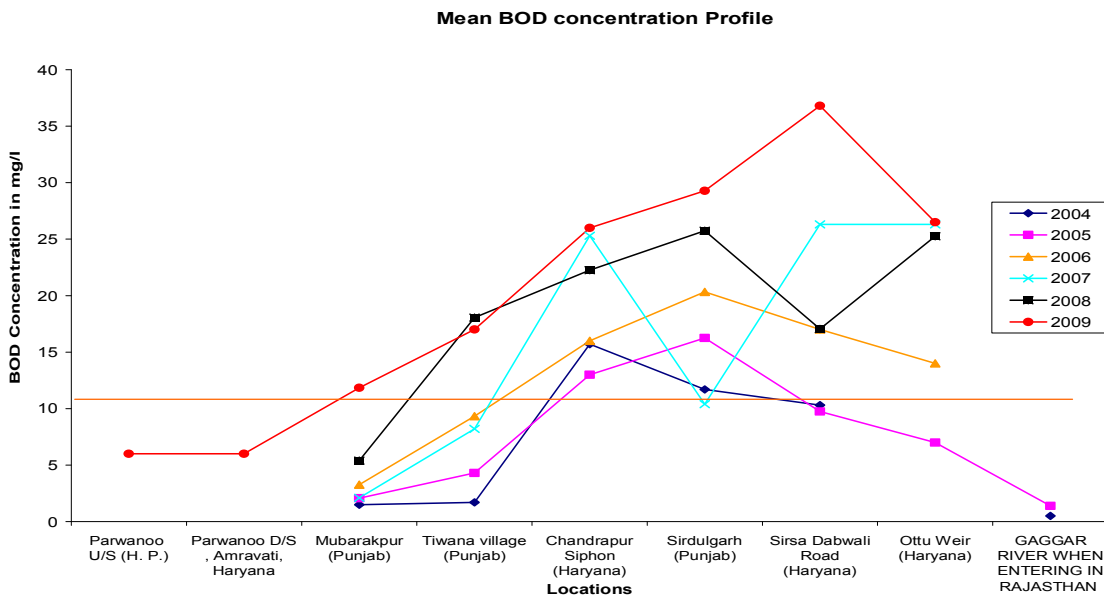
Fig 10: Mean BOD Concentration Profile

The water quality of river Ghaggar assessed during the year from 2004-09 is shown in fig.10

It may be revealed from the above figure that during the assessed period, the BOD concentration was always found above the prescribed standard. In 2009, BOD level was observed as high as compared to previous years at all monitoring points. The highest concentration of BOD was observed at Sirsa Dabwali road during 2009 i.e. 36.8mg/l. However, in Ottu Weir (Haryana), BOD level decreased sharply as a common trend which was observed during 2004-09. The water quality of River Ghaggar starts deteriorated after Parwanoo downstream, Amravati, Haryana and increasing trend was observed there upon.
