**ENVIRONMENTAL QUALITY MONITORING OF CRITICALLY POLLUTED AREA
– CHANDRAPUR, MAHARASHTRA**

1.0 OBJECTIVE OF THE VISIT

Annexure-I

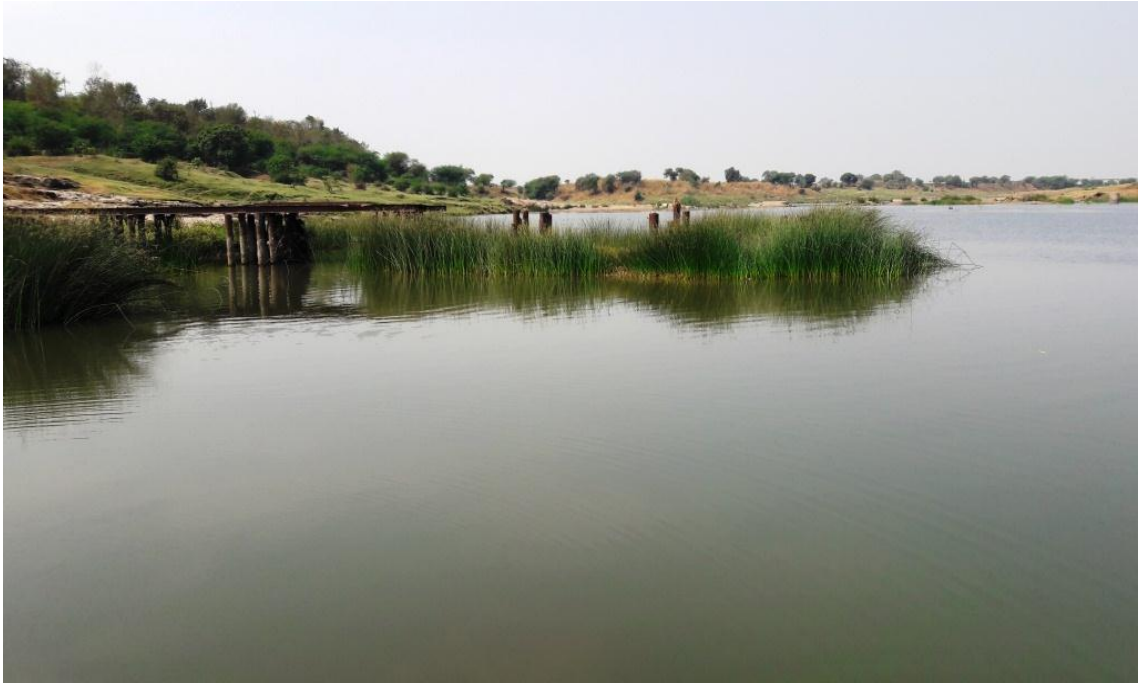
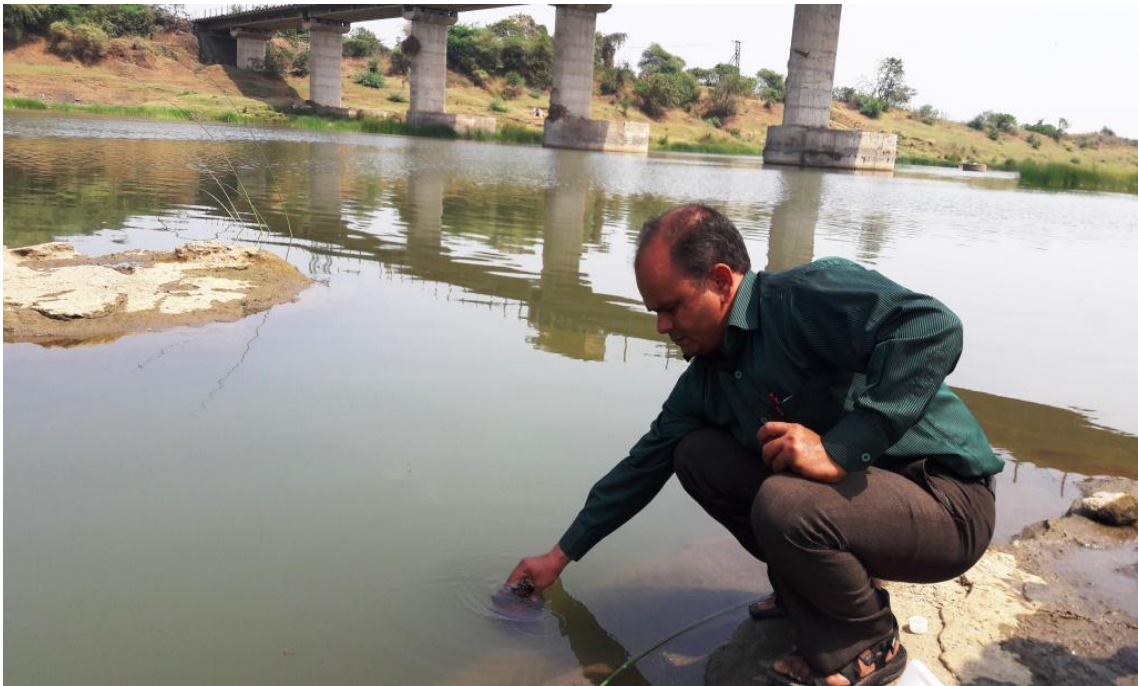
Photographs-1 & 2: SWQM location-1

- SWQM location-1 (at Wardha River – Intake point for M/s ACC Cements, Near Mungoli open cast mines, Ghuggus) there were visual evidences of growth of aquatic plants like grass & sedges at river banks and growth of macroalgae attached to rocks, gravel of river bed at shallow depths of stagnant water. Apart from this fishing and cloth washing activities were observed at river banks (**Photographs-1 & 2, Annexure-I**).

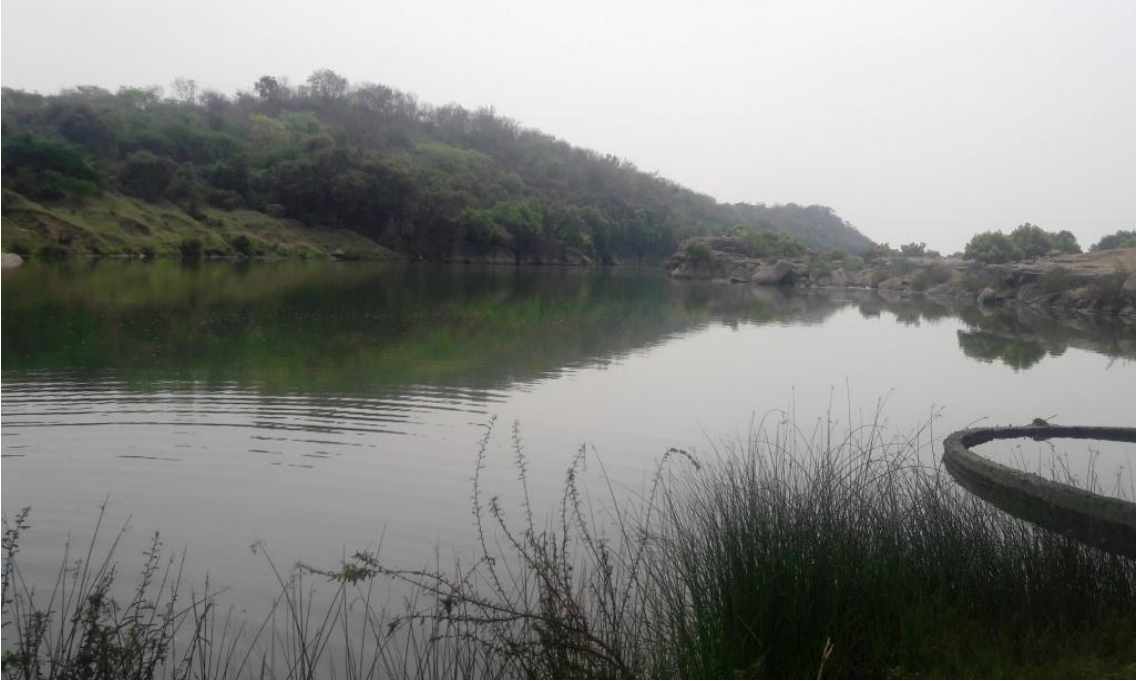
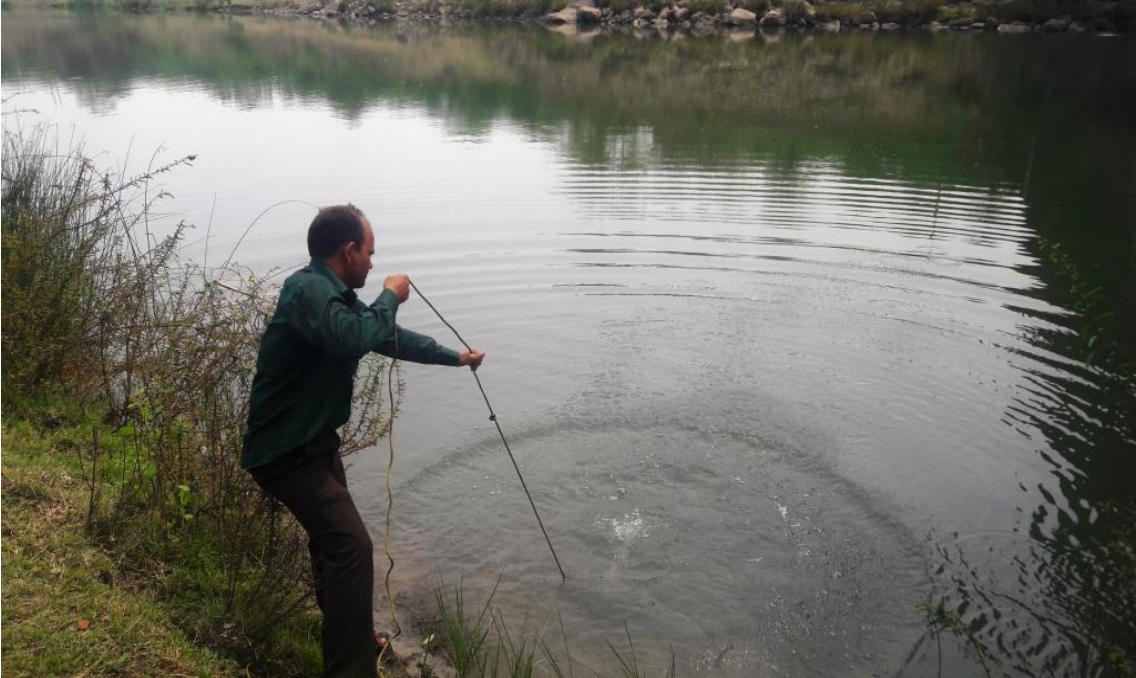
Photographs-3 &4: SWQM location-2

- SWQM location-2 (Wardha River, Near High flood level observation office, Ghuggus – Wani bridge, Niagoan) there were visual evidences of growth of aquatic plants like grass & sedges at river banks and no human interference activities was observed during sampling (**Photographs-3 & 4, Annexure-I**).

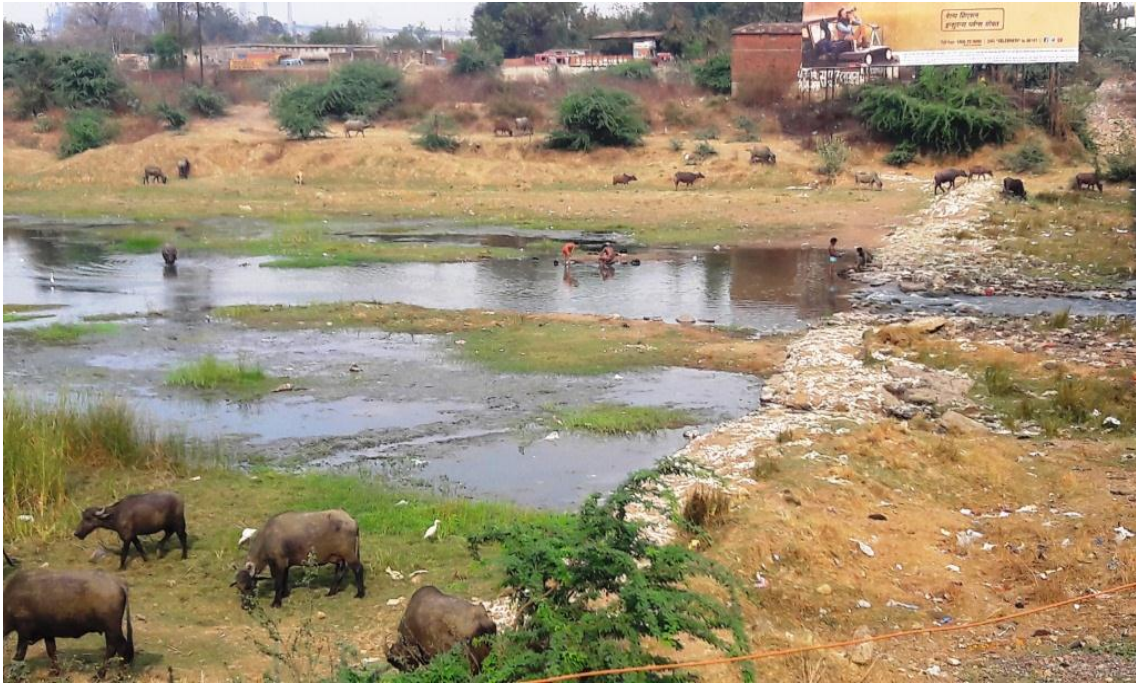
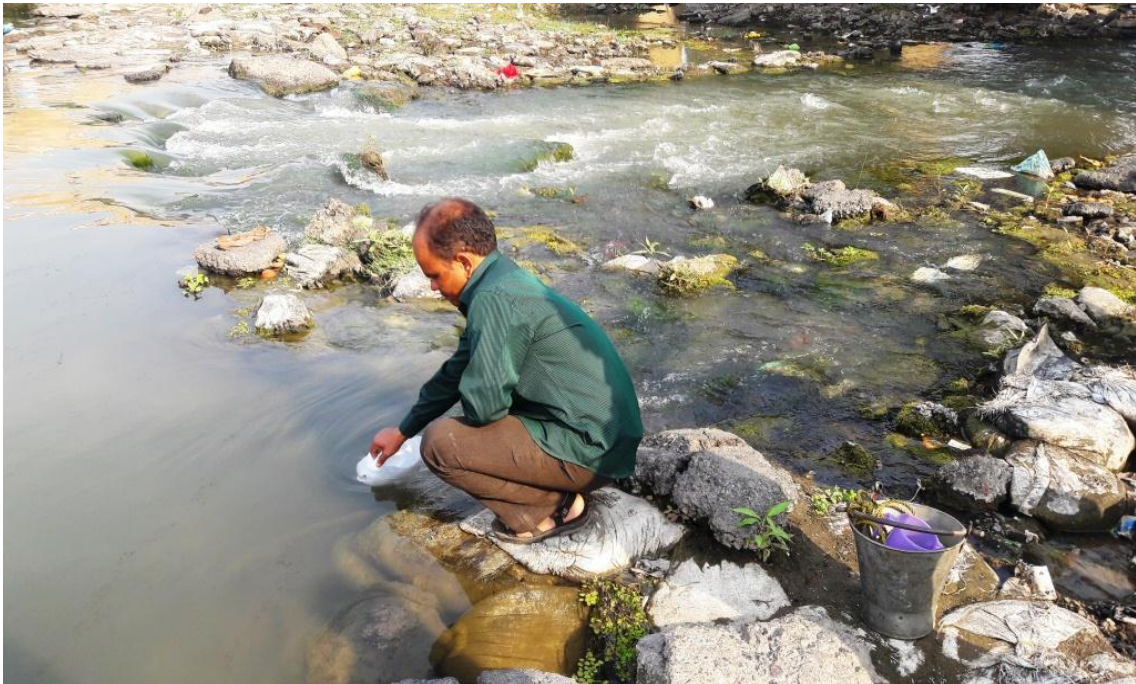
Photographs-5 & 6: SWQM location-3

- SWQM location-3 (Erai River, Near Nagpur – Chandrapur bridge, Chnadrapur) there were visual evidences of abundance growth of aquatic plants like grass & sedges at river banks and growth of macroalgae attached to rocks, gravel of river bed at shallow depths of stagnant water. Apart from this fishing, bathing and cloth washing activities were observed at river banks. Also, livestock grazing at river banks and across the river was observed. There was haphazard dumping of solid wastes like poultry wastes and floral wastes i.e. religious offerings were observed near river banks. Reportedly, the untreated sewage generated from Urja Nagar, Chandrapur is also discharged through drains/outfall into Erai River u/s of SWQM location-3 (**Photographs-5 & 6, Annexure-I**).

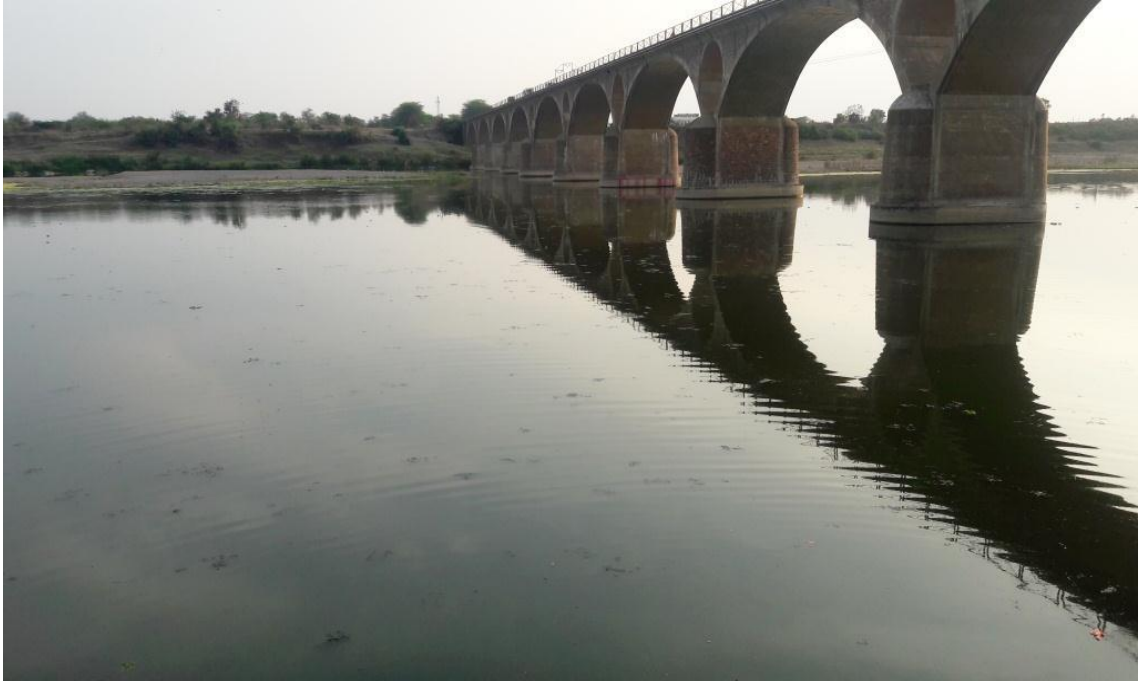
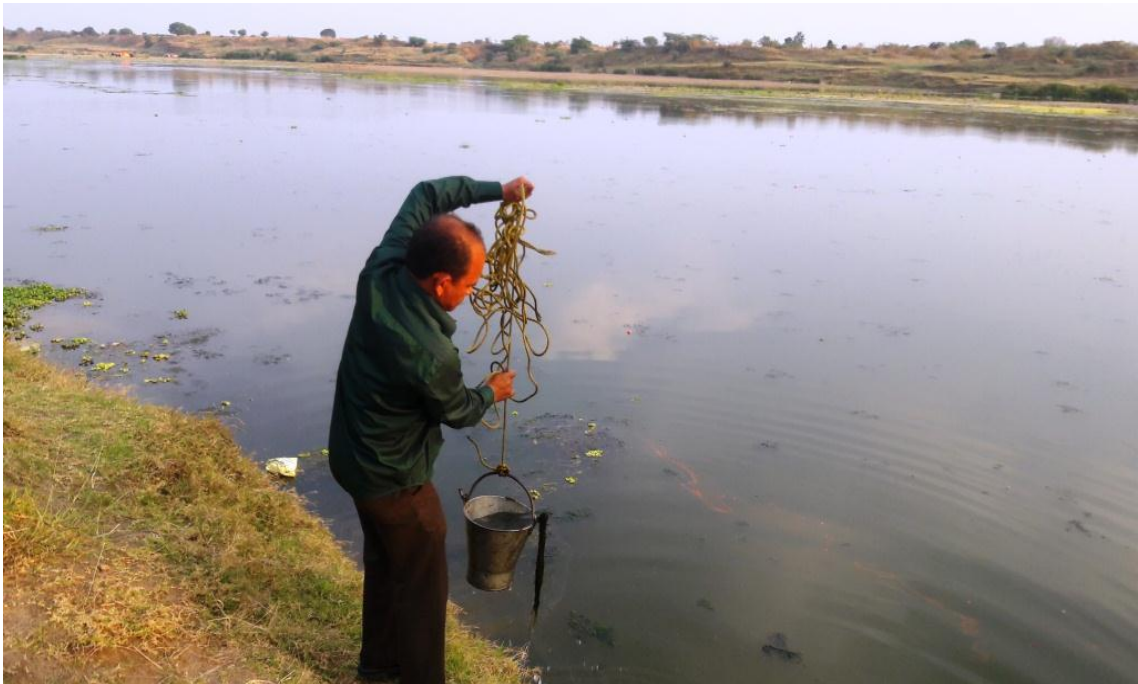
Photographs-7 & 8: SWQM location-4

- SWQM location-4 (Wardha River at Ballarpur Fort, Near Intake Well of M/s BILT, Ballarpur) there were visual evidences of abundance growth of vegetation at river banks and across the river. Also, dumping of plastic wastes and floral wastes i.e. religious wastes were observed near river banks. Apart from this fishing and cloth washing activities were observed at river banks (**Photographs-7 & 8, Annexure-I**).

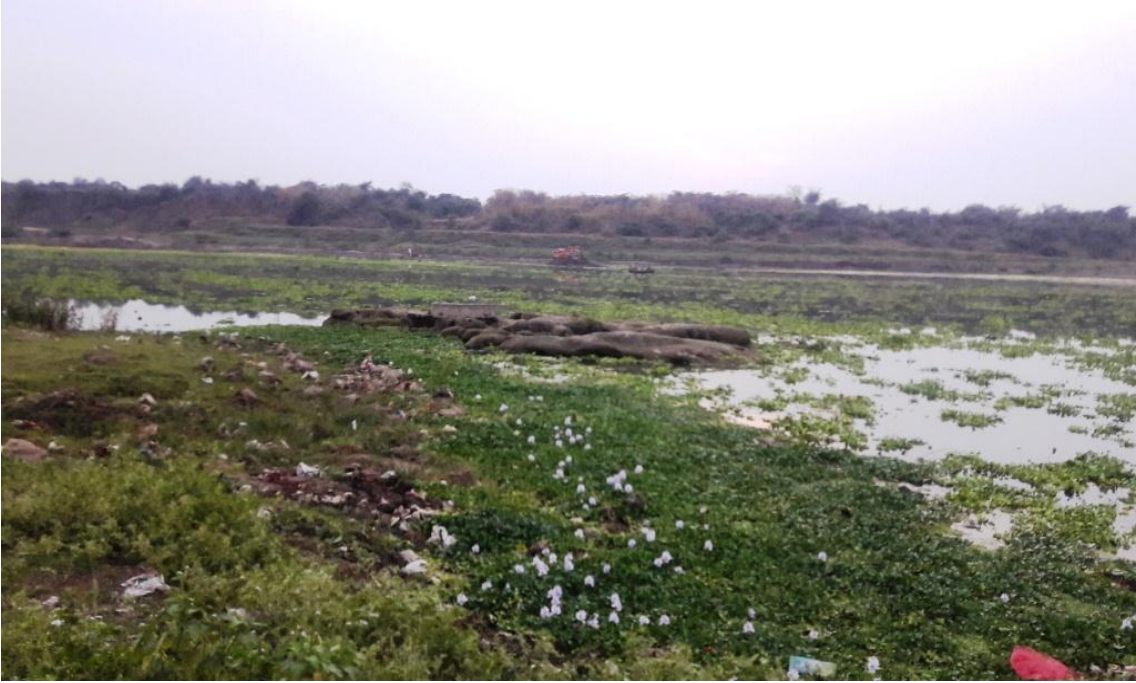
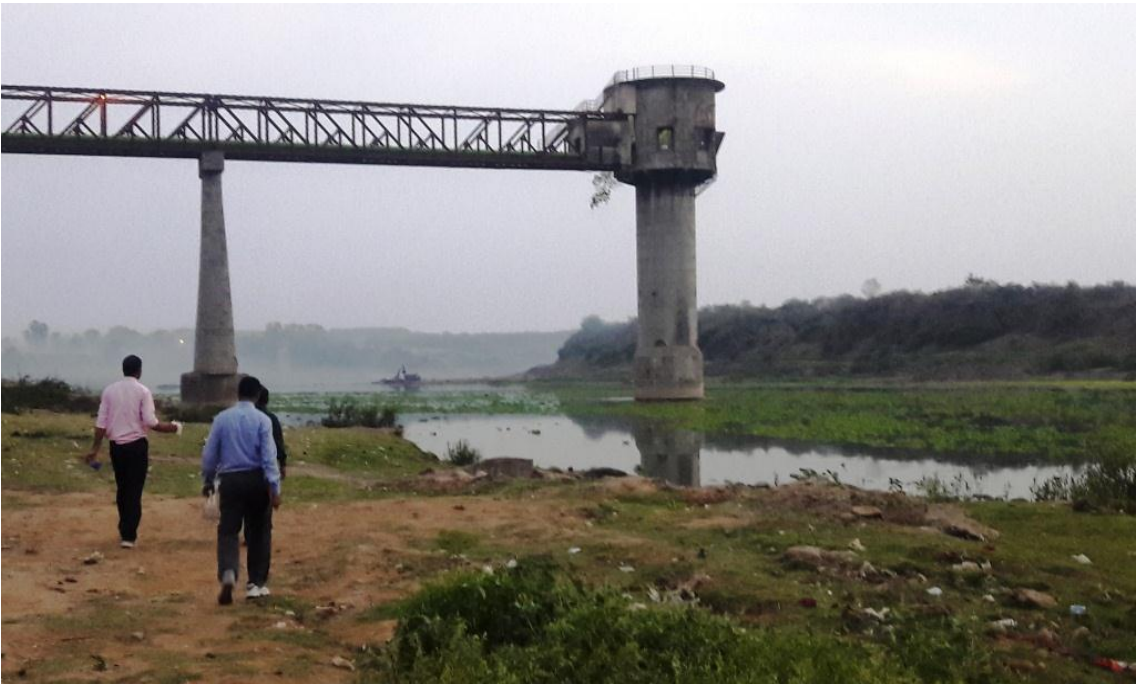
Photographs-9 & 10: SWQM location-5

- SWQM location-5 (Wardha River at Rajura Bridge, Rajura –Downstream of domestic & industrial discharges) there were visual evidences of growth of macrophytes (submerged & floating vegetation) at river banks. Apart from this, fishing activities were observed at river banks (**Photographs-9 & 10, Annexure-I**).
