**CENTRAL POLLUTION CONTROL BOARD
ZONAL OFFICE (SOUTH), BENGALURU**

**REPORT ON MUNICIPAL SOLID WASTE MANAGEMENT &
PROCESSING FACILITY AT KOCHI, KERALA**

Photographs of MSWDF at Brahmapuram, Kochin

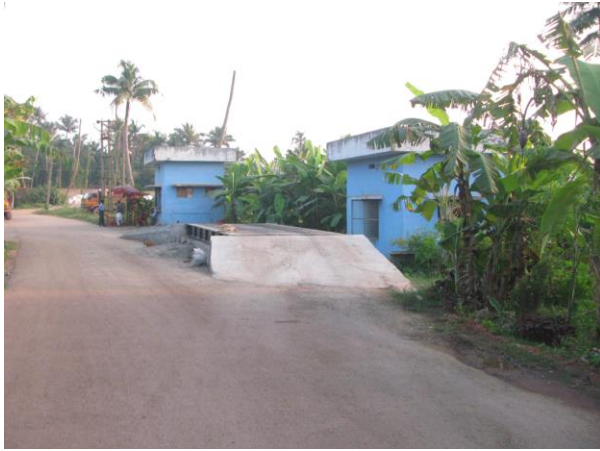
On the day of inspection **11.12.2013**, it was observed that the quantity of municipal received by the facility was 96.780 MT in a 27 trips of vehicle from 12.30 Hrs. to 16.15Hrs. The unit has Weigh Bridge to record the quantity of solid wastes received and vehicle details, time of arrival are maintained in a record.

Fig.1 : Weigh Bridge at the entrance

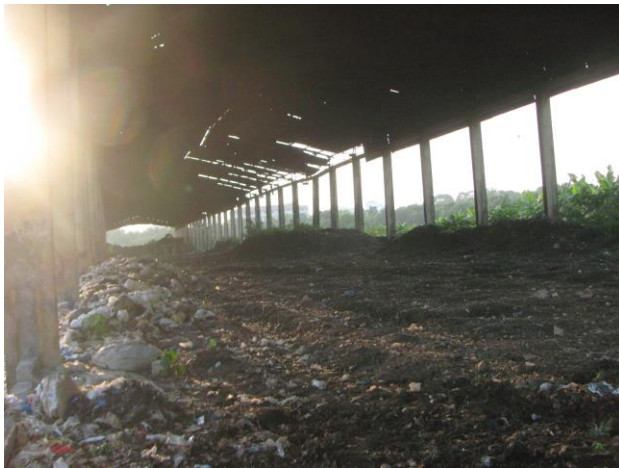
- The waste storage area is provided with shed, but due to poor design & construction, the sheds have collapsed at many places and not repaired and maintained. This facility is developed with a fund of Jawaharlal Nehru National Urban Renewal Mission.

Fig.3 : Shed used for MSW storage

- To repair the existing sheds provided for composting and replacing the damaged roofs. Also clear the plantation inside the shed area and drain area.
- To reconstruct the existing drains with proper system for collection of leachate and treatment of the same.

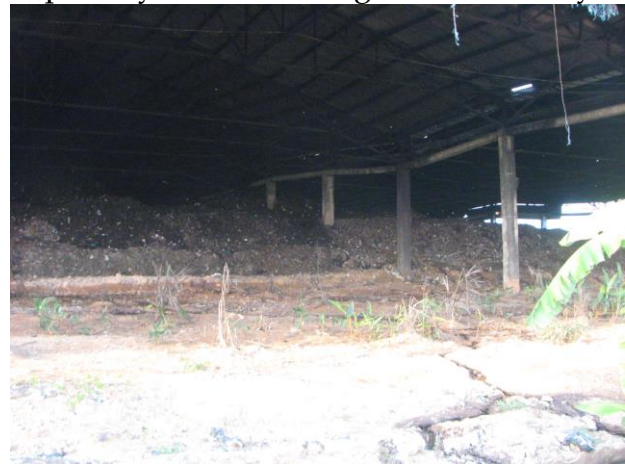
Fig.4 : Collapsed shed

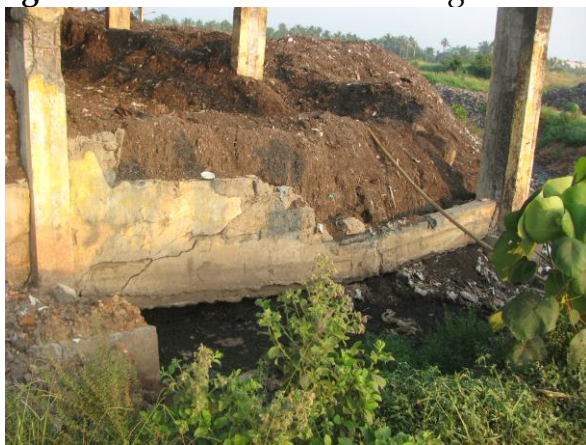
Fig.5 : collapsed structures

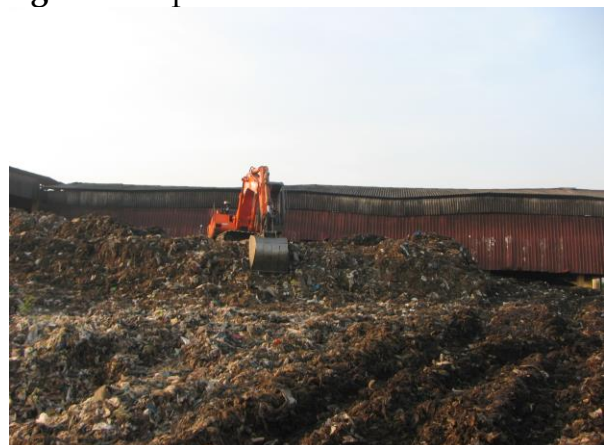
Fig.6 : Excess MSW stored in open place

- To stop dumping / storing of municipal solid waste in open place and utilise the shed area optimise for composting.
- To pave all the internal roads and develop storm water drain on the both side of the road.

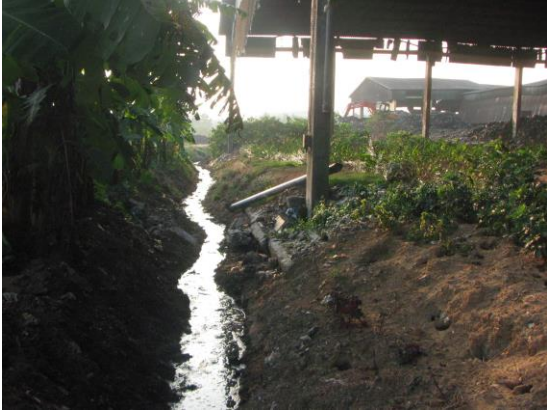
The leachate collection system, drainage system provided for totally collapsed. There is no proper maintenance & operation of the system. Housekeeping of area is very poor.

- The garland drains provided compost yard is damaged fully, leachate are poorly managed. There is no leachate treatment system, the entire leachate is utilised for plantation.

Fig.7 : No proper drain for leachate carrying, Kaccha drain

- To reconstruct and maintain the leachate treatment system.
- To improve the house keeping in process area and composting area.
- To meet the prescribed compost quality standards w.r.t Copper, to ensure safe application of compost.

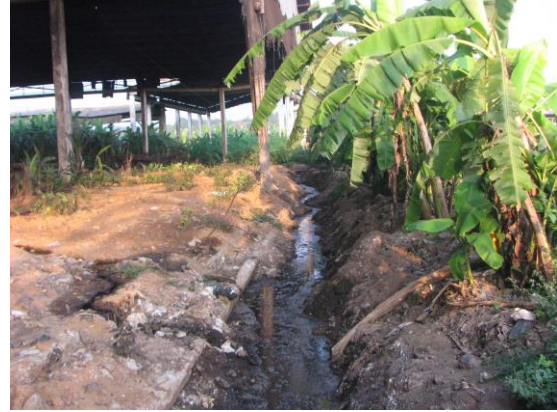
- The facility is provided with approach and internal roads for free movement up to compost area. The internal roads are to be paved and the existing storm water drains are totally collapsed not in a position to repair. The entire system to be reconstructed.

Fig. 8: Damaged drains, plantation done inside the shed area too.

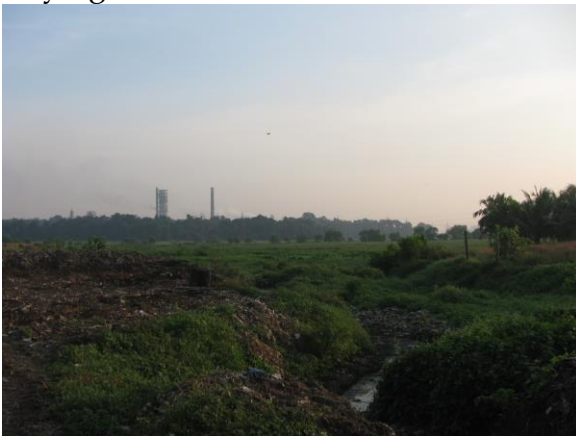
Fig.9 : Entire Leachate is used for land application

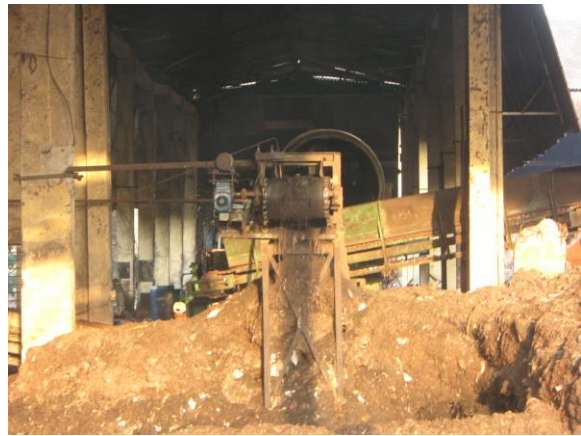
Fig.10 : Compost processing area

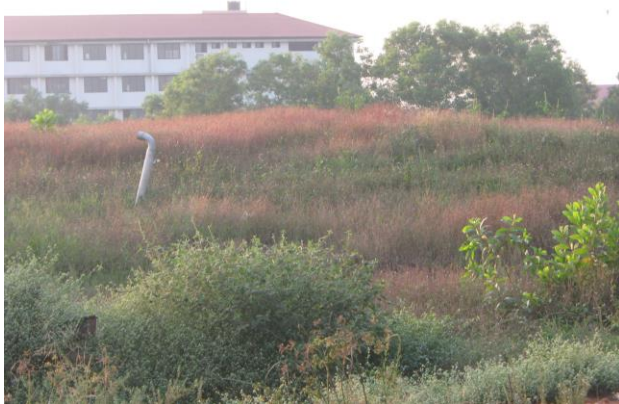
The Kochi Municipal Corporation engaged M/s Bharat Traders for manual separation of Plastic wastes from the MSW. The unit informed that about maximum of 25 Tons plastic wastes are received along with MSW. The M/s Bharat Traders segregate only about 3 tones per day of plastic waste reaming all ends up in MSW rejection and for landfilling. M/s Bharat Traderes is paying Rs. 1.5 /Kg of plastic waste to Corporation. The unit claims that all rejection is landfilled in 8000 m² area landfill.

Fig.11 : Old landfill with gas venting system

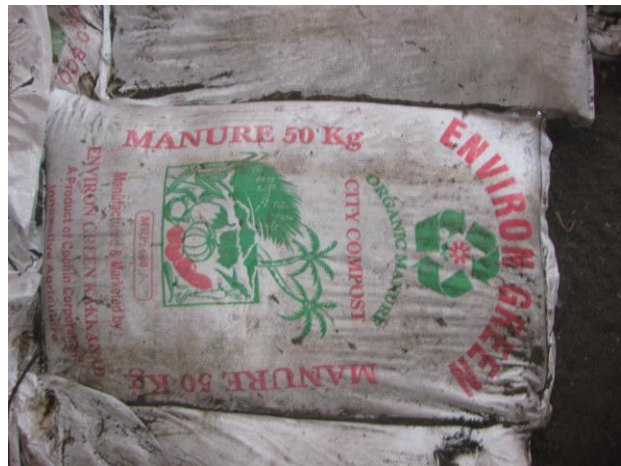
- The parameter with respect to copper is exceeding the standard in finished compost.
- The finished compost is marketed in the name of Enviro Green City Compost in 50 kg bags. This is sold at the rate of Rs. 5 per kg.
- The relevant Photographs are attached as **Annexure 1**.

Fig.12 : Finished Compost for sale
