**EVALUATION REPORT OF COMMON HAZARDOUS  
WASTE TREATMENT, STORAGE AND DISPOSAL  
FACILITIES**

**M/S KERALA ENVIRO INFRASTRUCTURE LTD.,  
KOCHI, KERALA**

**South Zonal  
Office,  
Bangalore**

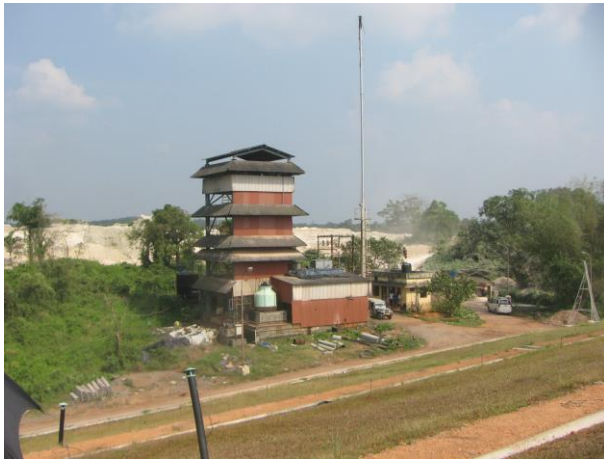
**Fig.1:** Showing the Leachate treatment system (MEE) with boiler.

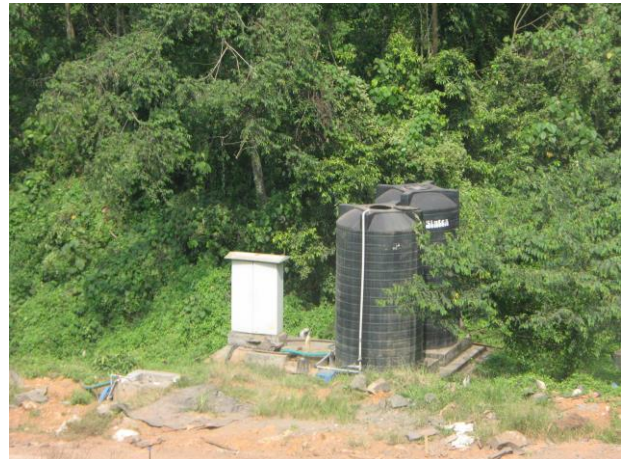
4. During inspection, it is observed that the unit has provided plastic tanks (Sintex) for collection of leachate and again re-pumped to MEE for treatment. In order to avoid pumping cost and operation difficulties, the unit may be directed to construct permanent RCC leachate holding tank near MEE and easy operation and to save energy cost.

**Fig.2:** Leachate Storage tank (Sintex) with pumping arrangement.

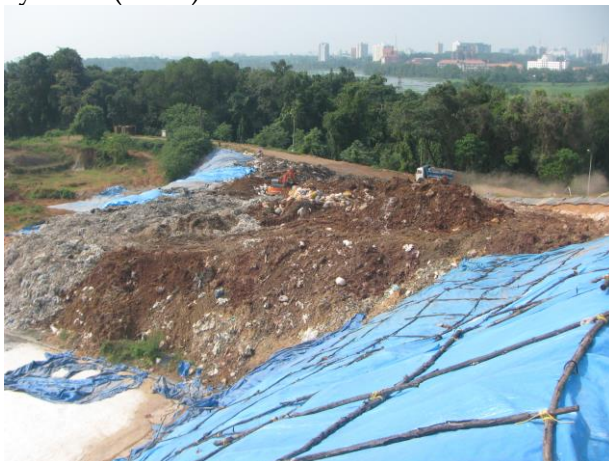
| 12 | Whether any provision made for covering the facility so as to avoid entry of rainwater during monsoon | : | Only temporary tarpaulin covers are provided to avoid entry of rainwater during monsoon. |

**Fig.3:** Cell 3 is in operation, temporary cover provided to the cells.

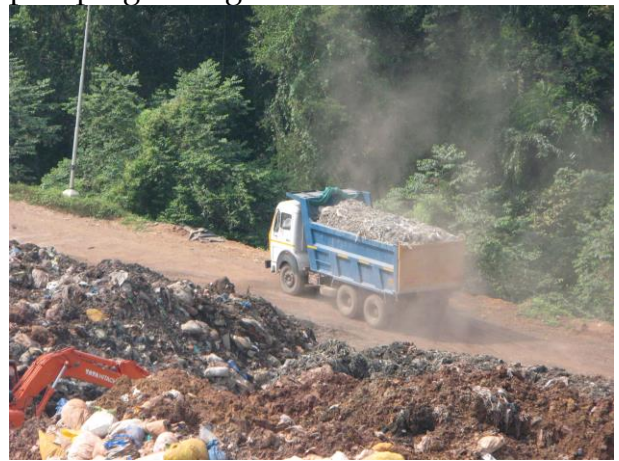
2. The Secured land fill Cells 1 & 2 are filled up (Covering 7500 M<sup>2</sup> area) and Cell 3 is in operation.
3. During the inspection it is observed that the wastes which can be utilized for resource recovery also being landfilled, the Kerala Board shall take appropriate measures to co-process incinerable wastes and to discourage landfilling of incinerable wastes.

**Fig.4:** Truck carrying H.W. for landfilling directly.

- To stop landfilling of waste which can be utilized for resource recovery.
- To direct the Kerala State Pollution Control Board to take appropriate measures to co-process incinerable wastes and to discourage landfilling.
- To construct permanent RCC leachate holding tank near MEE in place of Sintex tank for easy operation and to save energy cost in pumping.
- To start Monitoring of gaseous emissions from vents of capped cells for total VOC and H<sub>2</sub>S
- To pave all internal roads with proper storm water drains to control fugitive emissions.

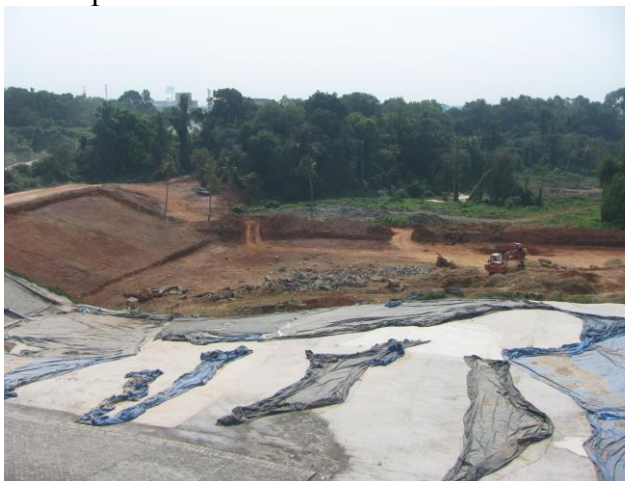
**Fig.5:** Cells under construction for expansion.

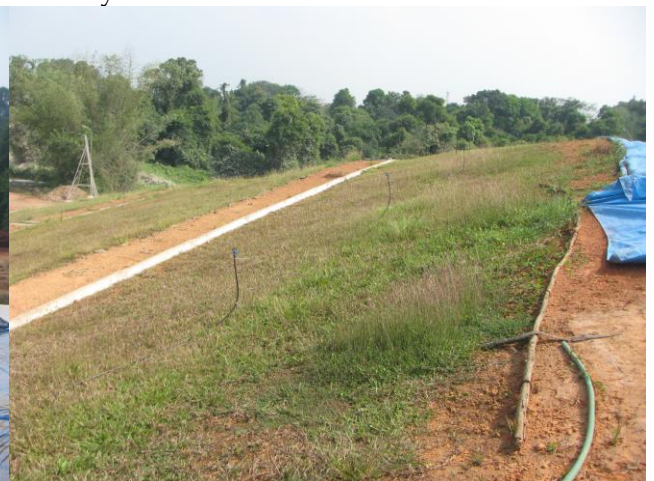
**Fig.6:** Cells green cover is provided with sprinklers.

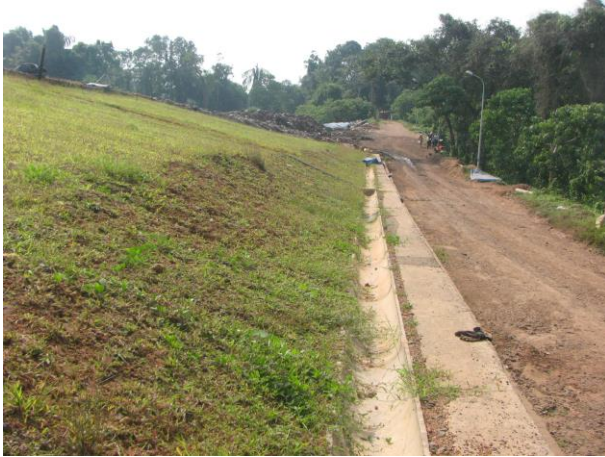
**Fig.7:** Cells cover bottom is provided with garland drain. The internal roads are not paved.

5. The unit may be directed to start Monitoring of gaseous emissions from vents of capped cells for total VOC and H<sub>2</sub>S.
6. All the internal roads used for transportation of wastes are not paved, due to that fugitive emission are more. The unit shall be directed to pave the roads with proper storm water drains.

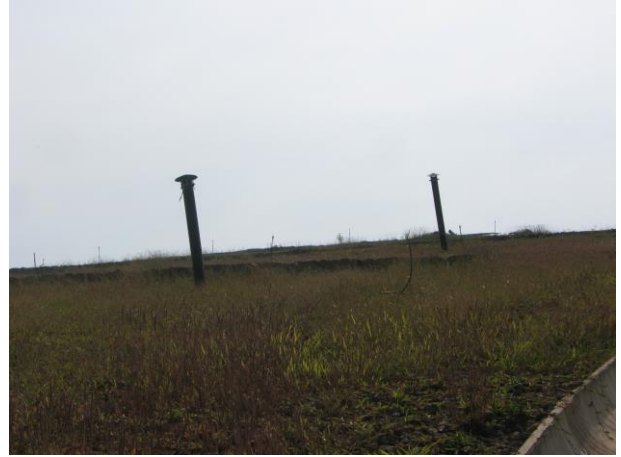
**Fig.8:** Cells cover is provided gas vents.
