**CENTRAL POLLUTION CONTROL BOARD  
ZONAL OFFICE (SOUTH)  
BENGALURU**

**Monitoring Report of M/s Kinfra Small Industries Park (KSIP), Common Effluent Treatment Plant, Nellad, Kerala**

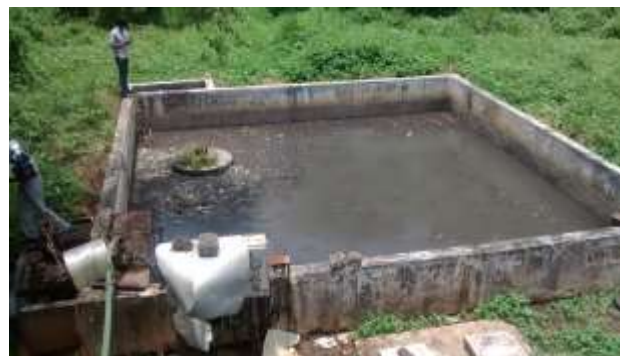
**Equilisation Tank**

- The treated effluent quality in case of TDS & BOD is not meeting the stipulated norms and discharged on land for gardening.
- The operation & maintenance of CETP is not satisfactory. The mixing aerator in equilisation tank and effluent pumping pump to aeration tank was found not working at time of inspection. So no flow was observed in the treatment units.

- Treated effluent quality should meet the stipulated parameter norm within the limit before discharge.
- Operation & Maintenance of CETP needs to be improved to have proper treatment and to have stand by pumps & mixing aerators for regular continuous operation.
- Primary treatment facility needs to be commissioned in CETP as per the inlet pollution load or KSPCB shall be directed to issue the notice to the member units to install primary treatment facility.
- Flow meters shall be installed at inlet and outlet of CETP.
- Treated effluent shall be reused/ recycled to achieve Zero Liquid Discharge.
- Regular cleaning/maintenance should be carried out all over the plant for proper safe access to treatment units.

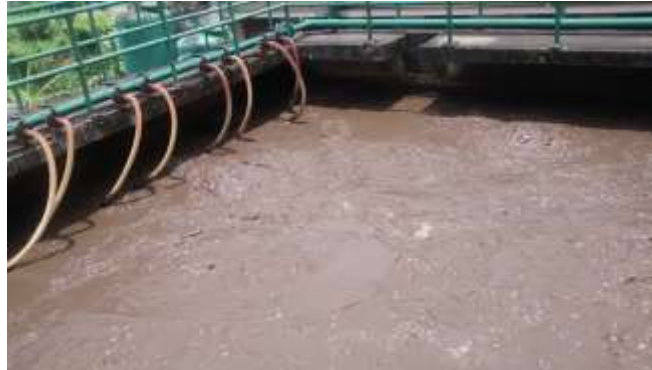
**Aeration Tank**

- It was informed that sludge is not produced so far, which is practically not possible and the analysis result of MLSS shows that the excess sludge from aeration tank is also not being removed periodically.

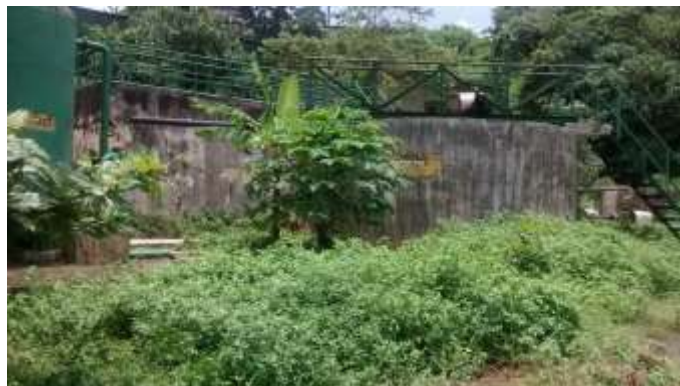
**View of Treatment units**

- It was informed that the member units are not having primary treatment facilities so the inlet load to CETP is more than the designed. Since the generation quantity is less than the design, the treatment is carried out by flow rate adjustment to CETP.
- The analysis result shows less load at inlet because the sample was collected from the top of the equilisation tank due to non-availability of the sampling arrangement and non-working of pump.
- No flow meters were installed at inlet and outlet of CETP.
- No proper access was available to the treatment unit due to plant growth, which is not removed and shows the poor maintenance.
