**CENTRAL POLLUTION CONTROL BOARD,
Zonal Office – South, Bangalore**

**REPORT ON TRIAL RUN STUDY OF CO-PROCESSING OF ETP SLUDGE IN
CEMENT KILN AT M/s ULTRATECH CEMENTS LTD., ARIYALUR, TN**

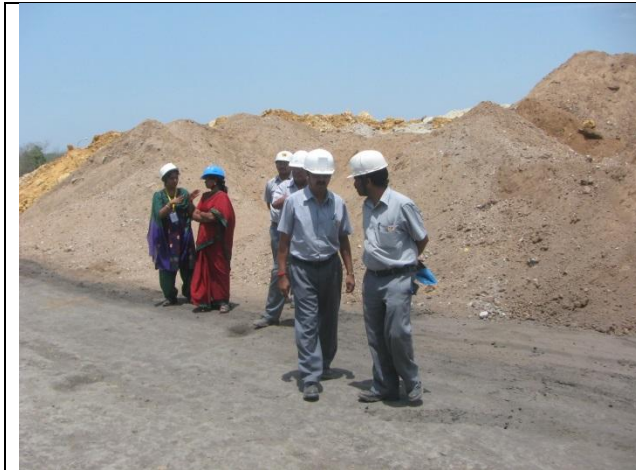
Fig.1: ETP sludge Storages for feeding

Storage: The total quantities of sludge brought from ETPs are stored in open place along with lime stone separately nearer to stone crusher. The blended and crushed sludge along with lime stone is staked separately with help of stacker and reclaimers in a shed.

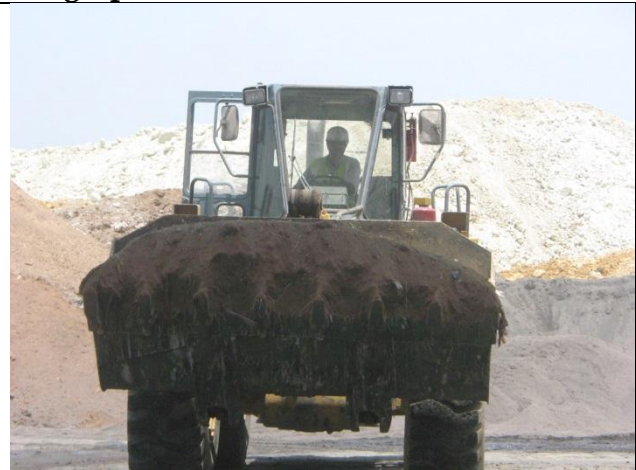
Fig.2:Tipper (bucket) lifter is used for charging the material

Preparation: The sludge was shifted by tipper (bucket) lifter and directly dumped (through hopper) to lime stone crusher along with lime stone. Each load of bucket tipper weighs about 3.5 tone of ETP sludge, about 50 tone of lime stone (2 tipper truck) is dumped along with sludge to maintain ratio of about 7%.

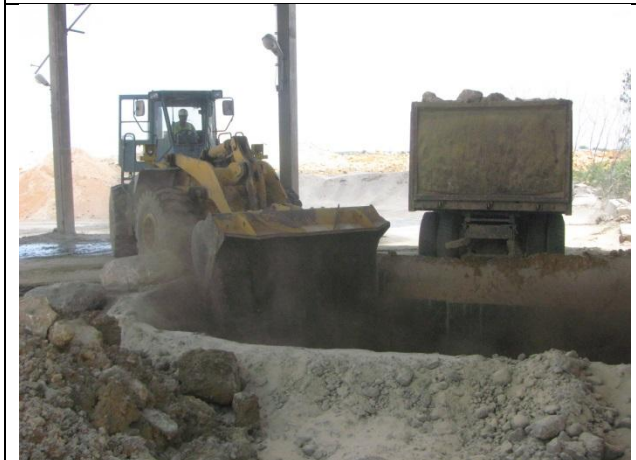
Fig.3:ETP sludge charging along with lime stone to the crusher

- The unit has handled/dumped the materials with a help of JCB dumper directly in to lime stone crusher along with lime stone. Crushed and blended lime store is stacked and reclaimed for raw meal preparation with a help of automatic stacker & reclaimer.

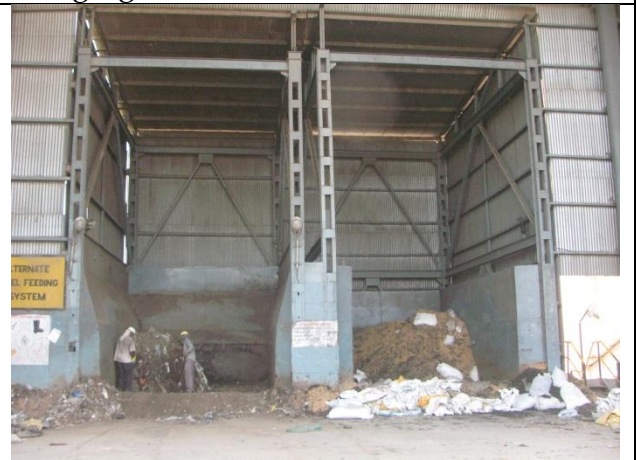
Fig.4: Alternate fuel charging arrangement (manually)

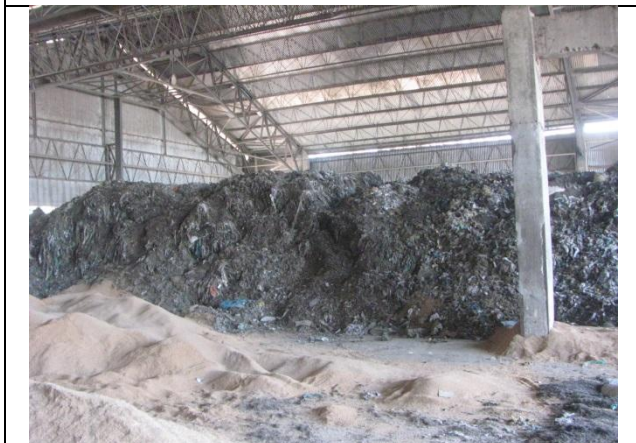
Fig.5: Alternate fuels stored in a shed (MSW, rice husk etc)

- The unit handles shorted municipal wastes, tyres, Paint sludge, and plastic as alternative fuel. The shed provided for handling of Municipal wastes are not enough, the shed shall be extended and leachate collection pit is to be constructed inside the shed.

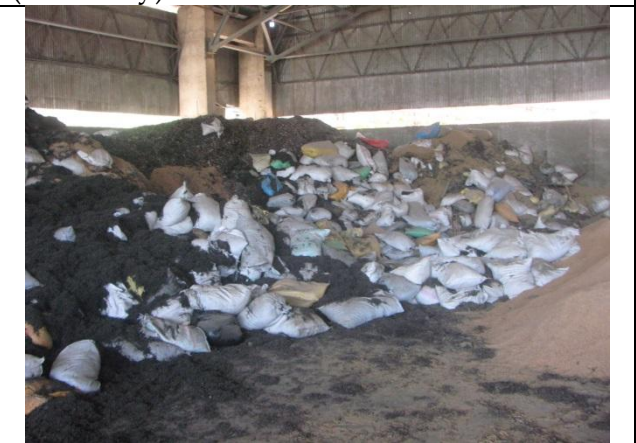
Fig.6: Alternate fuels stored in a shed

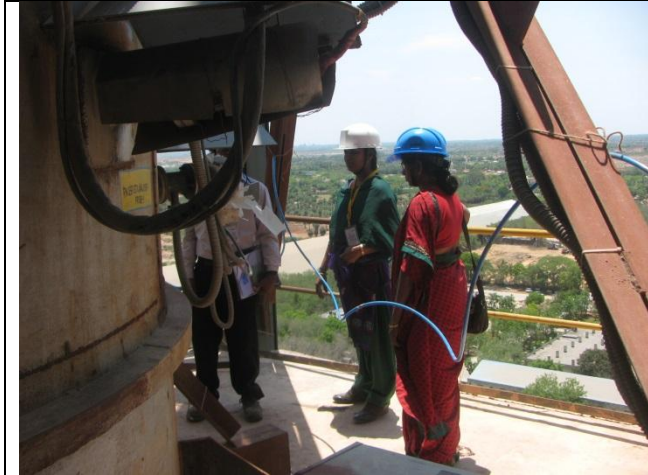
Fig.7: Stack monitoring witnessed by PCBs

The unit has provided ESP to control the particulate matter followed with a stack. The stack height is 82 M and 3.2 Meter dia. The CPCB team witnessed the co-processing of sludge in the kiln. The unit has engaged M/s Vimta Labs Ltd, Hyderabad carried out as per Guideline for normal operation; trail run at fixed % of H.W and normal operation for 5 days. **The summary of the emissions monitoring results as per protocol of monitoring for source and ambient will be submitted by M/s Vimta Labs Ltd.**

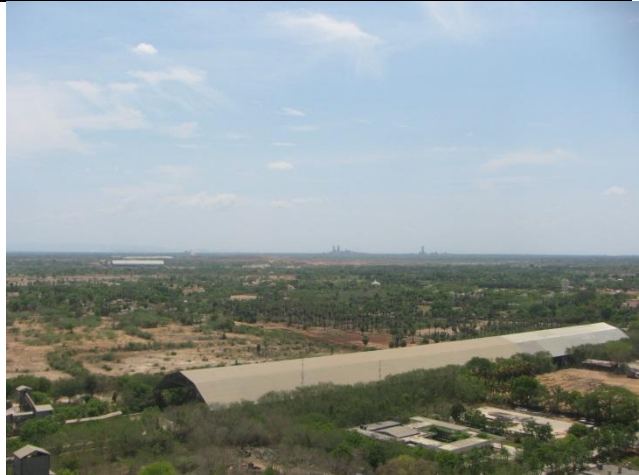
Fig.8: Shed with stacker & reclaimer for lime stone

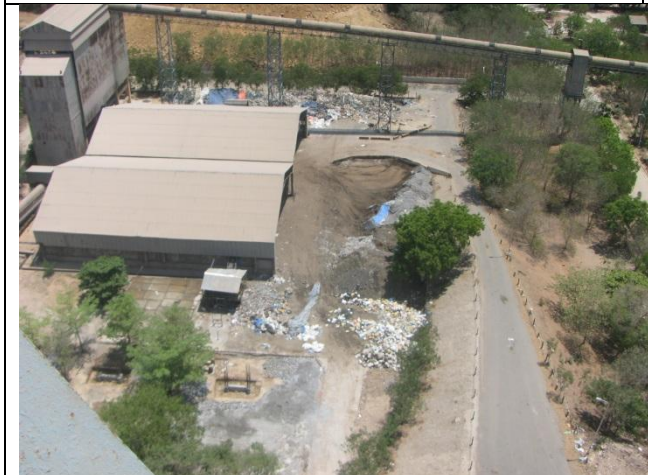
Fig.9: Sheds provided for AFR

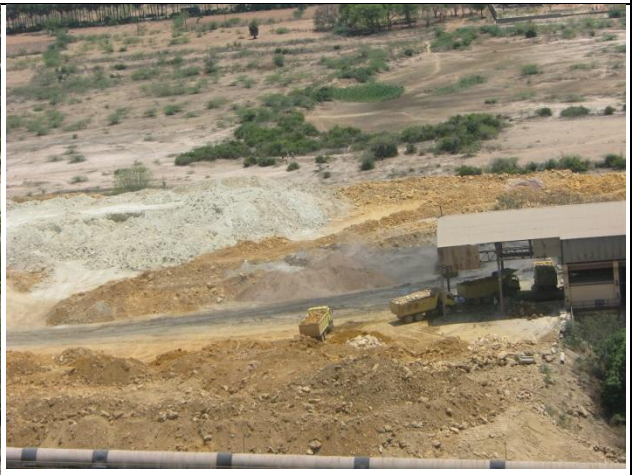
Fig.10: Sludge stored along with lime stone, charging area to the crusher

- The unit shall develop and maintain the sprinkler system to arrest fugitive emission at lime stone & ETP sludge loading area to arrest fugitive emission. Also to construct wind barrier around material handling area to arrest the carryover dusts.

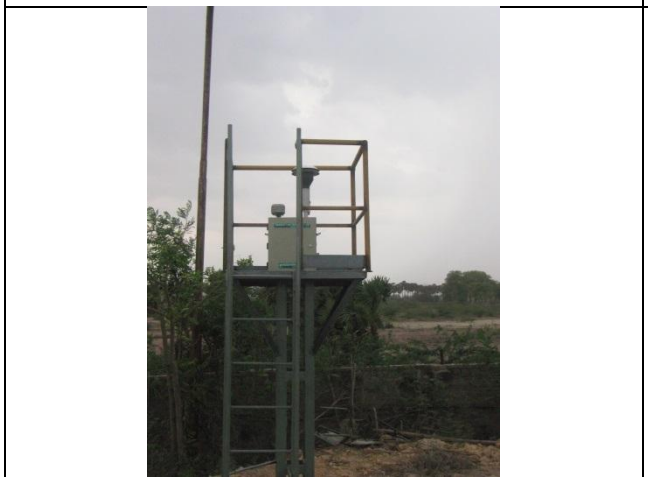
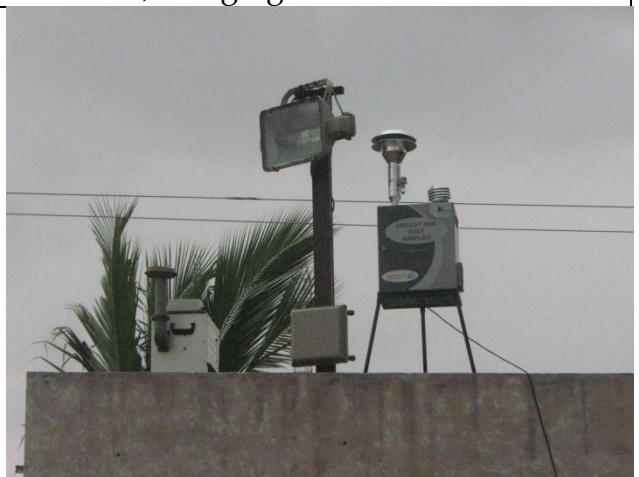
Fig.11: Ambient Air Quality Monitoring

Fig.12: Ambient Air Quality Monitoring

- As per the analysis report of IETP/CETP sludge, presence of traces of heavy metals was found, hence monitoring of heavy metals in source emissions and ambient air quality is required to assess the adequacy of control measures provided to kiln.
