**EVALUATION REPORT OF COMMON HAZARDOUS
WASTE TREATMENT, STORAGE AND DISPOSAL
FACILITIES**

**M/S KERALA ENVIRO INFRASTRUCTURE LTD.,
KOCHI, KERALA**

**South Zonal
Office,
Bangalore**

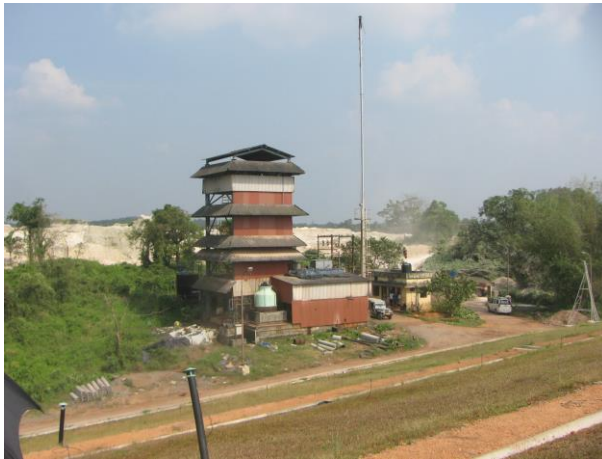
7. On the day of inspection the MEE was not in operation, the inspection team collected samples from leachate tank and the MEE condensate. The analysis results are given below:

Fig.1: Showing the Leachate treatment system (MEE) with boiler.

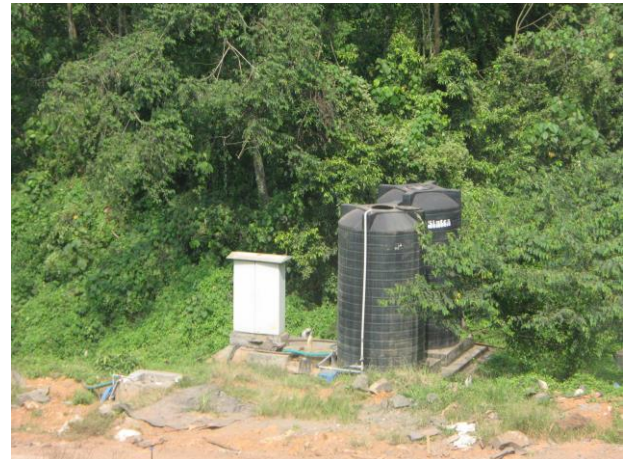
4. During inspection, it is observed that the unit has provided plastic tanks (Sintex) for collection of leachate and again re-pumped to MEE for treatment. In order to avoid pumping cost and operation difficulties, the unit may be directed to construct permanent RCC leachate holding tank near MEE and easy operation and to save energy cost.

Fig.2: Leachate Storage tank (Sintex) with pumping arrangement.

- To stop landfilling of waste which can be utilized for resource recovery.
- To direct the Kerala State Pollution Control Board to take appropriate measures to co-process incinerable wastes and to discourage landfilling.
- To construct permanent RCC leachate holding tank near MEE in place of Sintex tank for easy operation and to save energy cost in pumping.
- To start Monitoring of gaseous emissions from vents of capped cells for total VOC and H₂S
- To pave all internal roads with proper storm water drains to control fugitive emissions.

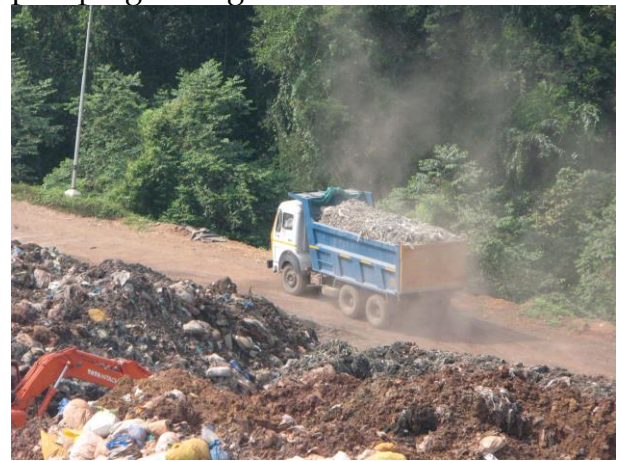
Fig.4: Truck carrying H.W. for landfilling directly.
